Condition Assessment
&
Reserve Fund Plan Update
2019

Sample Garden Condominium
Rockville, Maryland

RE: **CONDITION ASSESSMENT AND RESERVE FUND PLAN UPDATE 2019**
Sample Garden Condominium
Rockville, Maryland
Project No. 99999

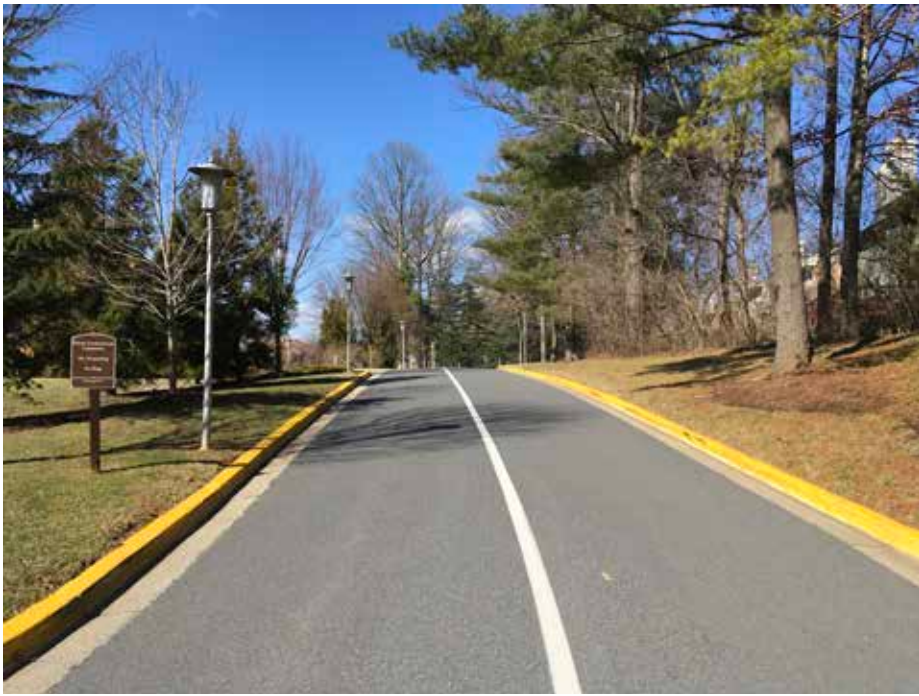
PHOTO #1
The asphalt installed in 2015 by Doitright Paving appears to be in generally good condition. However, some relatively odd areas of deflection were observed, which should be excavated, and the sub-base should be reconstructed. Repairs to the sub-base are an important part of asphalt maintenance and should be conducted routinely to maximize service life.

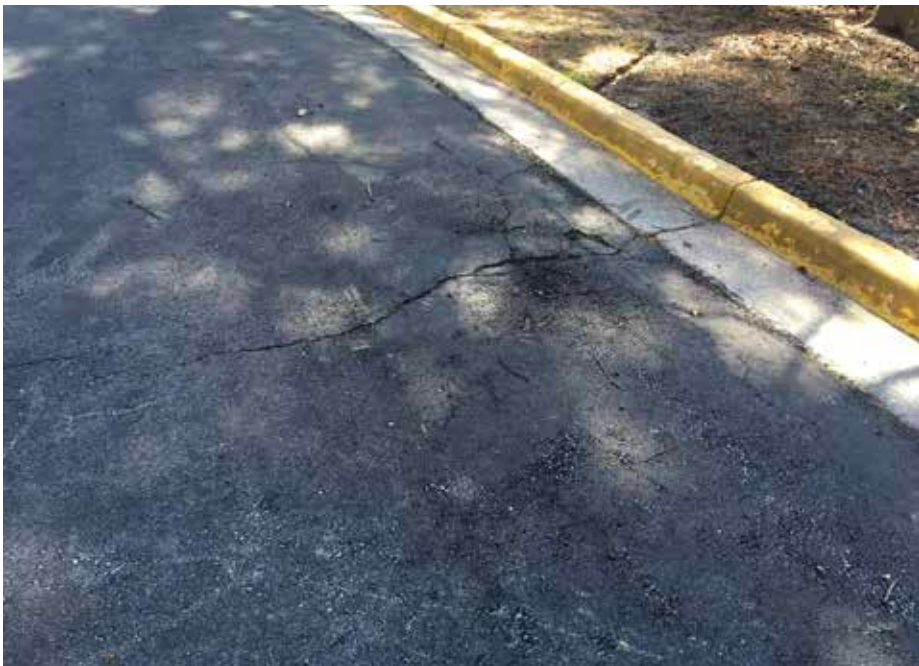
PHOTO #2
The 2013 asphalt overlay appears to be in generally good condition except for one section, which was overlaid with asphalt that was insufficiently thick. Because both ages of asphalt require repair, we have combined the asphalt restoration and repair projects.

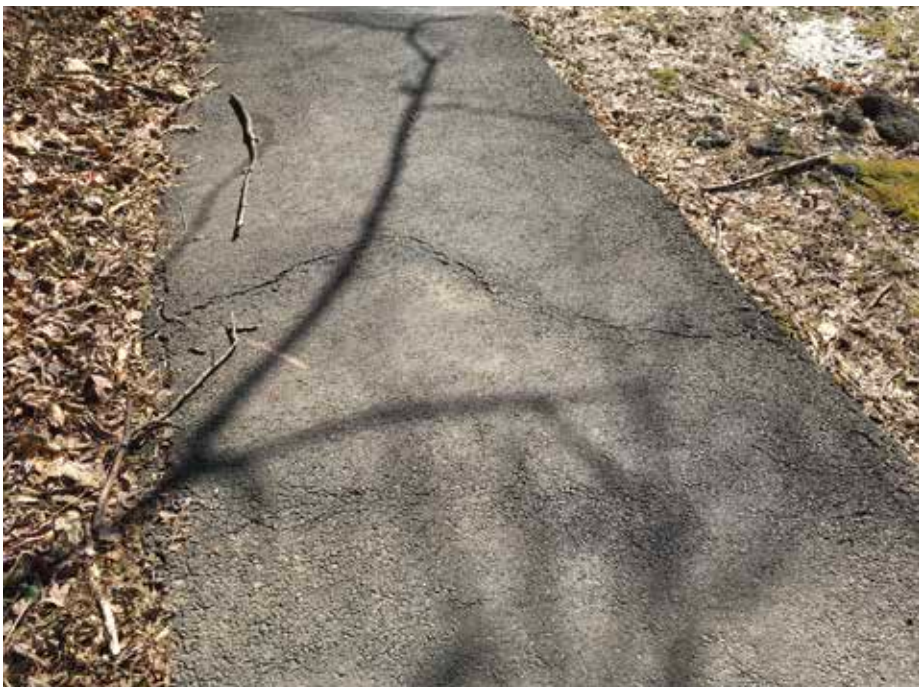
PHOTO #3
The asphalt footpath is in generally fair condition. Some areas are in the process of being covered by eroded soils and other sections have some tree root damage. We have scheduled a full restoration of the path, which should include the removal of tree roots and an overlay of at least two inches of asphalt to build up the surface above the adjacent earth.

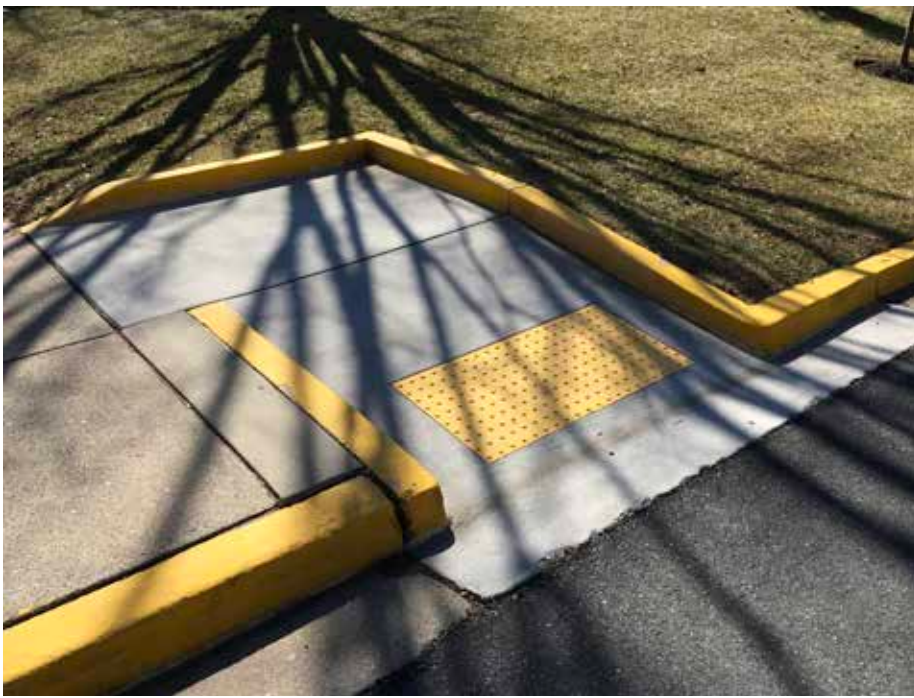
PHOTO #4

The concrete throughout the site is in generally very good condition. We have scheduled a few minor repairs for the 2019 cycle. Any potential tripping hazards should be corrected as soon as practicable.

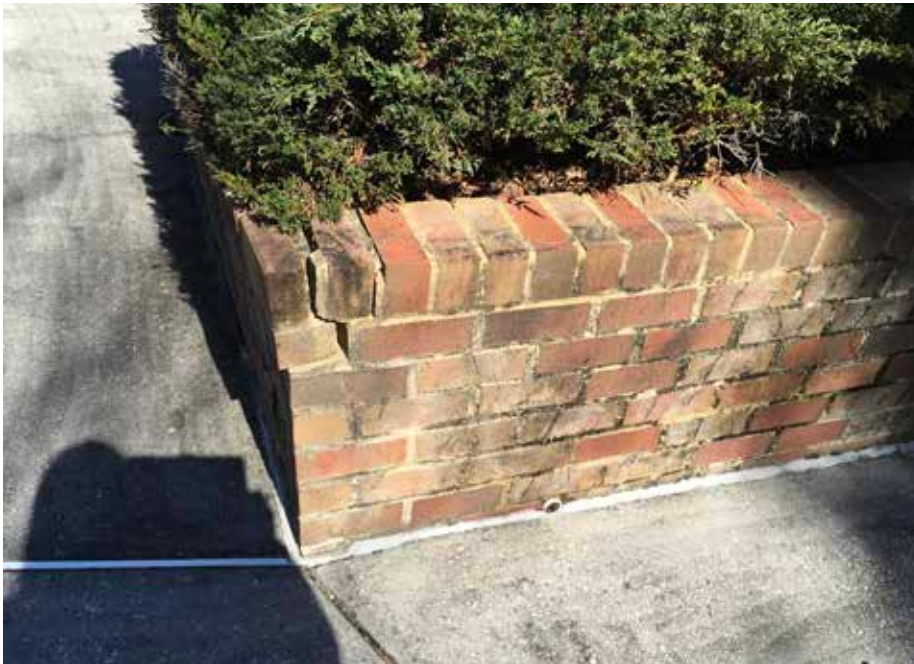
PHOTO #5

The brick retaining walls throughout the site are in generally good condition. However, the walls located within the pool complex were observed to be somewhat deteriorated. We have scheduled a repair and tuckpointing project near-term to address any wall deficiencies throughout the site.

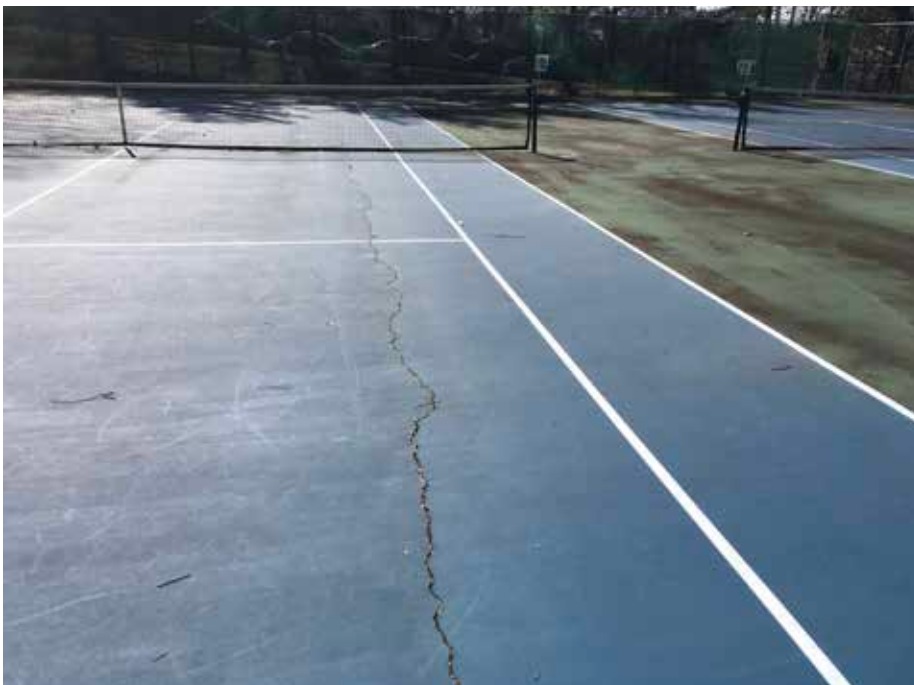
PHOTO #6

The tennis court was observed to have some transverse and lateral cracking throughout as well as cracking around the net post footings. We have scheduled a repair and color coat project near-term, which should be considered a life extension project until the full restoration, scheduled mid-term. The restoration should include an additional drainage provision, which may include the construction of a low retaining wall.

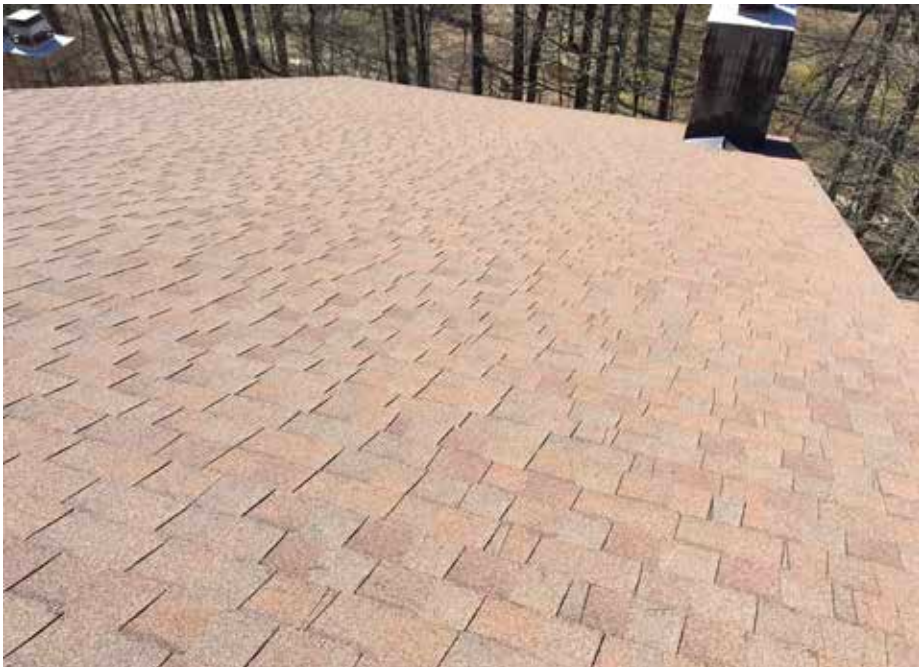
PHOTO #7

The asphalt shingle roofing appears to be in very good condition and the pool house roofing was recently replaced. No significant deficiencies were observed or reported.

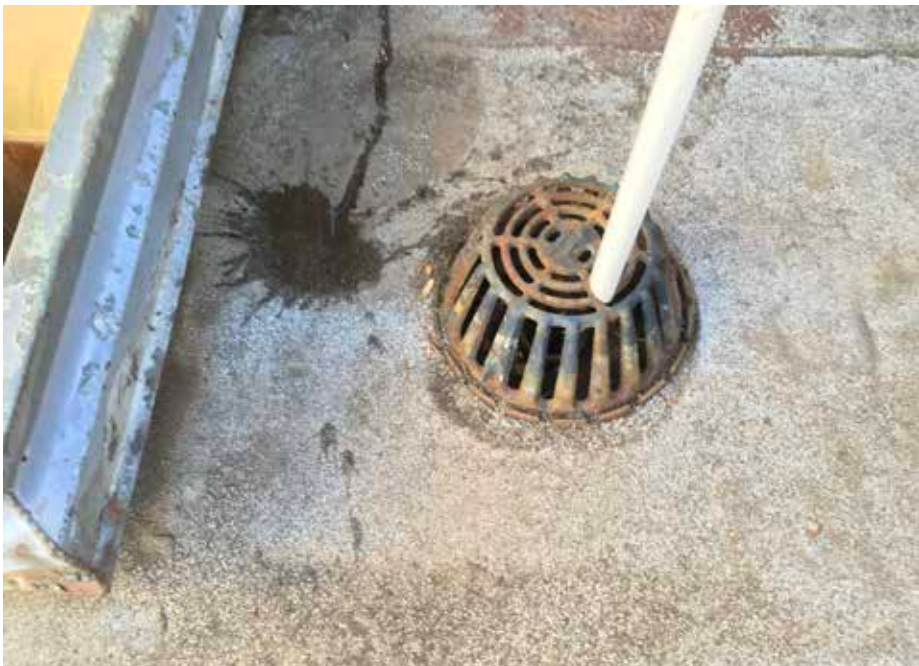
PHOTO #8

The flat roofs were constructed with centrally located roofing drains, which historically have been adequate. However, with the increased rainfall experience over the past few years, the drainage has become inadequate. We suggest an engineering study be performed to determine the best course of action to promote drainage. The membranes throughout are nearing the end of their service lives and have been scheduled for replacement.

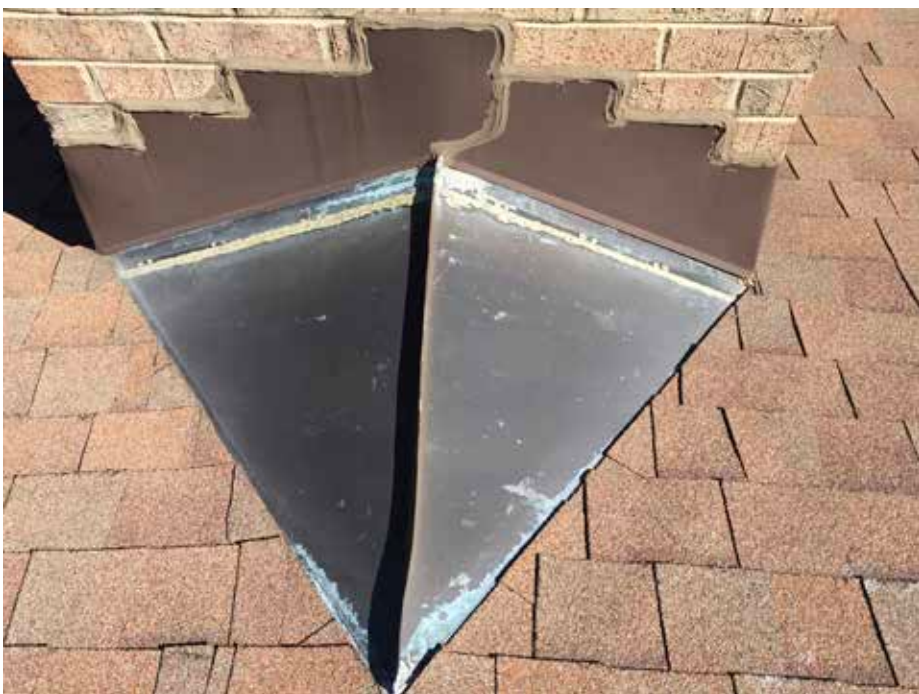
PHOTO #9

Localized water intrusion has been a problem in several locations and has manifested in efflorescent staining on the chimneys and some moderate damage to ancillary building components. An examination revealed that all chimneys are constructed with flashing and crickets. However, the water intrusion suggests that there is inadequate water proofing, which may be in part due to the cricket flashing having been installed under the shingles.

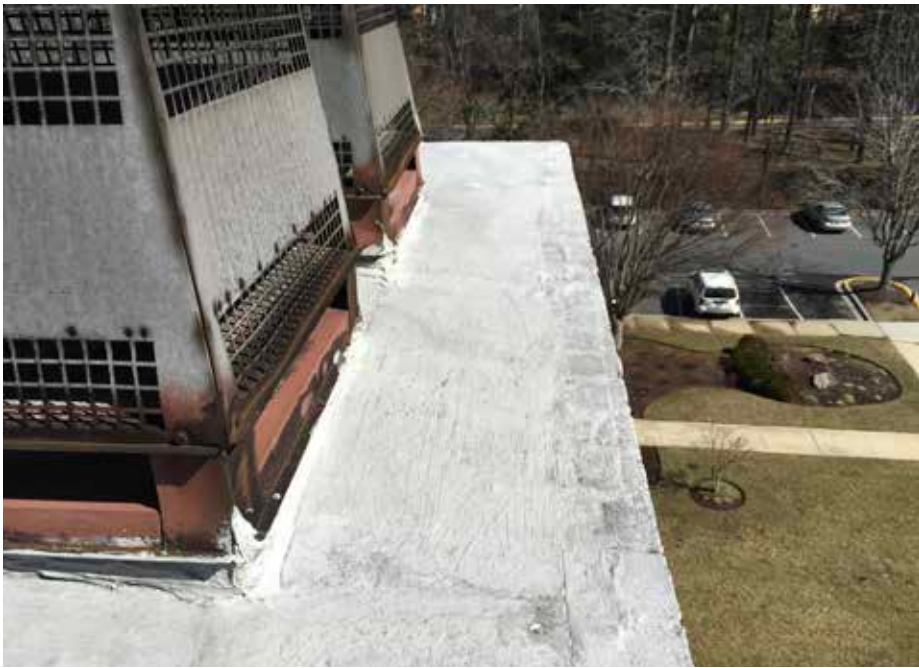
PHOTO #10
All chimney crowns have a liquid applied coating, which appears to be in good condition. However, the crowns and membrane should be water tested to determine definitively where the water intrusion is occurring.

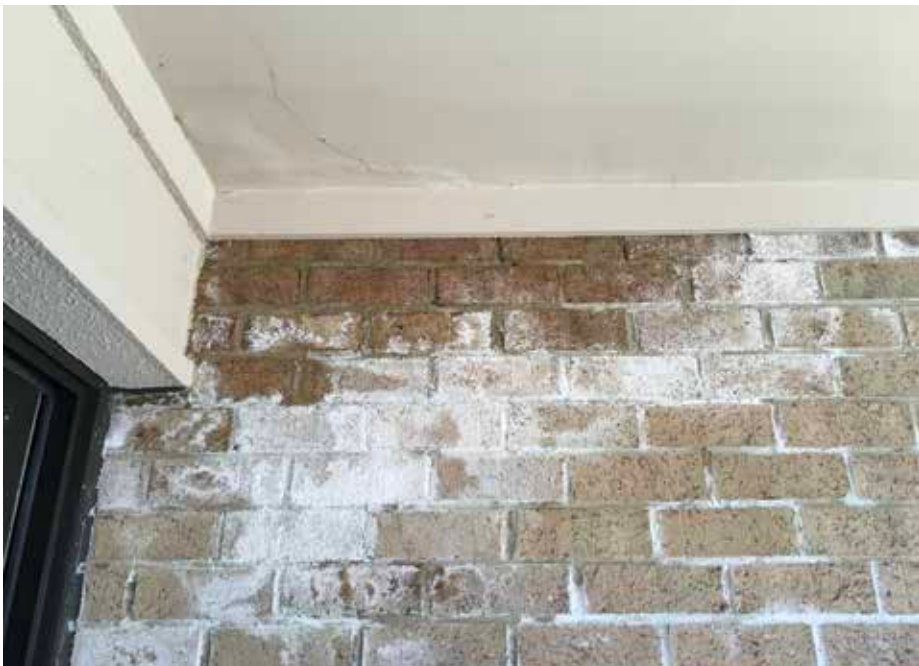
PHOTO #11
An example of stained brick and damaged porch drywall as a result of water intrusion. If not addressed, structural damage may occur.

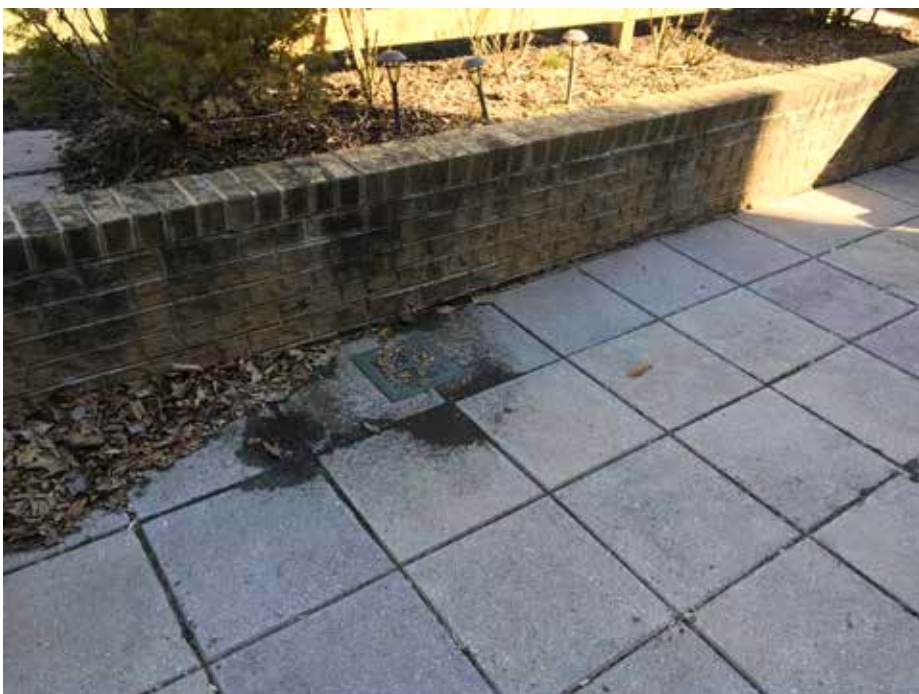
PHOTO #12
Cast concrete pavers were reported to be sand bedded on top of the liquid applied garage membrane. The system was reported to be reliable with no leaking reported.

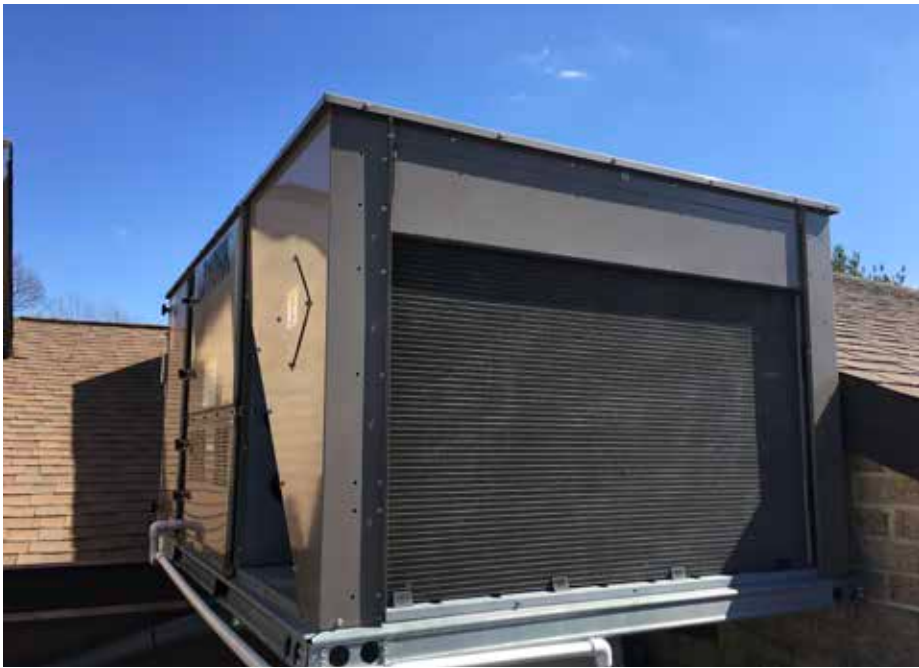
PHOTO #13
All corridor HVAC systems have been replaced. The units have been installed on steel beams, elevated above the flat roofs. The systems were installed without the benefit of air returns, which limits their ability to dry inside air. Engineering should be conducted to determine how to construct returns in conjunction with the roofing replacement project.

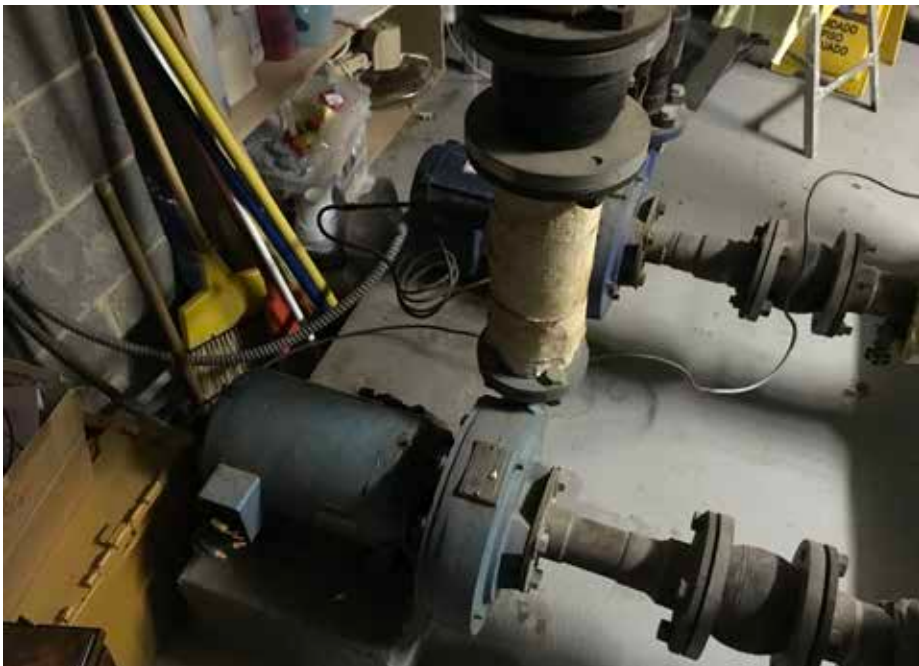
PHOTO #14
The domestic water supply booster pumps are seldom used because the city water supply is adequate most of the time. In addition to very light demand, the pumps are cycled, so that the demand is spread evenly between the two. This will significantly increase service life.

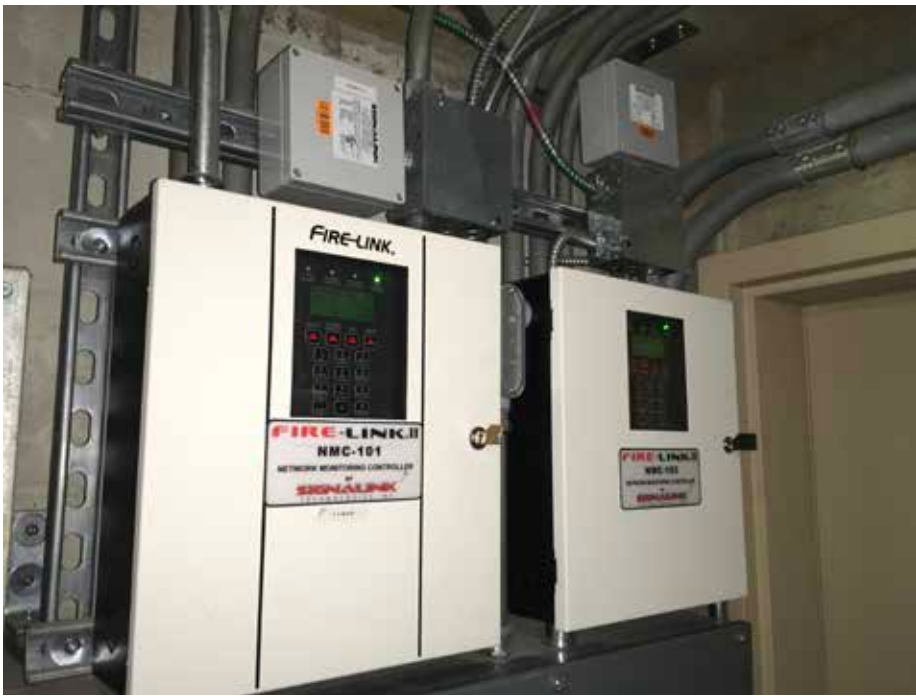
PHOTO #16
The fire alarm and suppression systems were reported to have been modernized and generally up to code. We understand that the suppression system check valves will be replaced in 2020 and every seven years thereafter.

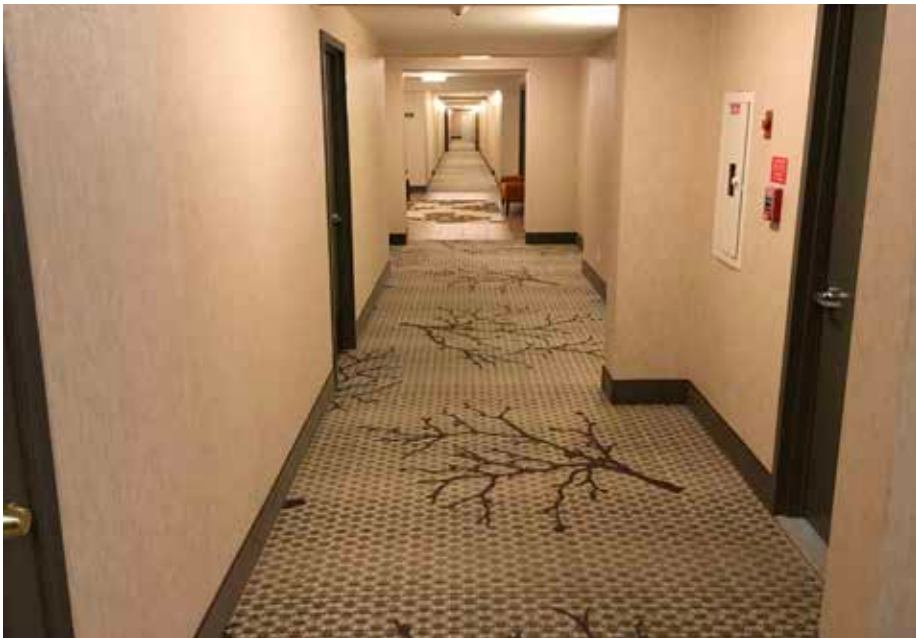
PHOTO #17
The interior refurbishment projects have been completed with the exception of the mailroom and garage lobby tile and the pool house interiors. These projects have been scheduled near-term at Management's request.

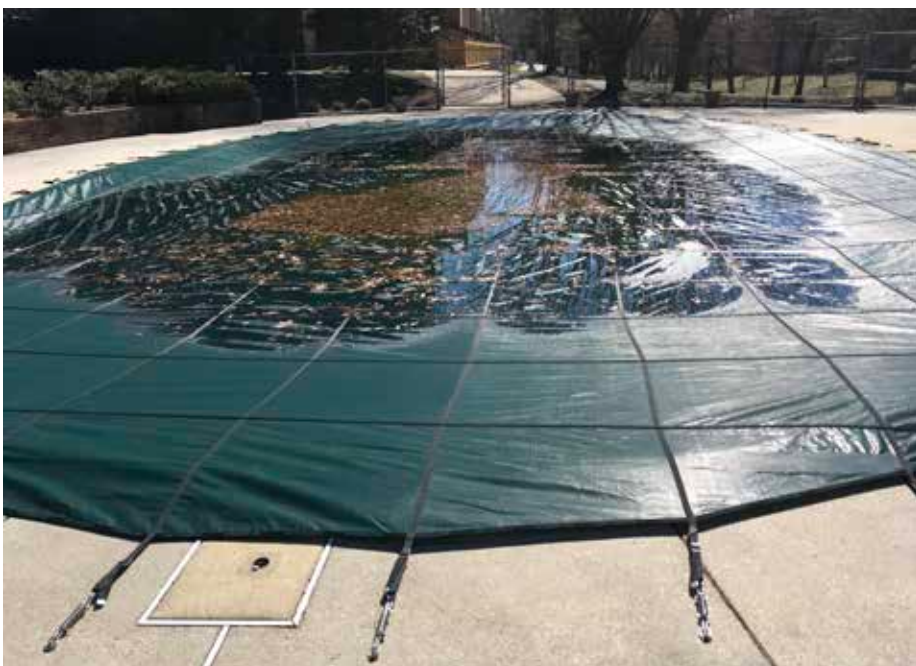
PHOTO #18
The pool was closed for the season and not observed. Management reported that the pool was in serviceable condition and the restoration has been scheduled mid-term.
