(Final Report, Revised August 11, 2015)
**Condition Assessment
&
Reserve Fund Plan Update
2015**

Sample

Bethesda, Maryland

RE: **CONDITION ASSESSMENT AND RESERVE FUND PLAN UPDATE 2015**
The Sample
(Final Report, Revised August 11, 2015)
Bethesda, Maryland
Project No. 7772

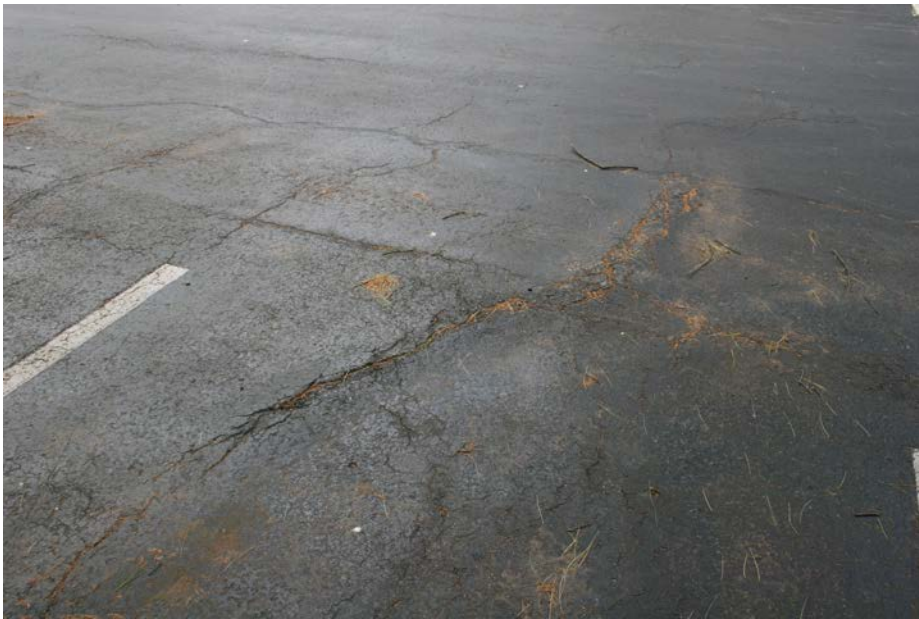
PHOTO #1
Some localized damage and tree root heaving is present in the parking lots. With localized repairs, the lots should be capable of additional service years.

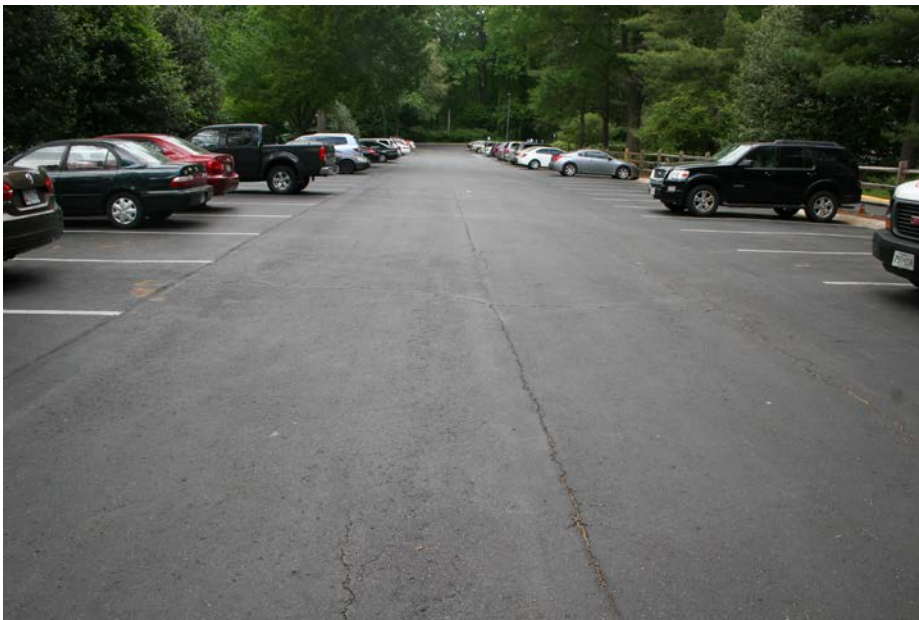
PHOTO #2
Some lots are in better condition than others. Typically, transverse and longitudinal cracking is present and will be crack filled this year.

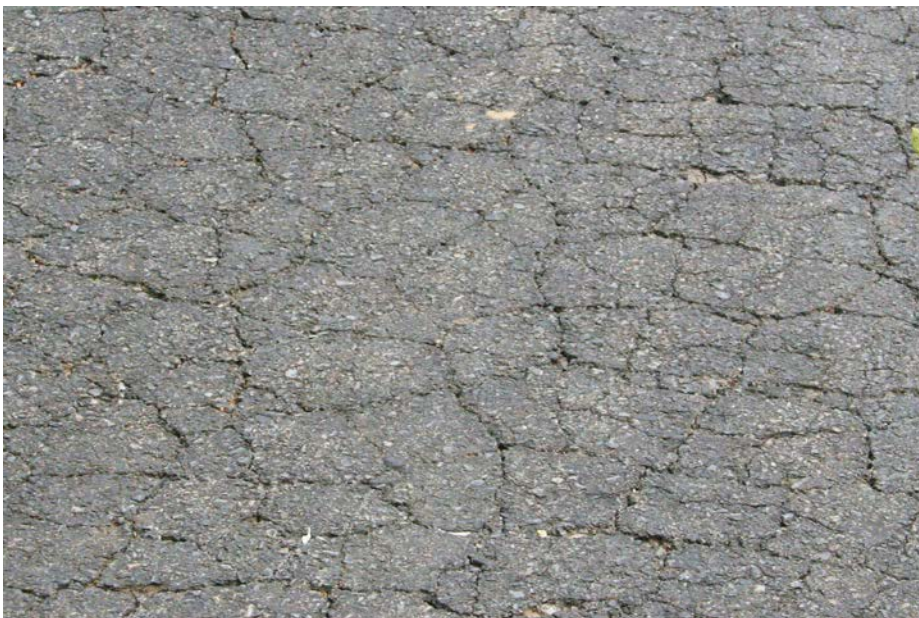
PHOTO #3
Localized areas like this are the final stages of deflection and pavement failure. All areas like this will be addressed with the pavement repair project scheduled this year.

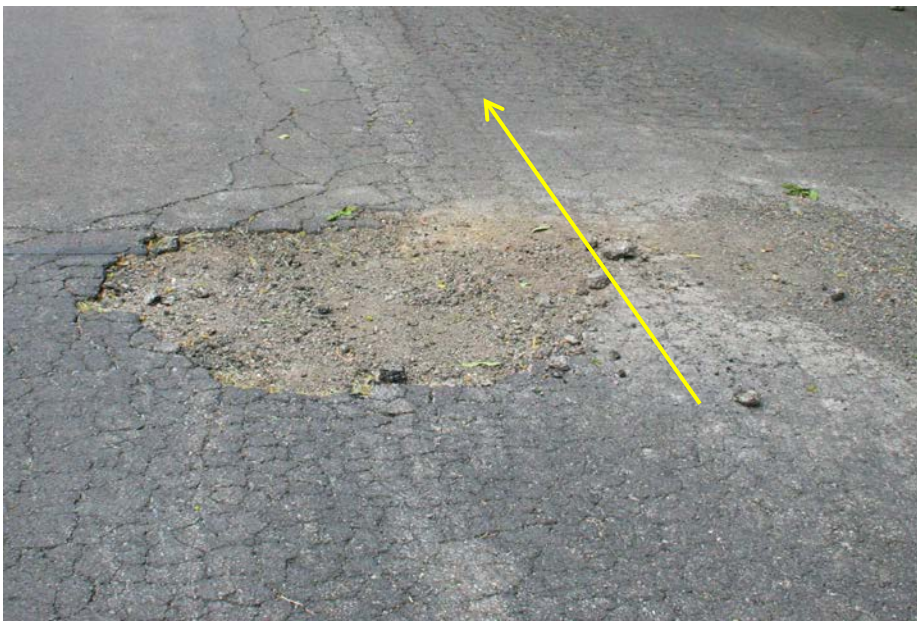
PHOTO #4

Here is the final stage of pavement failure where the deflected pavement is worn down to a pot hole. These areas will be completely re-built during the pavement repair project. Note the poor pavement condition above the pot holes where an overlay restoration was performed without benefit of removal of the older deflected pavement.

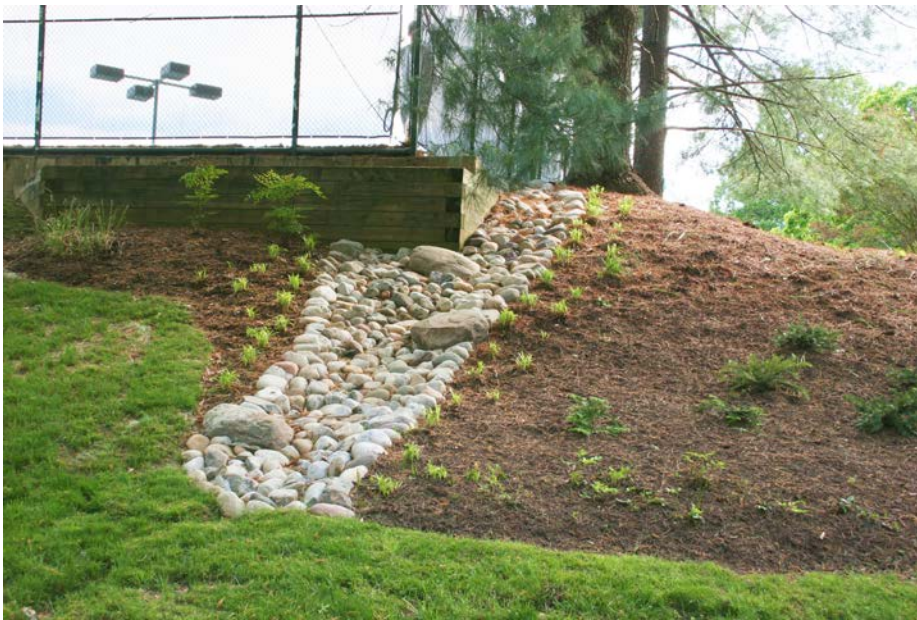
PHOTO #5

Erosion control measures have been accomplished through the site and are attractive and functional.

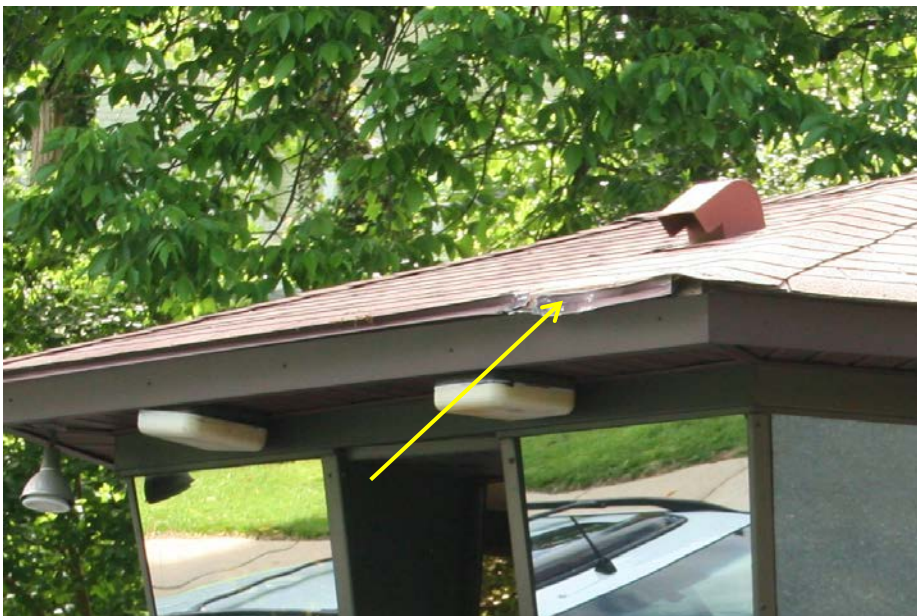
PHOTO #6

This impact damage to the Gatehouse roof was present in 2012 and has not yet been repaired. While a minor issue, it should be addressed.

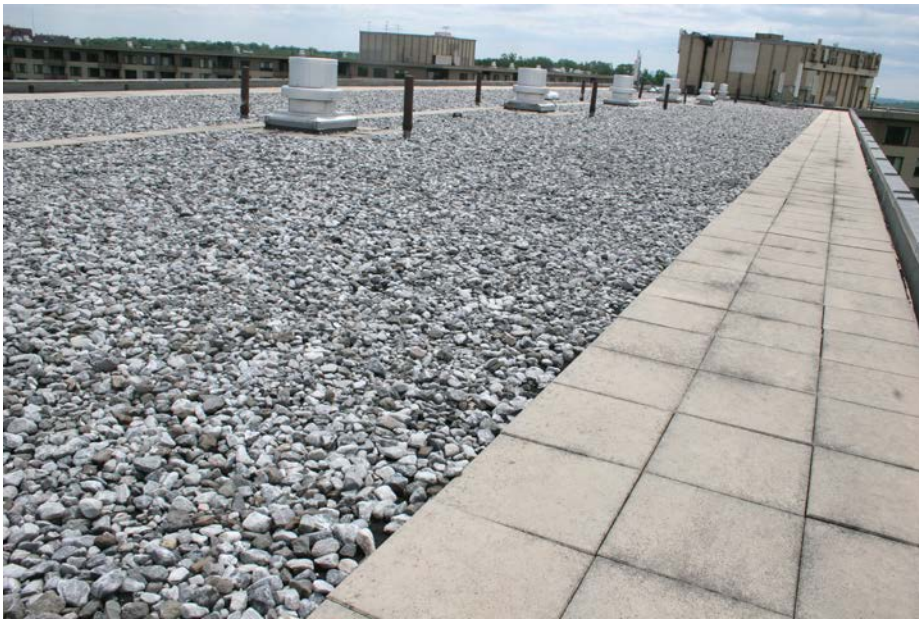
PHOTO #7
Overview of the 1998 roof field showing ballasted roofing and pedestrian pavers. Generally the roofing appears to be holding up well and may be capable of additional service years beyond the projected twenty.

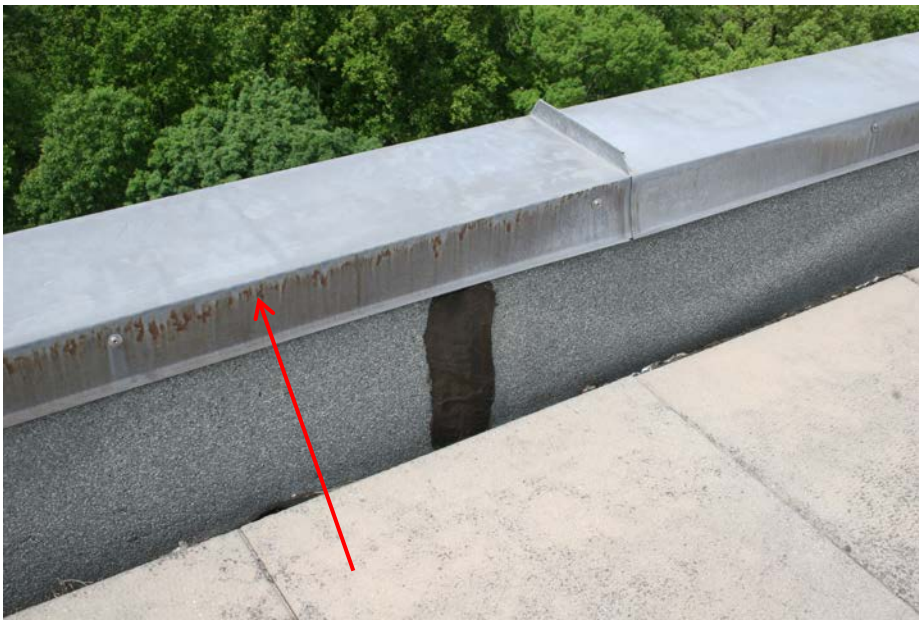
PHOTO #8
The galvanized metal parapet copings are in continuing good condition, but are beginning to rust from exposure to weather.

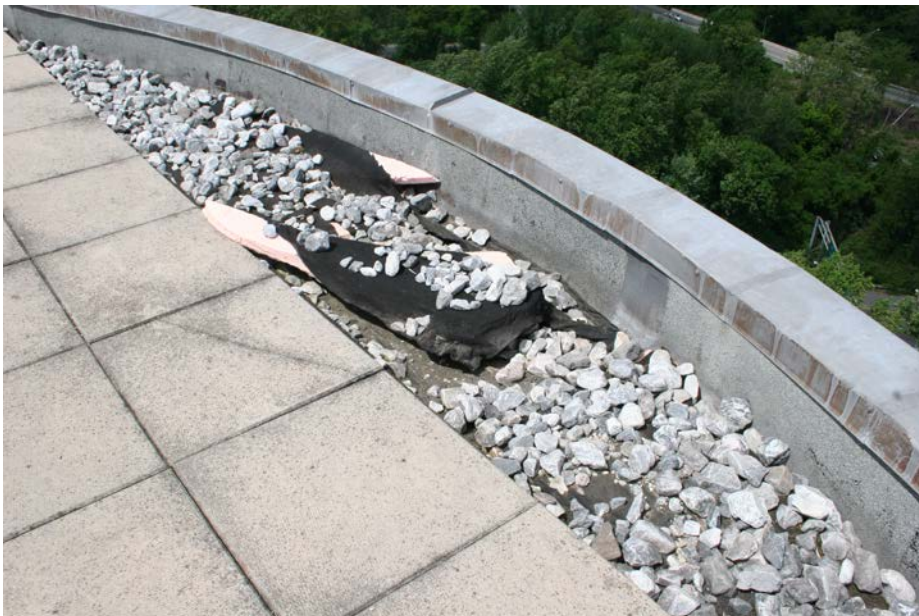
PHOTO #9
Filter cloth and insulation has been disturbed here leaving the membrane exposed. Areas like this should be addressed under the preventive maintenance contract.

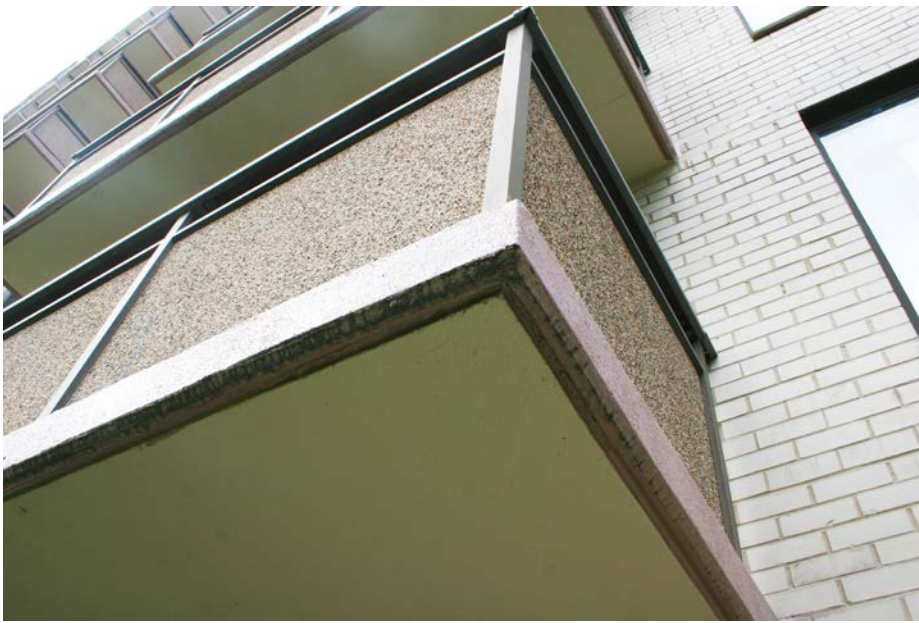
PHOTO #10
Generally the balcony soffits and edge coatings appear to be in continuing good condition.

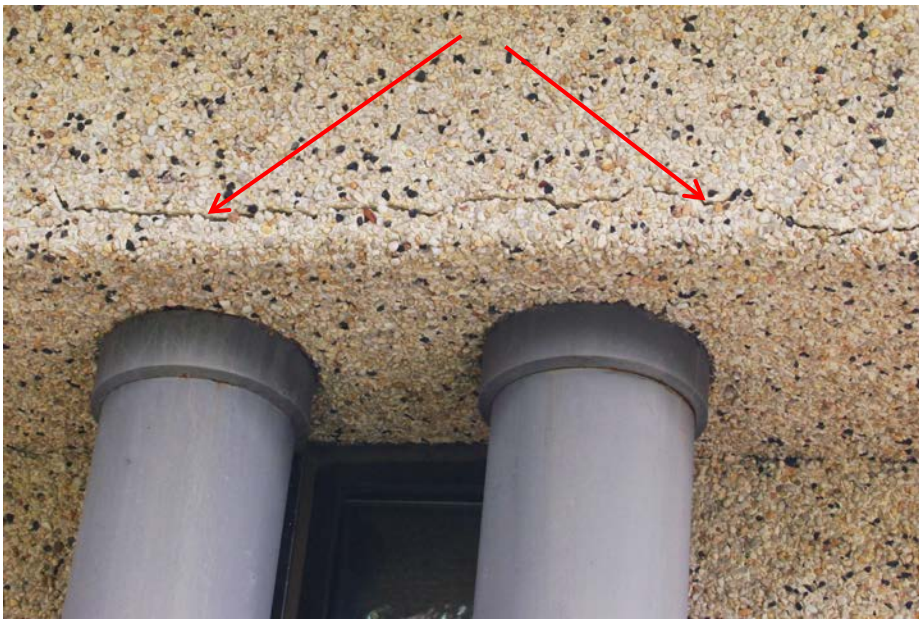
PHOTO #11
This cracking in the aggregate coated precast structure at the entrance side elevation should be evaluated. It may be just a surface issue, but it could also be an indication of a more serious problem.

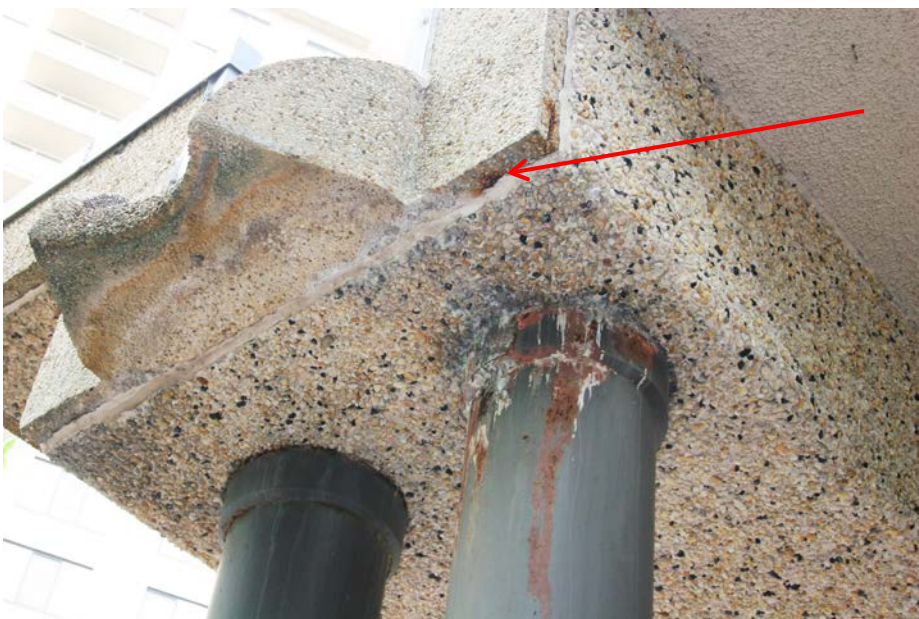
PHOTO #12
The precast components have been exposed to weather for over 40 years now and are beginning to show their age. Rust on the panel (red arrow), and on the metal columns should be addressed.

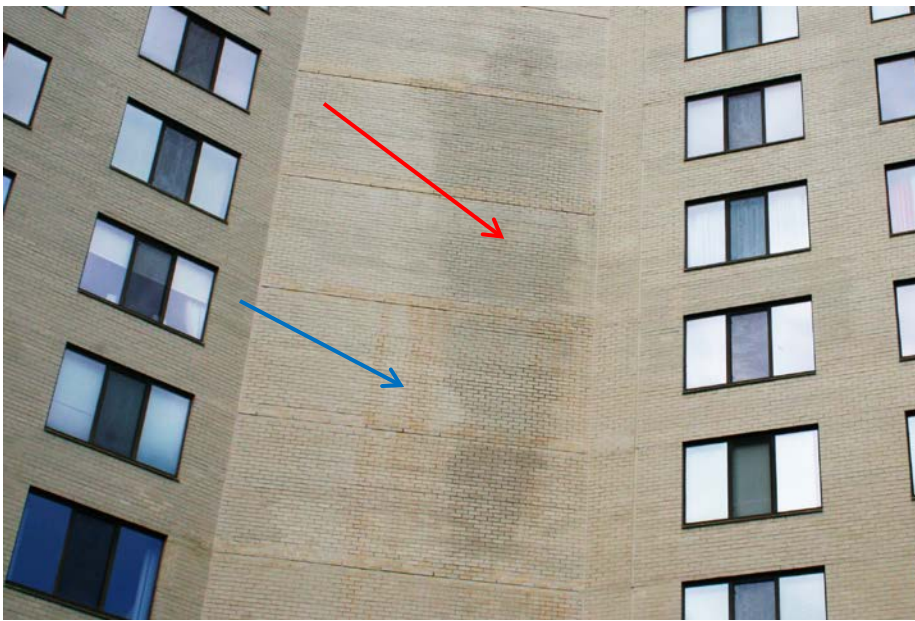
PHOTO #13

It had not rained at the site for several days and the dark area (red), appears to be wet. Also, rust stains (blue), appear to be extending down from each floor shelf angle. This area of the façade was repaired a few years back and may require additional investigation.

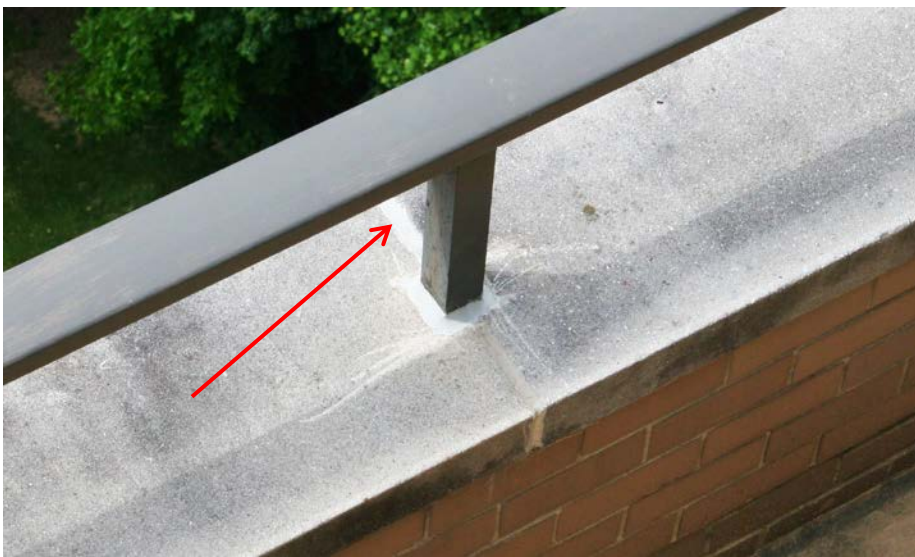
PHOTO #14

Coping joints and embedded post pockets at railing mountings appear to be in well-maintained condition.

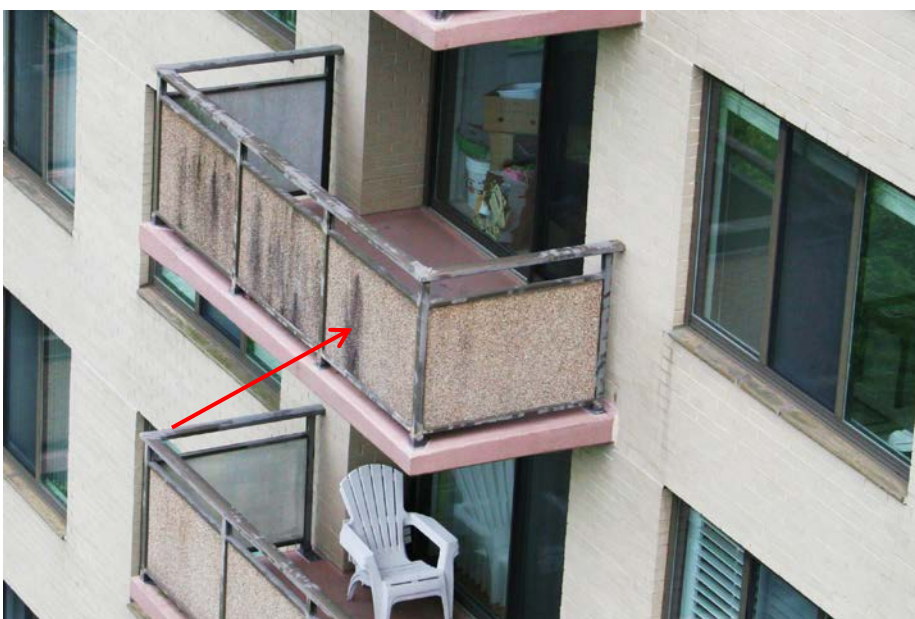
PHOTO #15

Some of the aggregate balcony panels are weathered and stained. Many railings appear to be tired and weathered. This condition should be addressed at some point in the future, possibly as part of the next interim balcony coating project.

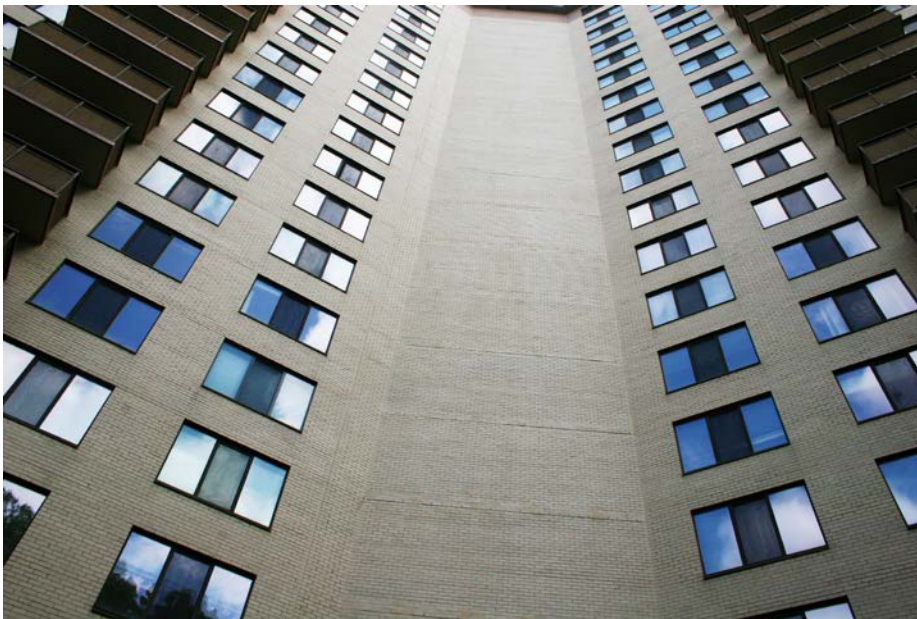
PHOTO #16

The façade masonry here appears to be sound and no veneer bulging is visually evident.

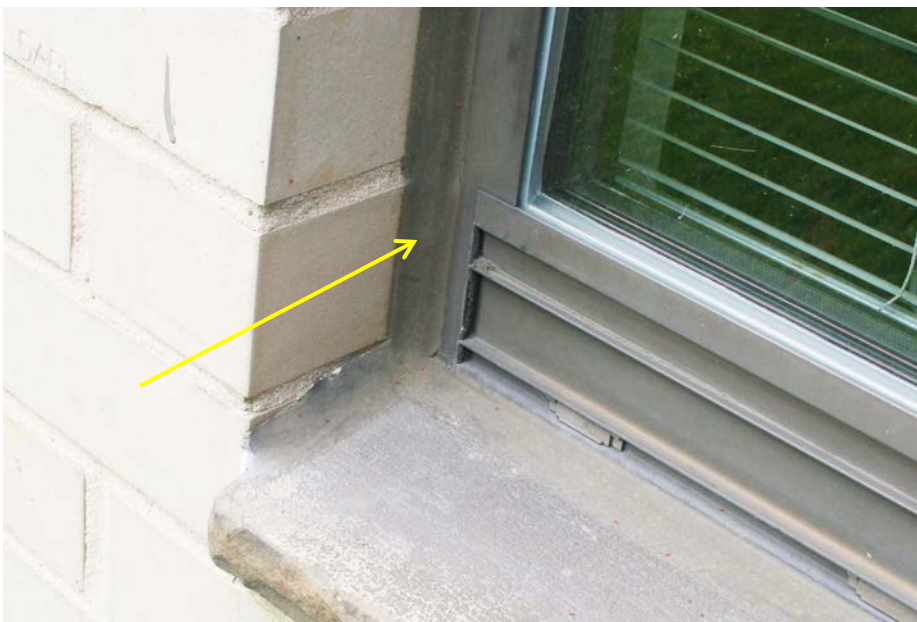
PHOTO #17

Soft sealants at window frames/masonry interfaces appear to be holding up better than anticipated. We have extended the service life. However, this presents a timing problem due to coordination with other exterior projects in the future.

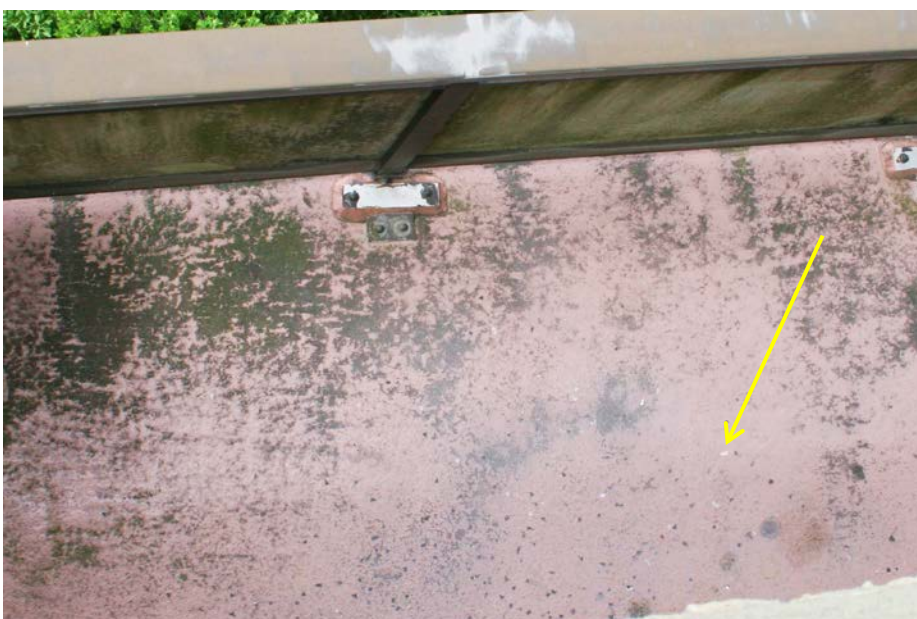
PHOTO #18

The balcony coatings are beginning to peel on some balconies. We have scheduled a small percentage of interim coating renewals annually until the full project, which is scheduled in five years. This condition was not anticipated and should not be occurring.

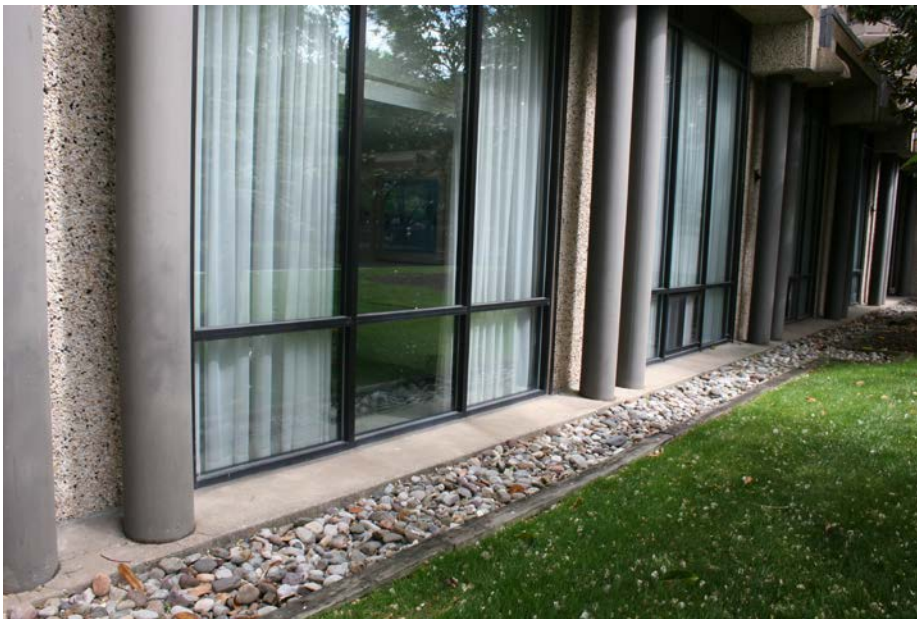
PHOTO #19

This area is above the Party Room and is the site of apparent water infiltration. A project to investigate the basement wall and perform appropriate waterproofing and/or other mechanical systems is scheduled near-term.

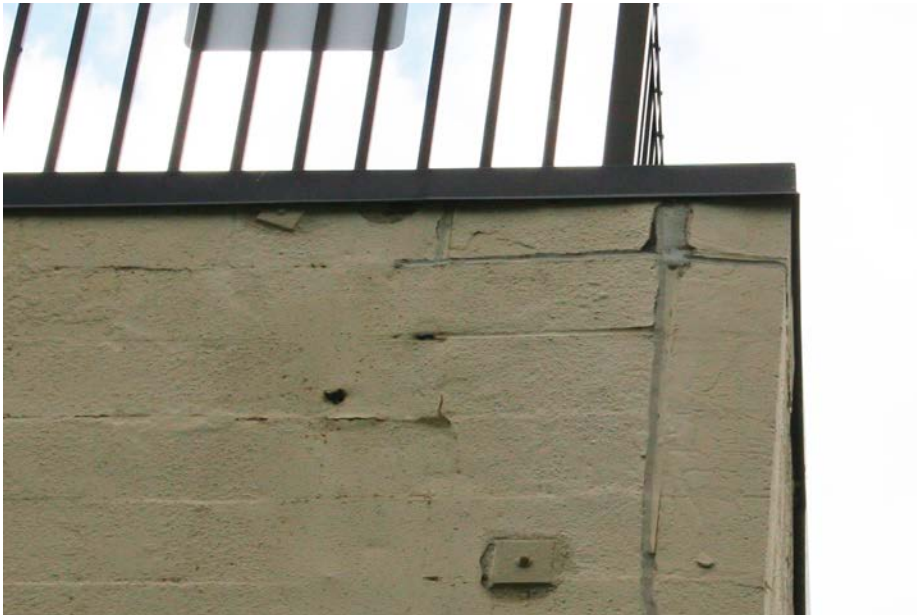
PHOTO #20

The garage wall has had numerous repairs over the years. This corner area now appears to be deflected and should be investigated.

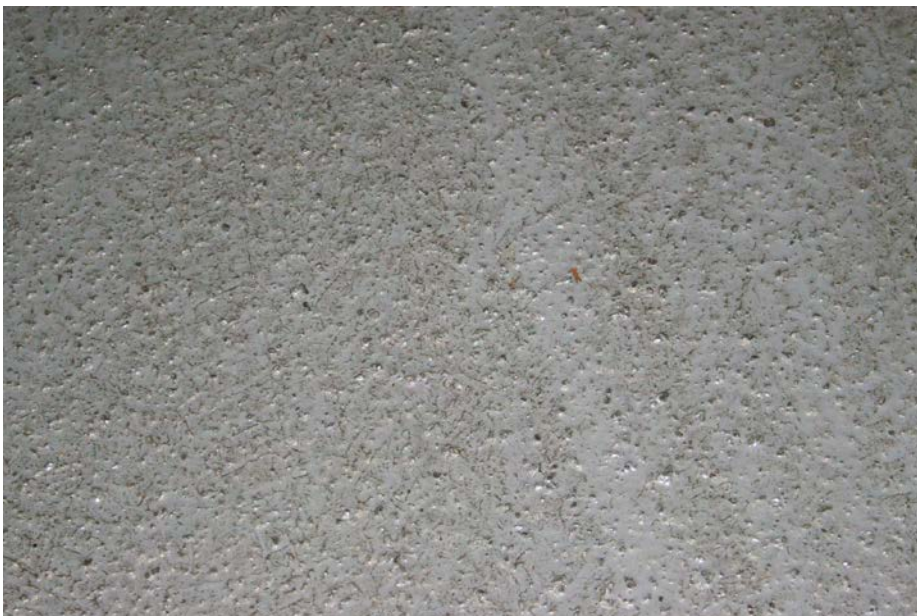
PHOTO #21

The garage elevated decks have been coated with a urethane traffic bearing coating. The coating appears to be holding up well with no significant wear or peeling observed.

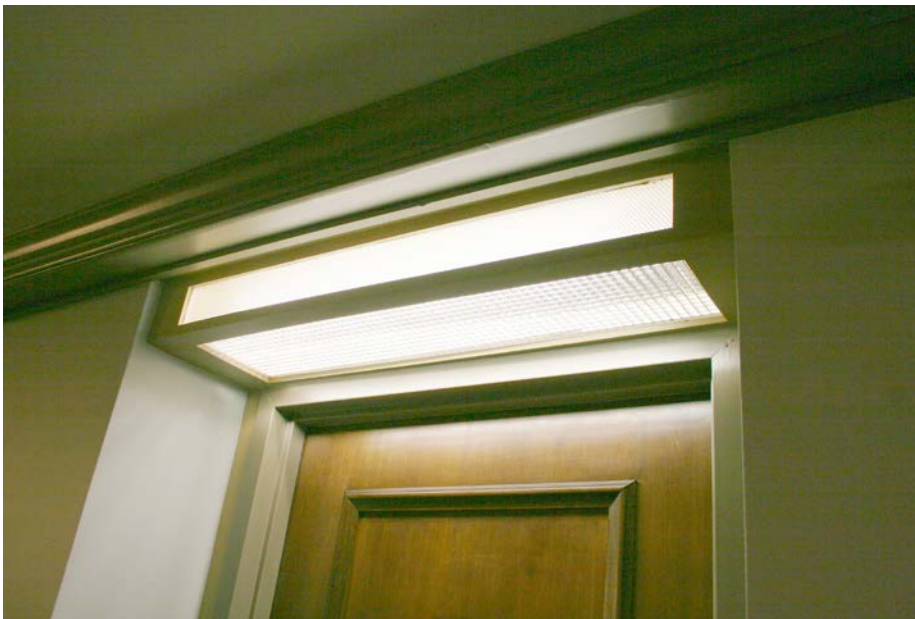
PHOTO #22
As part of the corridor restoration project, “top hat” lighting fixtures will be installed above all unit doors. This will be a welcome improvement to the overall lighting situation of the corridors.

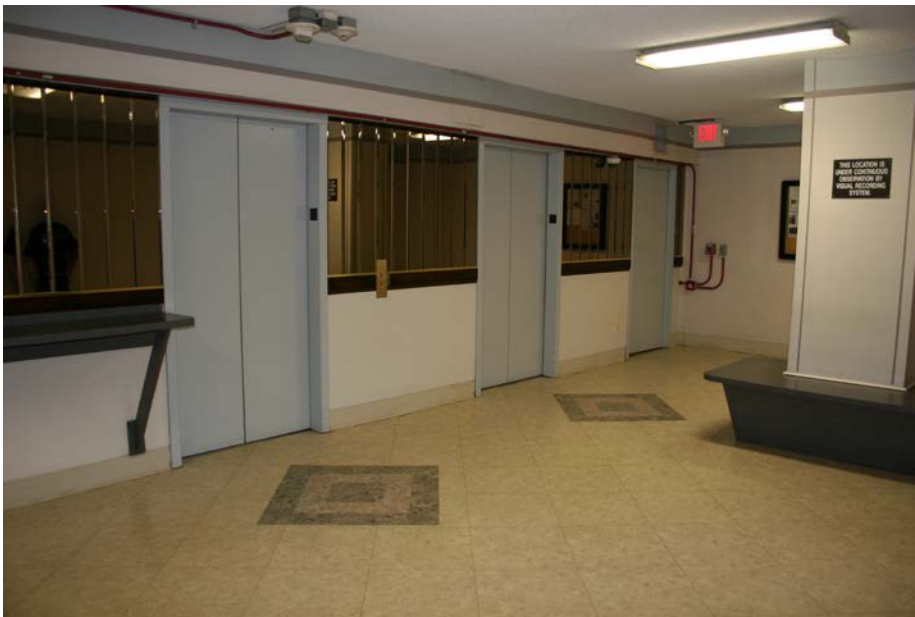
PHOTO #23
The garage elevator lobbies and the service lobbies will also be upgraded near-term.

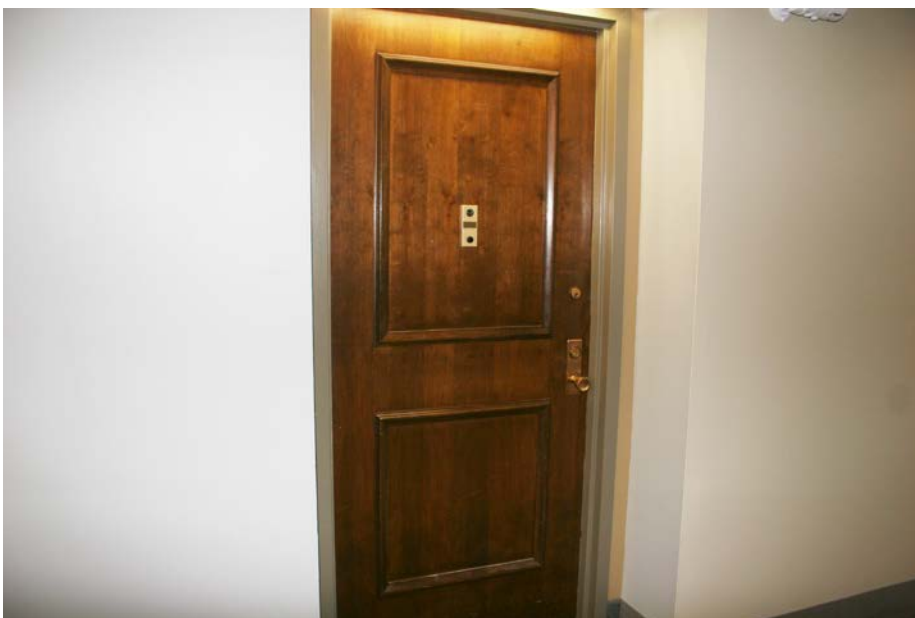
PHOTO #24
All unit doors will be retained in the corridor refurbishment project, but will be carefully re-finished.

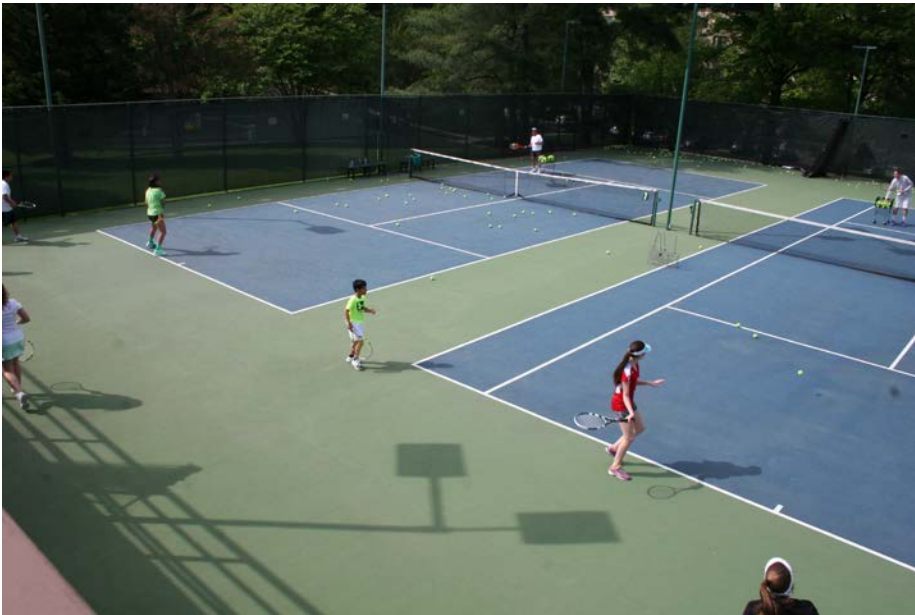
PHOTO #25

The tennis courts were all restored a few years back and appear to be in continuing good condition.

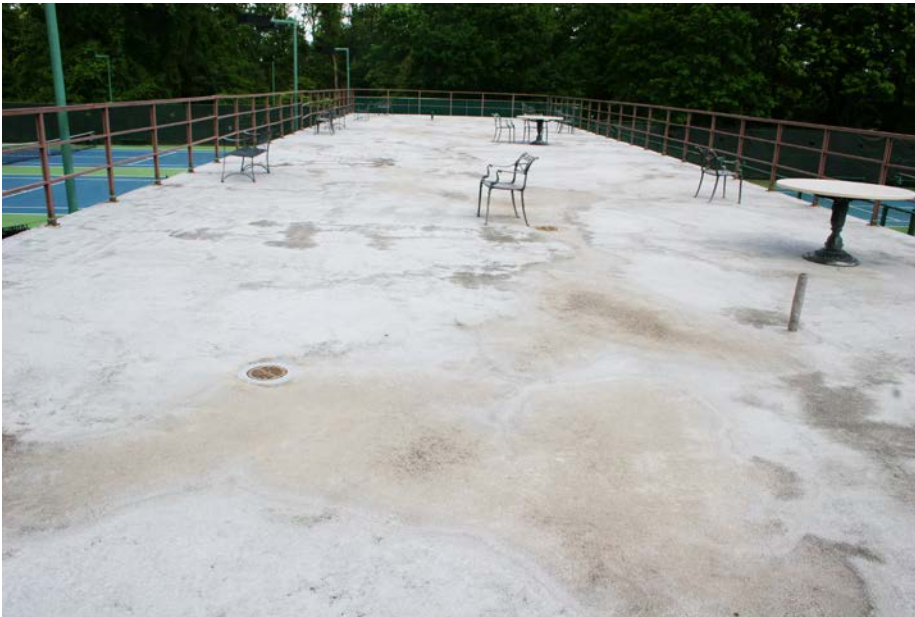
PHOTO #26

The tennis observation deck coating is weathered and scheduled for near-term renewal.

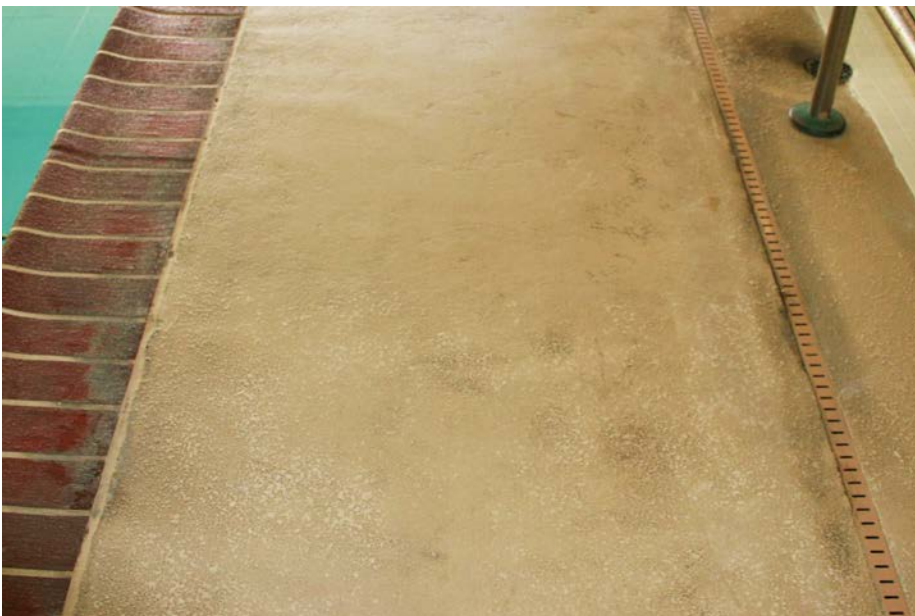
PHOTO #27

The indoor pool deck pedestrian coating has been problematic and attempts to repair have not been successful. A full removal and re-application has been scheduled near-term.

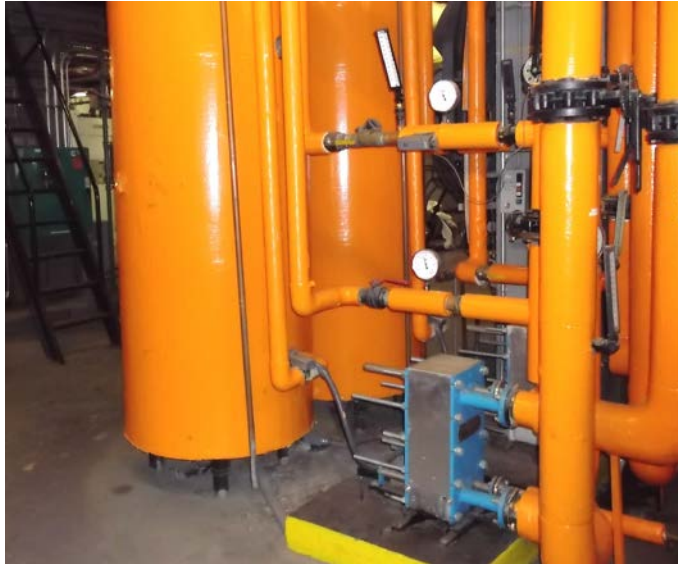
Photo #28

Typical of four domestic hot water heat exchangers – two per tower and their associated indirect-fired domestic water heaters. The heat exchangers are due for maintenance and Management has advised of the purchase of rebuild kits to limit down time.

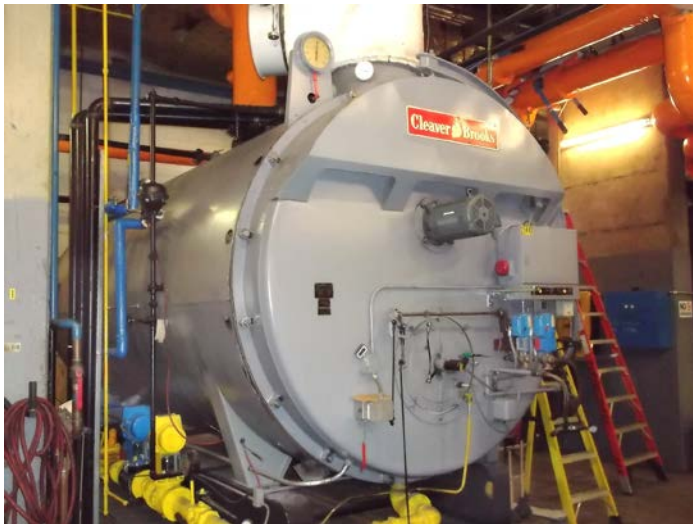
Photo #29

One of three original Cleaver Brooks Scotch Marine steam boilers in continuing viable condition with upgraded burners.

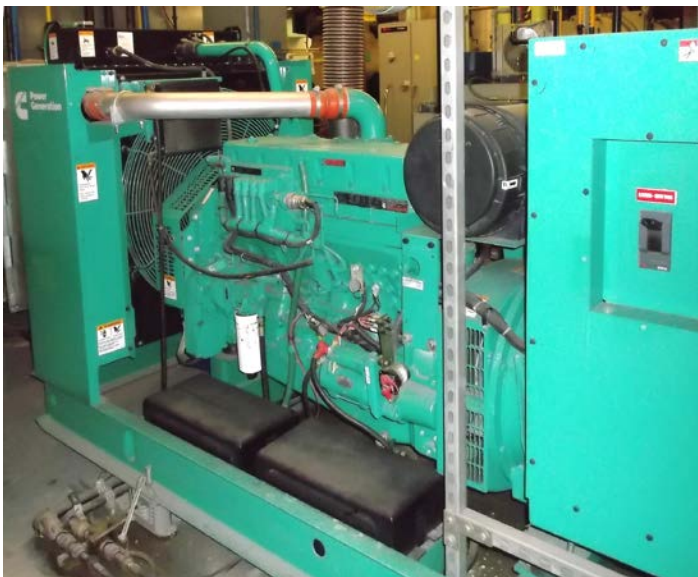
Photo #30

One of two replacement emergency power generators. The automatic transfer switches were rated at 250kW; however, the generators (based on nameplate date) are rated at 300-kW.

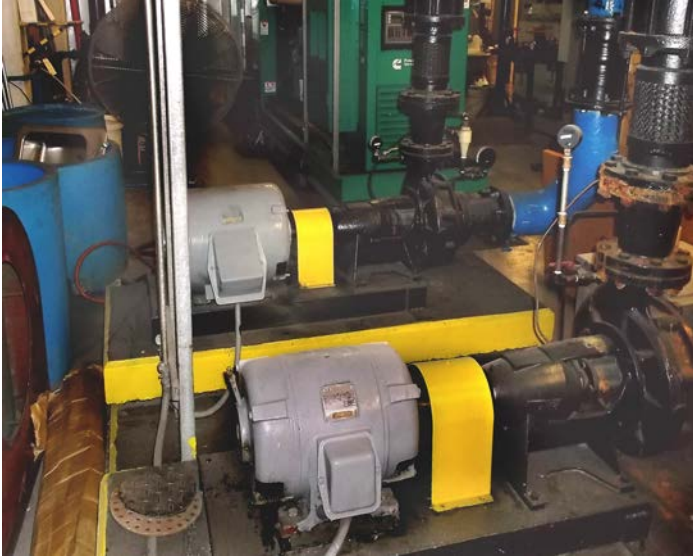
Photo #31

Domestic water booster-pump system typical for both towers. Since they are not pressure regulated systems and are due for replacement, they will require replacement with modern packaged systems utilizing VFD pump motor drives.

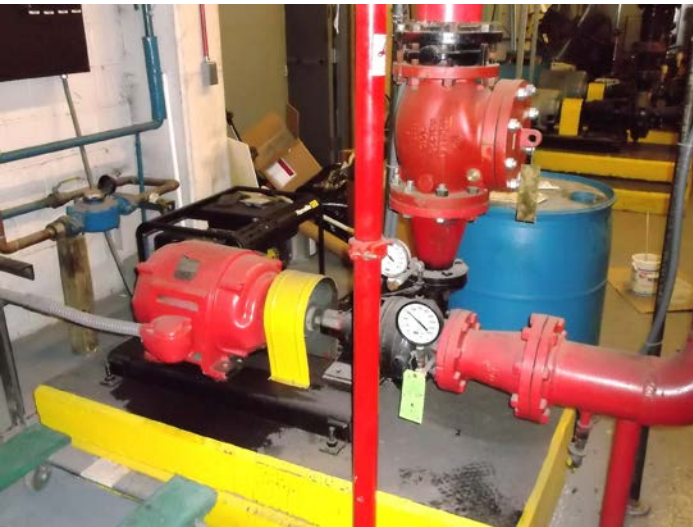
Photo #32

Fire suppression standpipe water booster pump system. These pumps appear to be well maintained and were only serving as a pressure boosting system for the standpipe hose connections.

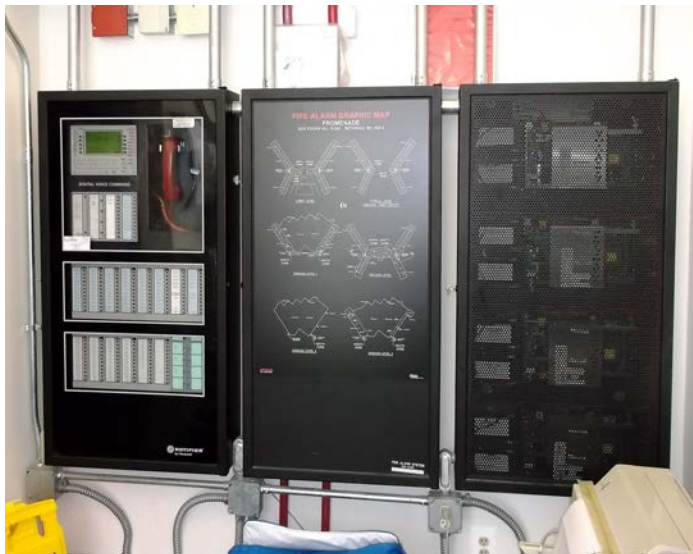
Photo #33

Replacement fire alarm system control panel that was part of a full fire detection and alarm system replacement and upgrade to an addressable system with voice evacuation and fire-fighter communications.

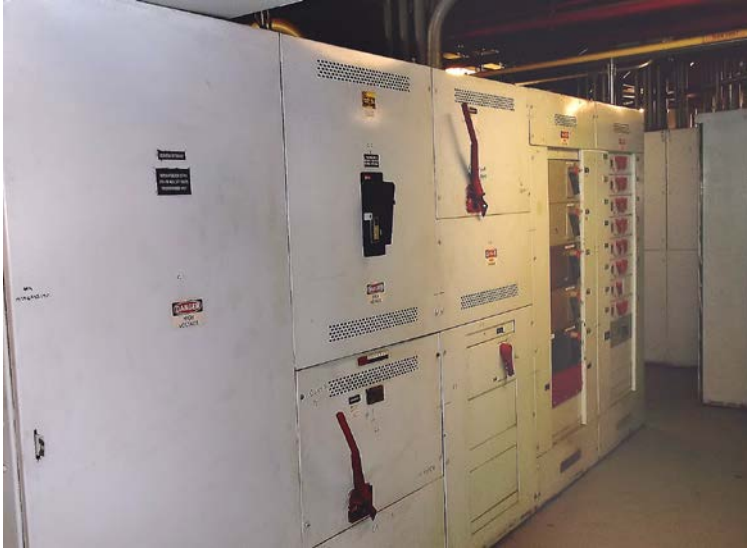
Photo #34

North Tower electric service entrance switchgear – typical of two switchboards that have reached the end of their expected service life and scheduled for replacement.

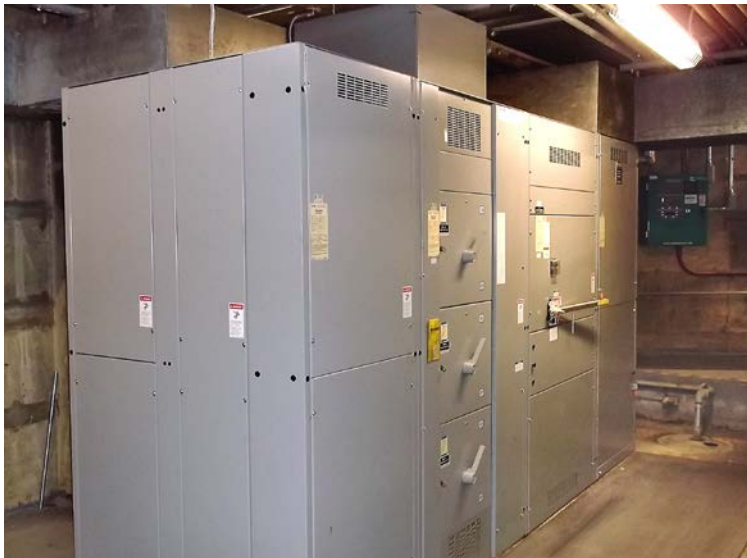
Photo #35

South Tower electric service entrance switchgear – typical of two switchboards that were replaced in 2012.

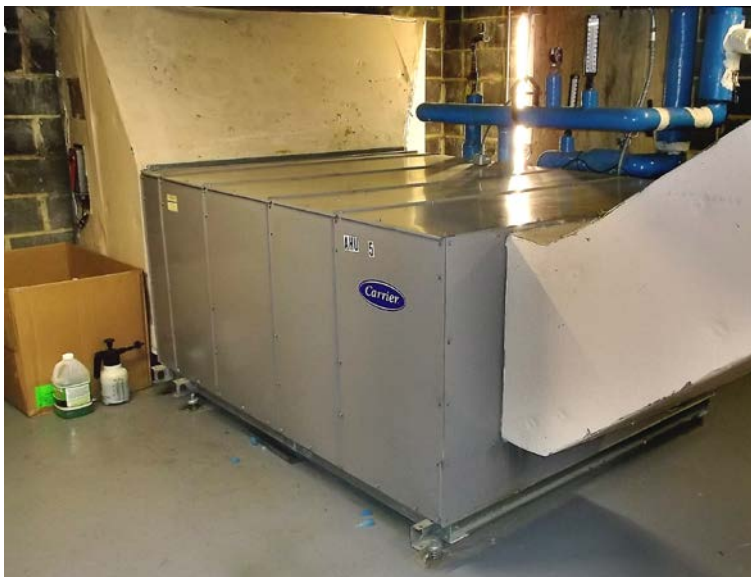
Photo #36

Typical common area central-station air-handling unit as an example of units replaced in 2001 and appearing to be in good overall condition.

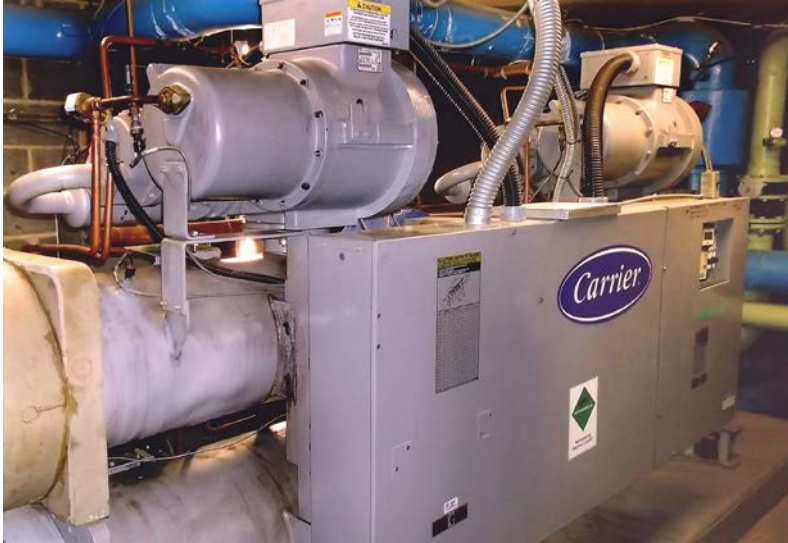
Photo #37

The commercial retail area water-cooled screw-compressor water chiller. It was replaced in 2001 and appears to be in good overall condition.

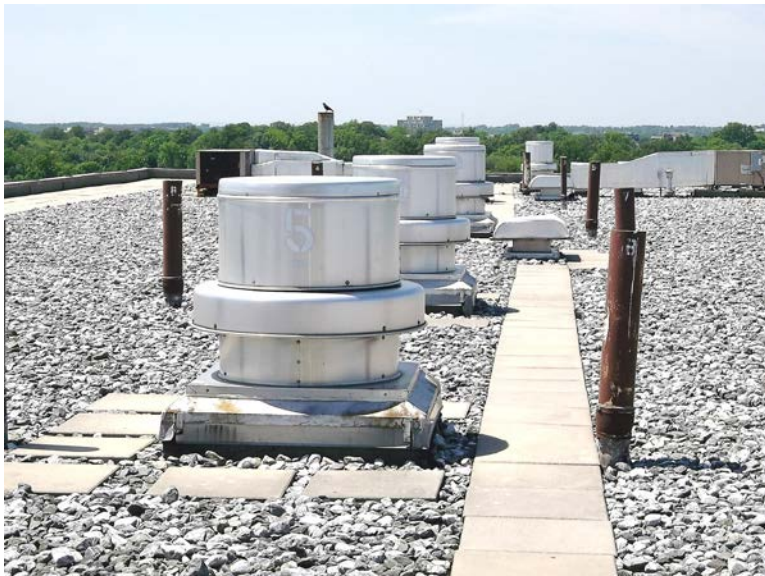
Photo #38

Typical rooftop exhaust fans that were replacements installed in 2008. All appeared to be in good overall condition.

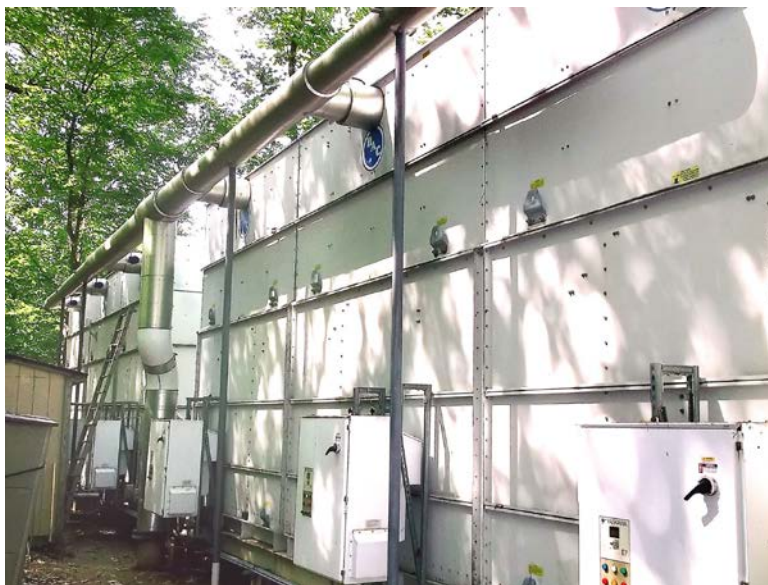
Photo #39

Main cooling tower. The tower was a replacement installed in 1996 and has reportedly served with no problems or issues. The cooling tower is scheduled for water basin refinishing.

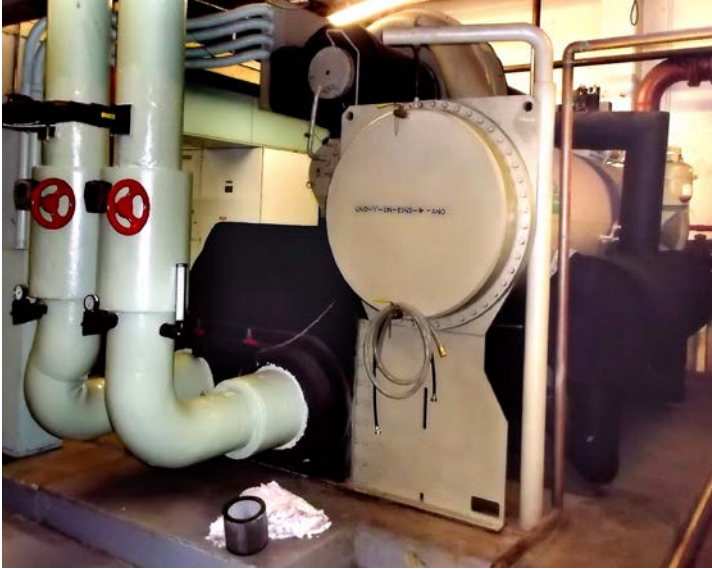
Photo #40
One of two main water chillers. They were replaced in 1996 and appear to be in good overall condition.

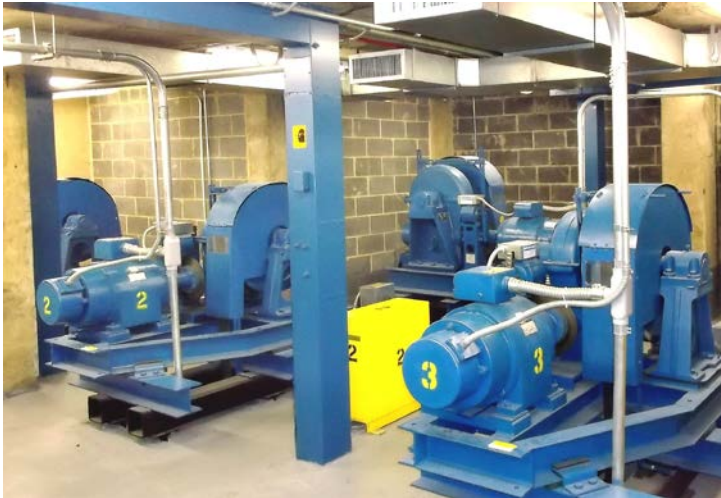
Photo #41
Elevator lift machinery – typical for six elevators – three per tower. An elevator modernization was performed in 2008 that included lift machinery replacement. The equipment appeared to in good overall condition.
