(Final Report, Revised August 11, 2015)
**Condition Assessment
&
Reserve Fund Plan Update
2015**

Sample

Bethesda, Maryland

RE: **CONDITION ASSESSMENT AND RESERVE FUND PLAN UPDATE 2015**
The Sample
(Final Report, Revised August 11, 2015)
Bethesda, Maryland
Project No. 7772

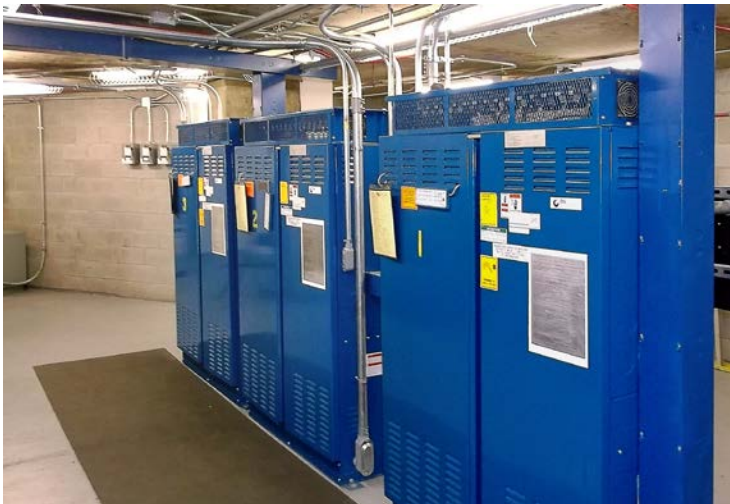
Photo #42
Elevator controllers – typical for six elevators – three per tower. An elevator modernization was performed in 2008 including upgrade to A.C. lift motors controlled by VFDs. The equipment appeared to in good overall condition.
