Condition Assessment
&
Reserve Fund Plan
2015
Sample Townhomes

Manassas, Virginia

RE: **CONDITION ASSESSMENT AND RESERVE FUND PLAN 2015**
Sample Townhomes Homeowners Association
Manassas, Virginia
Project No. 88888

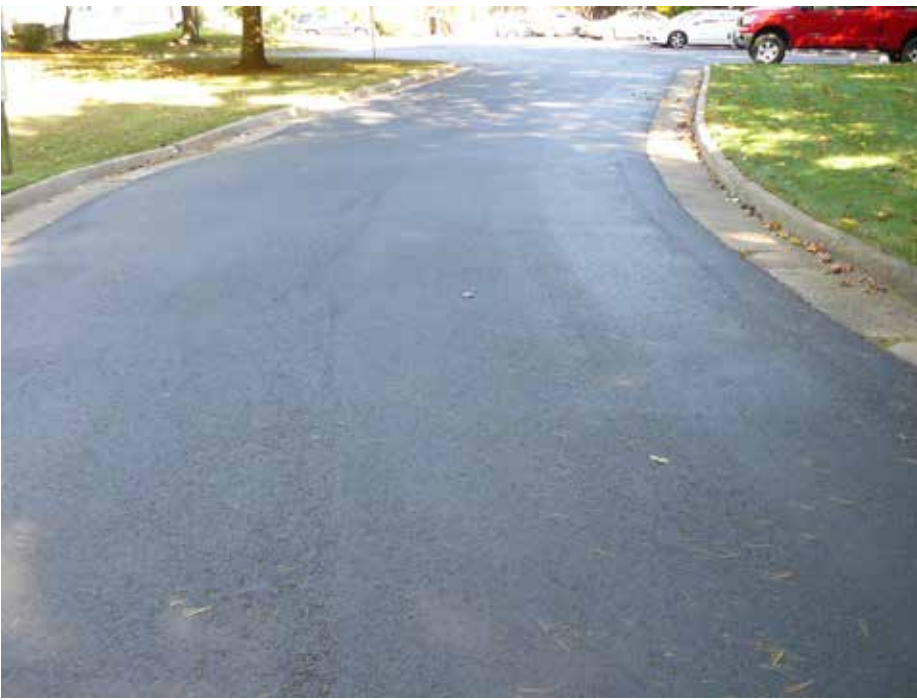
PHOTO #1
All five drivelaners are in overall good condition. No major deflection was observed.

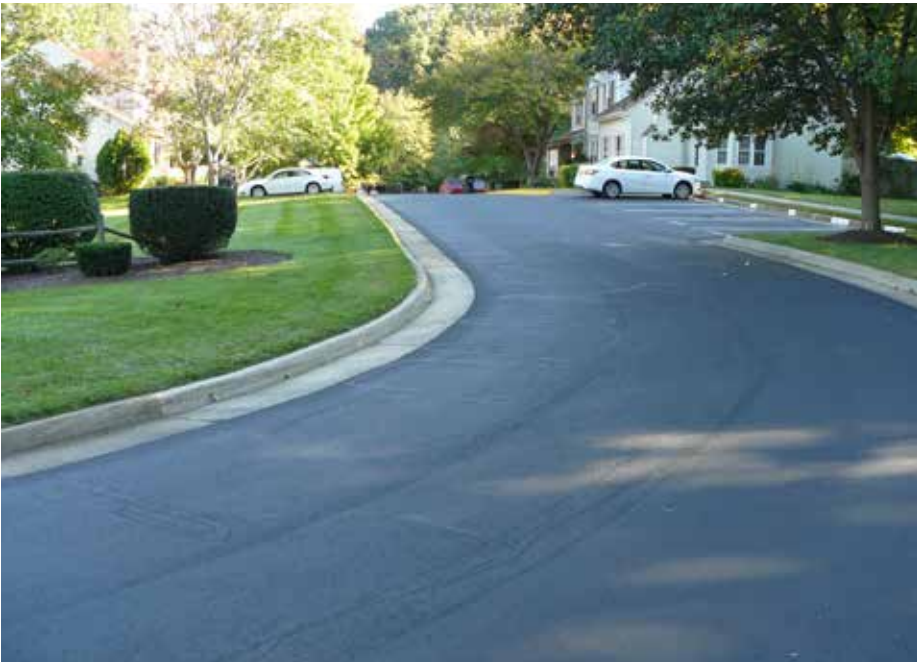
PHOTO #2
All streets have received crack filling, seal coating, and restriping in the last three years.

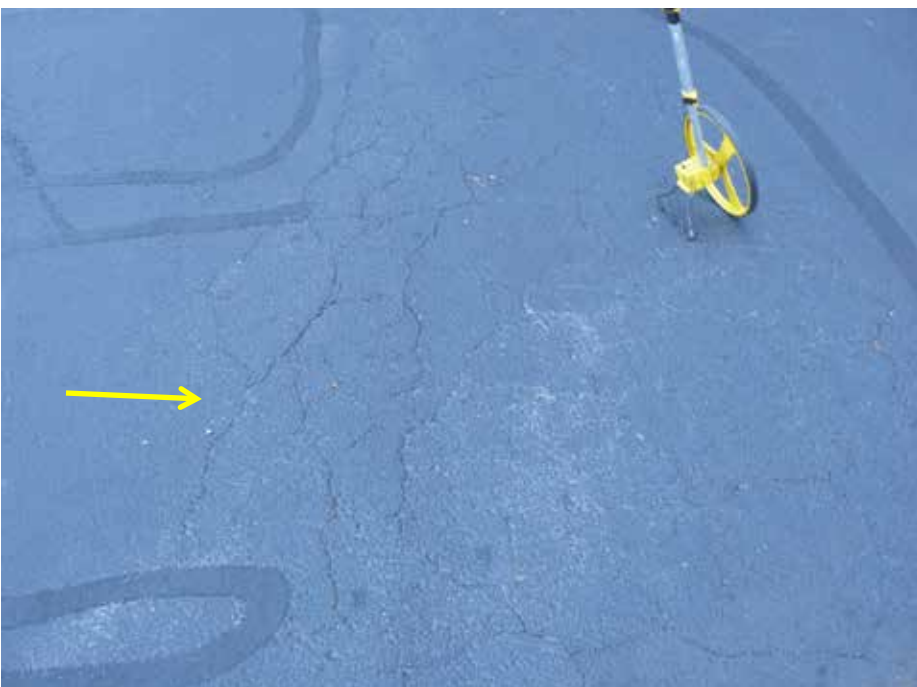
1.3	Asphalt Repair Allowance	1	LS	\$15,000.00	\$15,000	6	2019	25%	\$4,139	2025	50%	\$9,601	2029	100%	\$21,195	Approximately 11 square yards of alligator cracked or deflected pavement (indicative of sub-base damage), and about 65 linear feet of non-filled longitudinal or transverse cracking was observed. Repairs are essential in order to achieve the projected remaining service life of the pavement. Full-depth repairs and crack filling are scheduled every six years throughout the study period, including the year of the asphalt restoration project. See the Asphalt Pavement Report, Section 7, for additional details.
2 CONCRETE COMPONENTS

PHOTO #3
A minor amount of deflected cracking was observed. These areas should receive full-depth repair during the next pavement maintenance cycle.

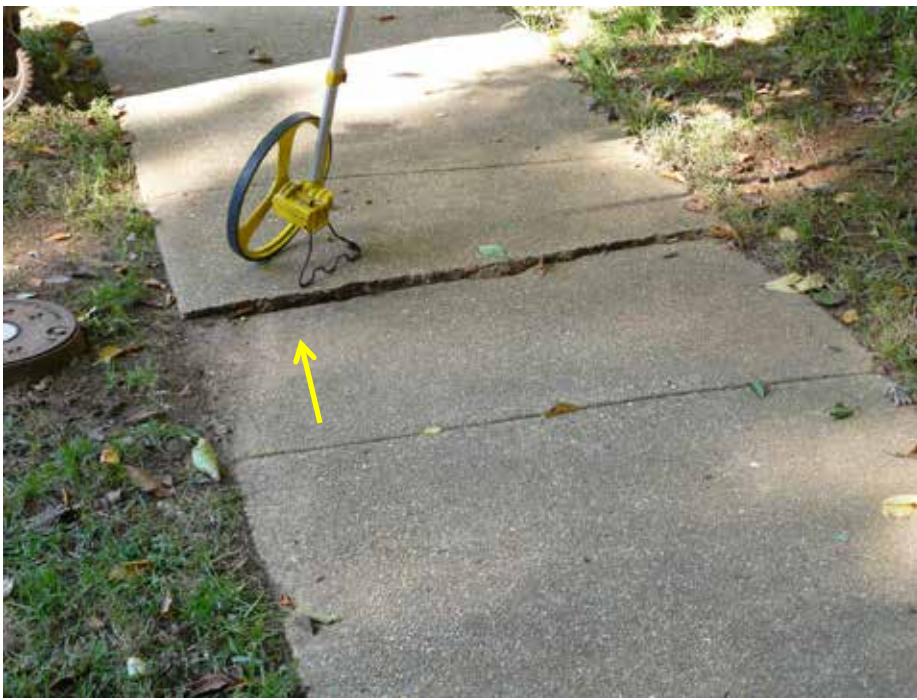
2.1	Concrete Sidewalks	12,104	SF	\$11.50	\$139,196	5	2015	4%	\$5,568	2020	3%	\$4,725	2025	3%	\$5,345	Concrete sidewalks, generally 4' wide, are present on one or both sides of streets within the community. Their thickness could not be visually determined. They are in generally good condition. About 448 square feet (3.7% of the total area) is either cracked, settled or heaved between sections. A majority of the settlement was observed on Name Lane and Name Court. We have not scheduled replacement of all sections with lesser surface defects. Severely scaled sections will tend to deteriorate more quickly over time and should be replaced in each replacement cycle. Cyclic repairs are scheduled, as full replacement at one time is not appropriate or anticipated. Concrete repairs are scheduled to coincide with work on other concrete components to take advantage of economies of scale in packaging concrete restoration work. The Board should be aware that repairs to small quantities of concrete may be more costly because of the difficulty of attracting competitive bids for small projects, which may not meet contractor minimums. Any trip hazards or hazardous surface deficiencies should be addressed as soon as practicable to prevent personal injury.

PHOTO #4
A few concrete sidewalk panels have cracked and settled. These are potential tripping hazards. These deficient sections of concrete should receive cyclic near-term repair.

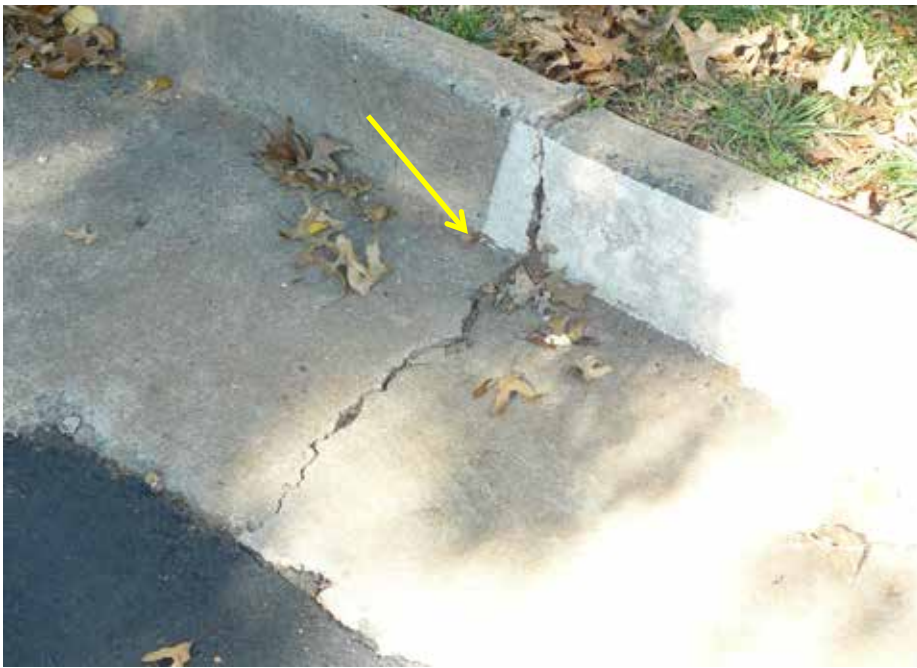
2.2	Concrete Curbs & Gutters	5,914	LF	\$36.00	\$212,904	5	2015	2%	\$4,258	2020	2%	\$4,818	2025	2%	\$5,451	The driveways and parking bays are lined with standard-profile, cast-in-place, concrete curbs and gutters. They are in generally good condition with about 1.1% of the length exhibiting transverse cracks or settled sections. We observed approximately seven damaged sections, which should be replaced. Minor chips usually do not justify replacement. Curb paint is in good condition and curbs can be repainted under the operations budget. Cyclic repairs are scheduled, as full replacement at one time is not appropriate or anticipated. Curb repairs are scheduled to coincide with work on other concrete components to maximize economies of scale. The Board should be aware that repairs to small quantities of concrete may be more costly because of the difficulty of attracting competitive bids for small projects, which may not meet contractor minimums. Any trip hazards or hazardous surface deficiencies should be addressed as soon as practicable to prevent personal injury.

PHOTO #5
A few of the concrete curb and gutter sections have also cracked and settled, requiring near-term replacement.

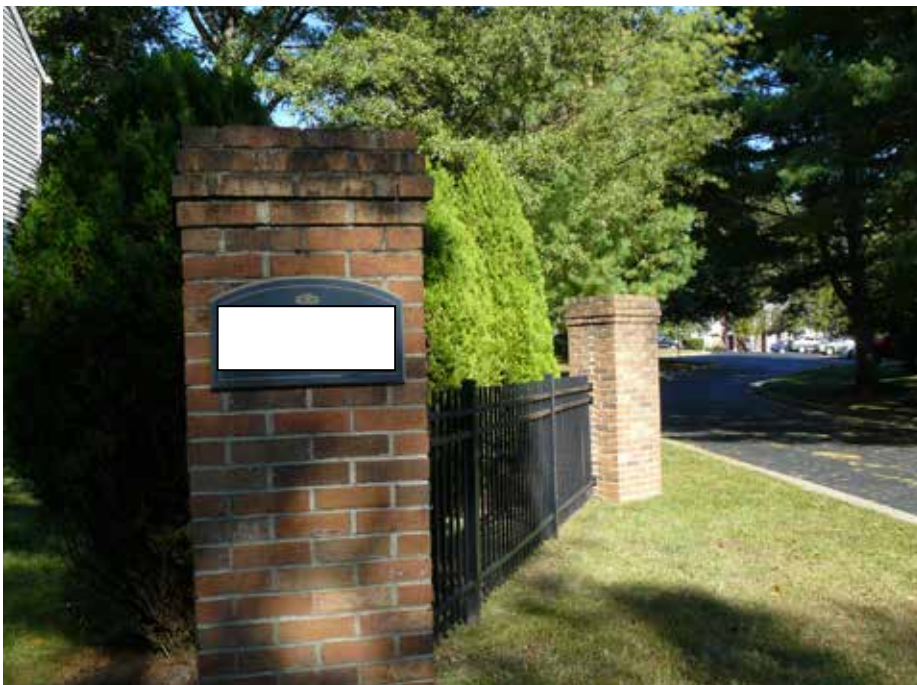
PHOTO #6
The two brick and mortar entrance monuments on Hot Lane are in good condition for their age. Maintenance such as pressure-washing and eventual tuckpointing will help to extend their service life.

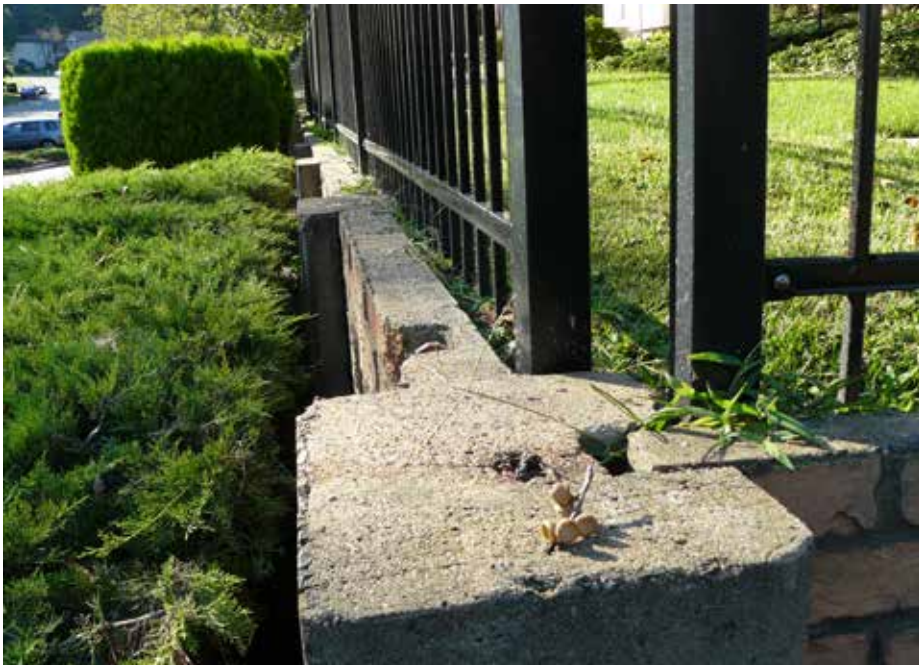
PHOTO #7
The concrete retaining walls constructed in front of several townhomes on Cold Drive are pre-cast panels, supported by cast in place concrete forms. The retaining walls are in good condition with no deflection observed.

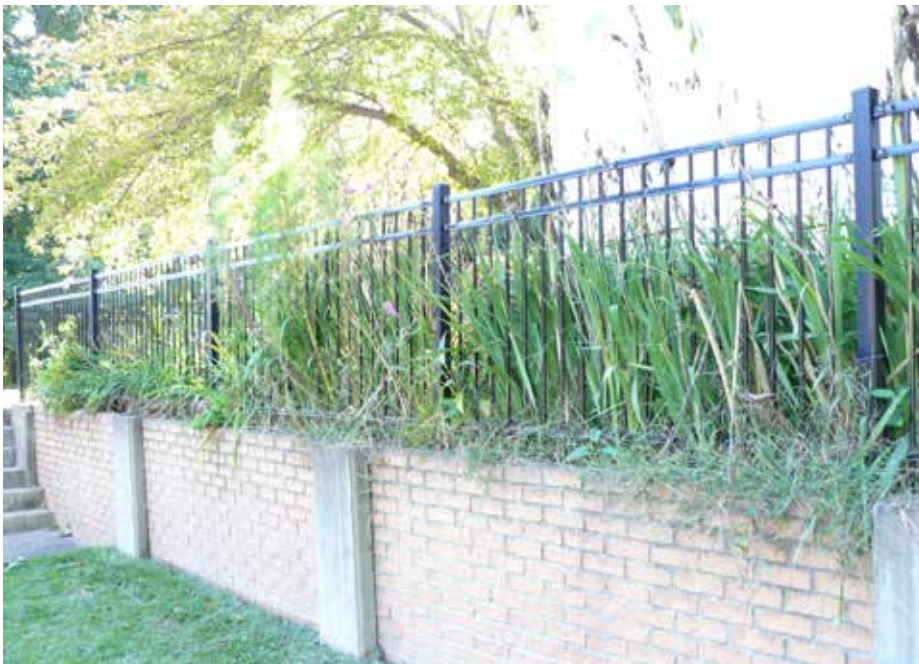
PHOTO #8
The metal railing installed for safety above the retaining wall is also in good condition.

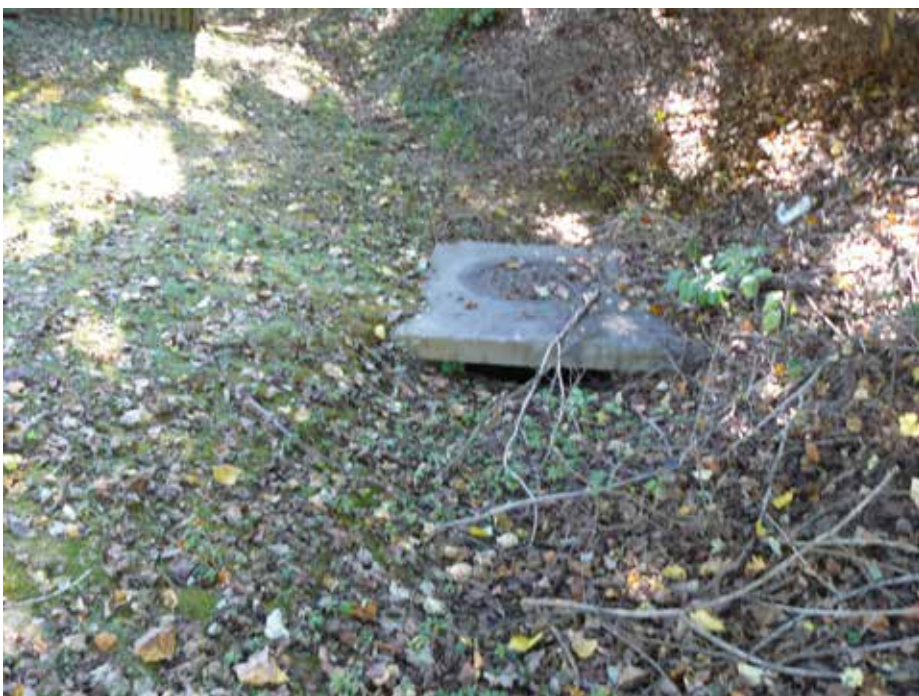
PHOTO #9
Several curb drop inlets and concrete yard drains were observed, which should be kept clear of debris for proper drainage.
