Condition Assessment
and
Reserve Fund Plan Update
2012

Potomac Place

Mclean, Virginia

January 20, 2012

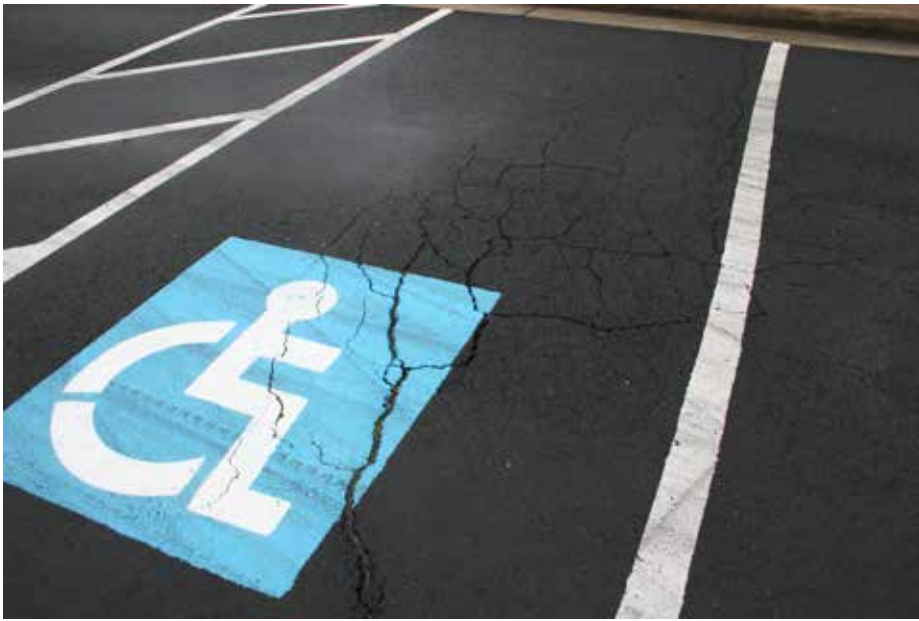
PHOTO #1
Although the Community Center parking lot was restored in 2007, this area is now in beginning failure, and requires full-depth repairs. The new pavement elsewhere is in continuing good condition.

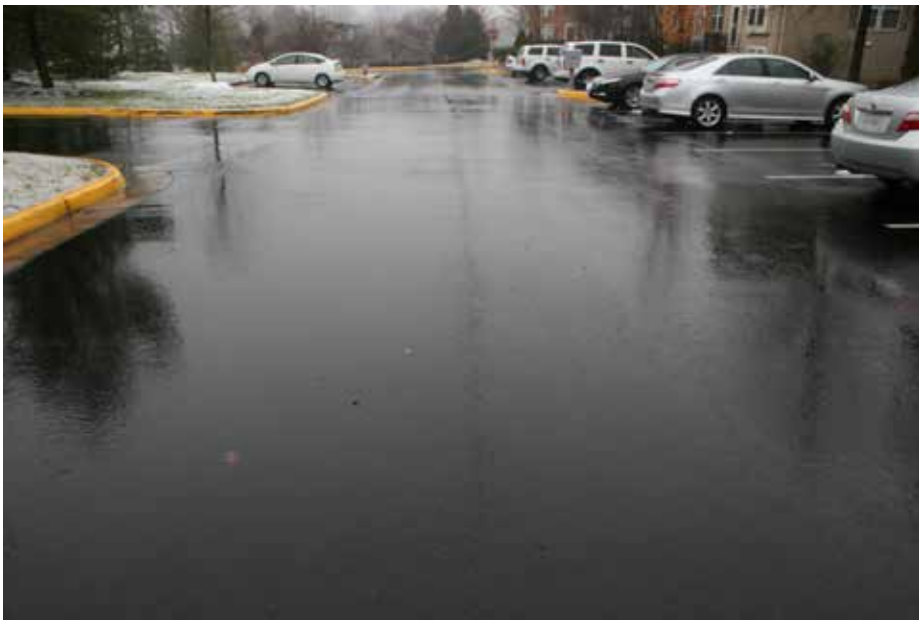
PHOTO #2
Folly Court, one of six streets that were fully restored in 2011, now appearing to be in like-new condition.

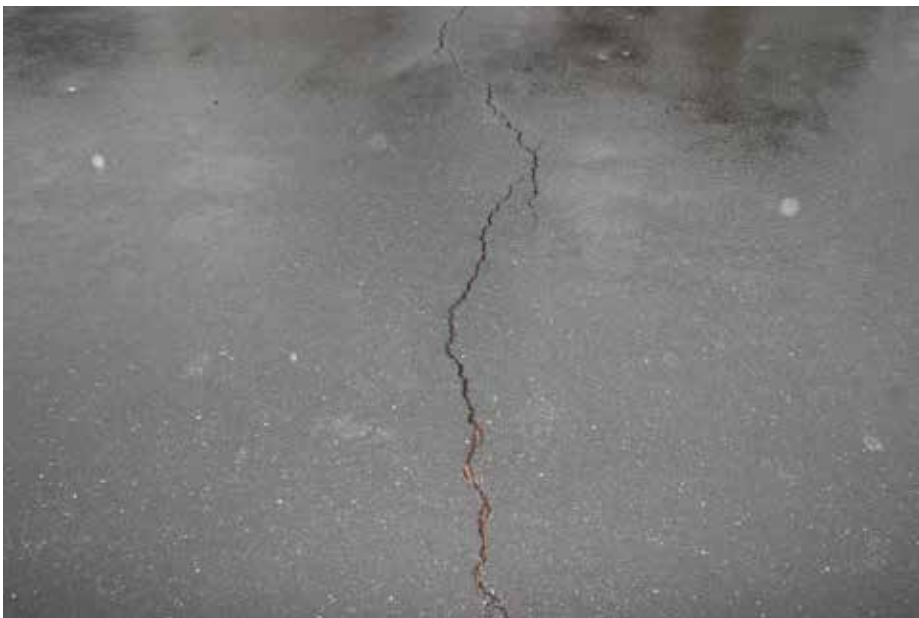
PHOTO #3
New crack appearing on older streets that were repaired and cracked filled in 2007. This will continue until the streets are restored.

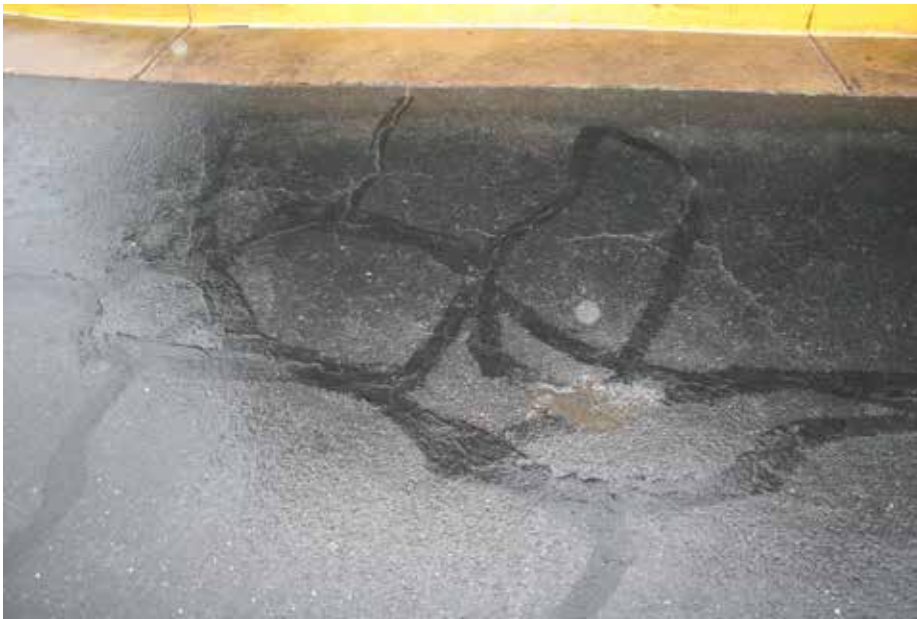
PHOTO #4

While this area was crack filled in 2007, it is obvious that additional deflection is now present. Areas like this should be milled to the appropriate depth and replaced in the next pavement restoration.

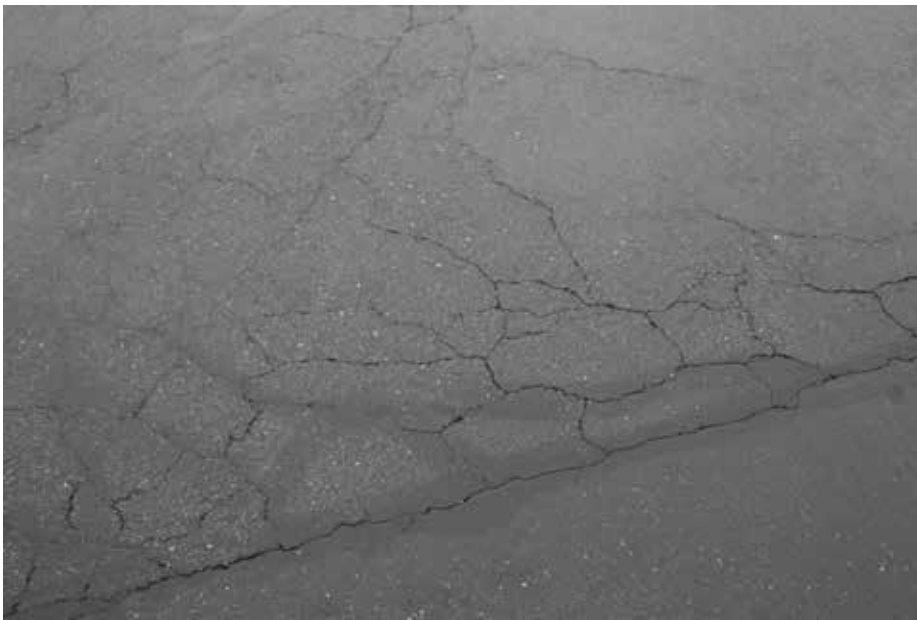
PHOTO #5

Some older crack filling is still visible here, but note the extensive new cracking as this pavement reaches the end of its service life.

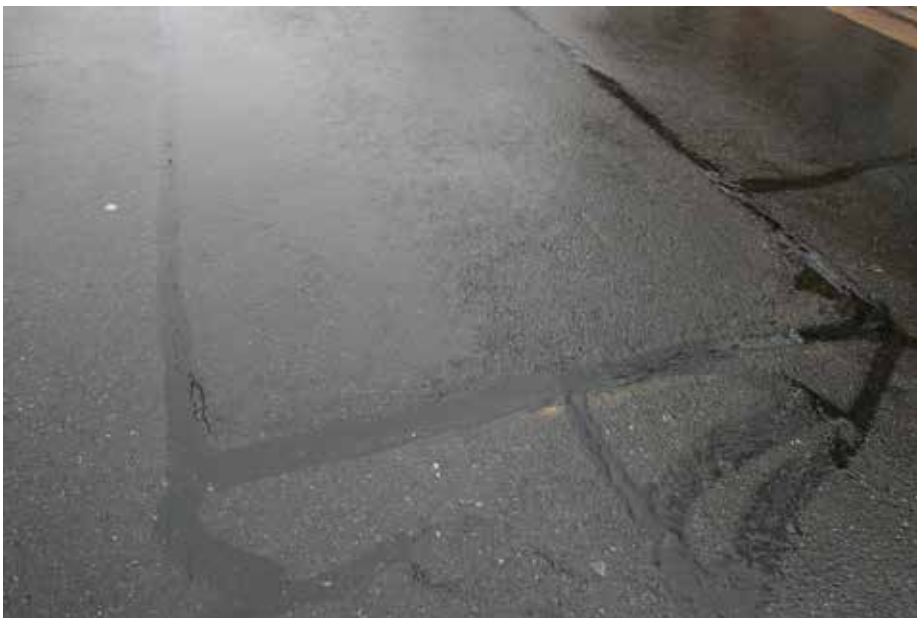
PHOTO #6

Here a 2007 extensive full-depth repair is present and holding up well. Note that there is little continuing radiating cracking on the perimeter of the patch. Also note the crack fill on the perimeter of the patch, which is the proper procedure and is often overlooked by pavers.

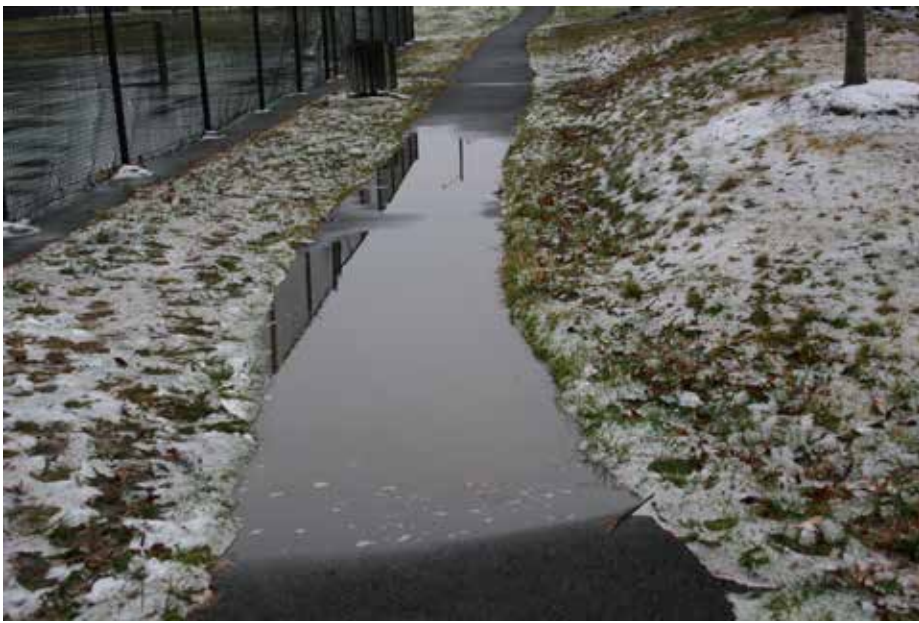
PHOTO #7
The Section 4 asphalt footpath is under water here. This could be considered a hazard, especially in freezing temperatures, when it will become ice.

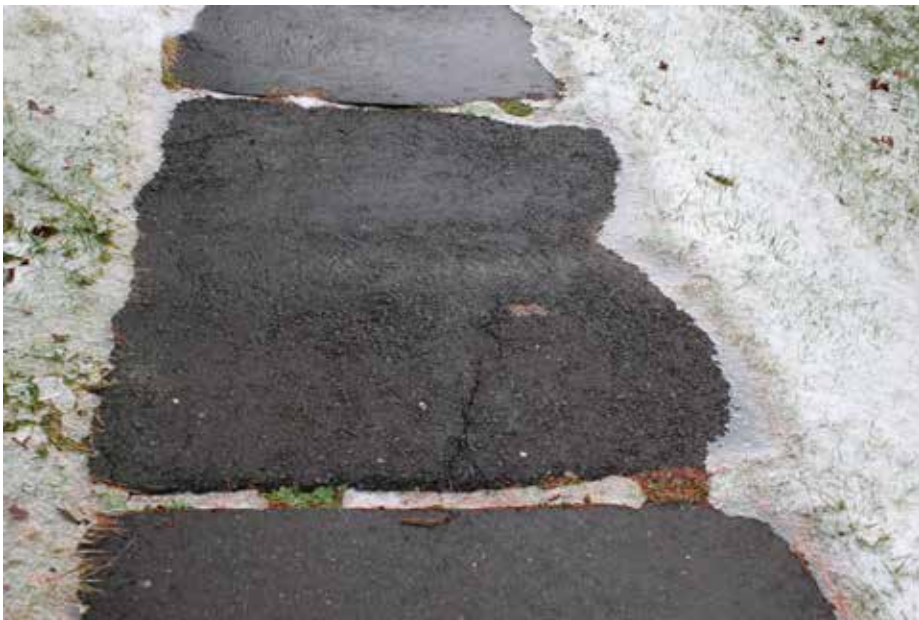
PHOTO #8
Areas like this now require localized full-depth repair. The material should be removed, new gravel base installed and the path repaved. Only about 13% of the system requires repairs at this time.

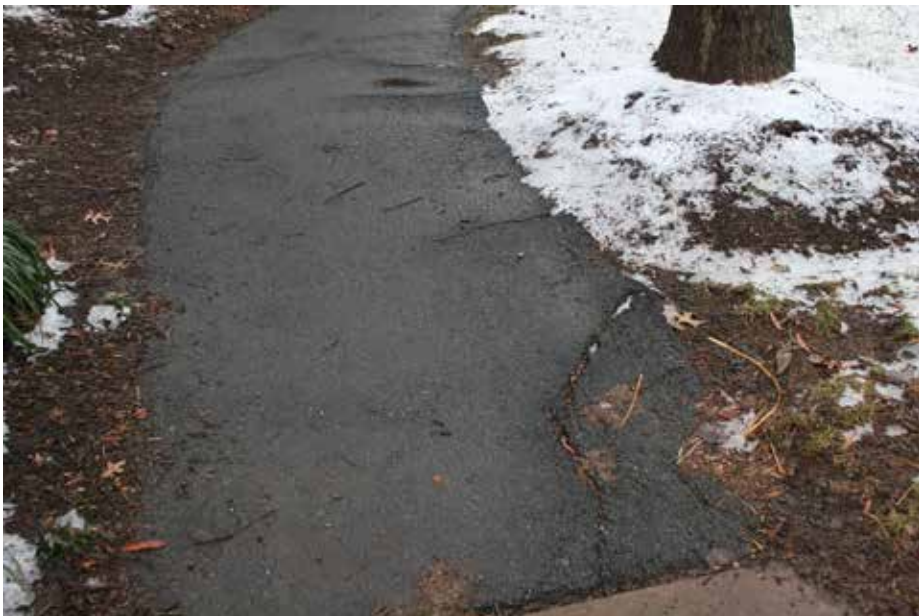
PHOTO #9
This is an example of typical tree root damage to footpaths. Eventually the heaves become tripping hazards and the roots must be removed before new pavement is installed.

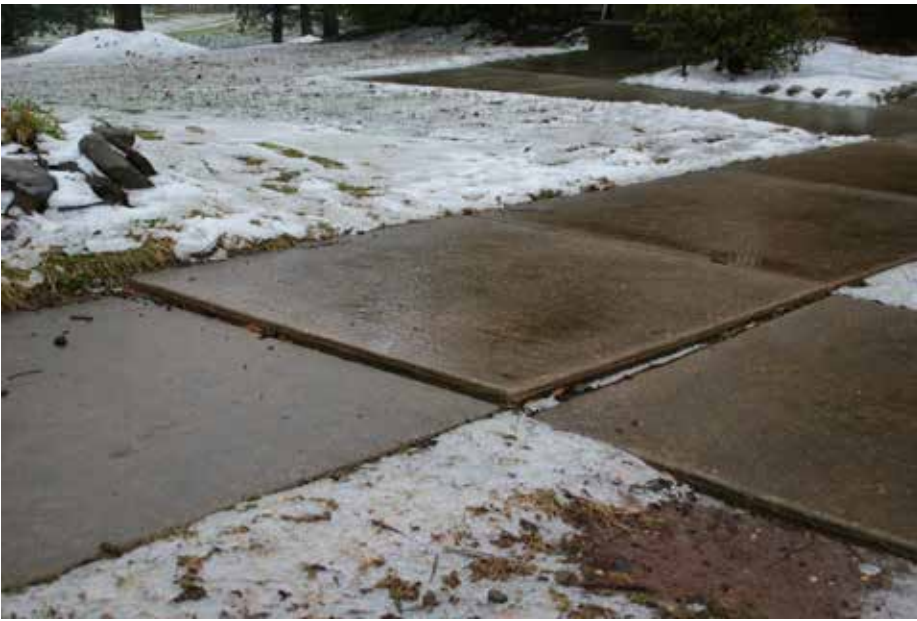
PHOTO #10

This is the worst of only a few heaved sidewalk panels. This is an obvious tripping hazard requiring replacement near-term.

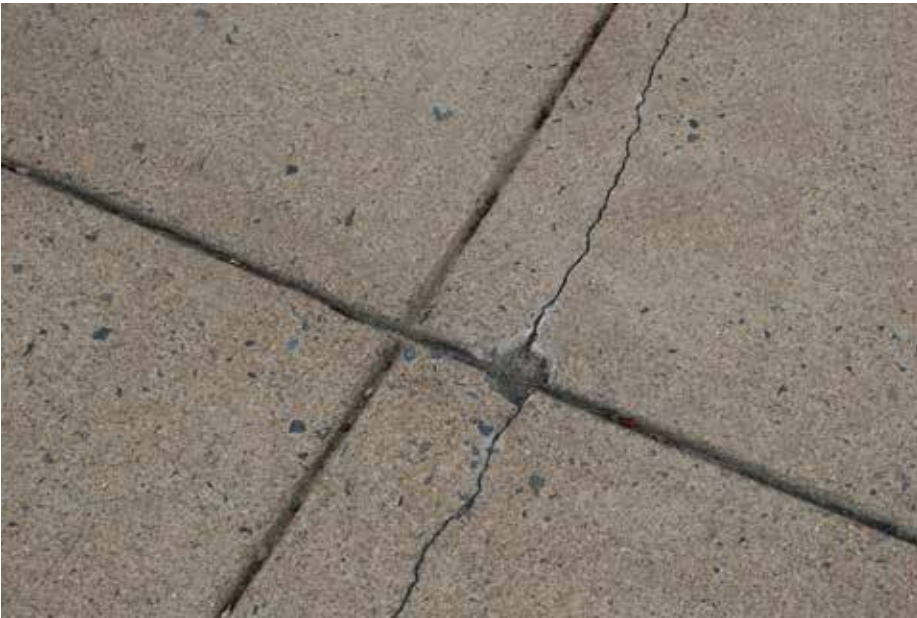
PHOTO #11

This crack is still quite tight and probably not at the point to justify the expense of replacement.

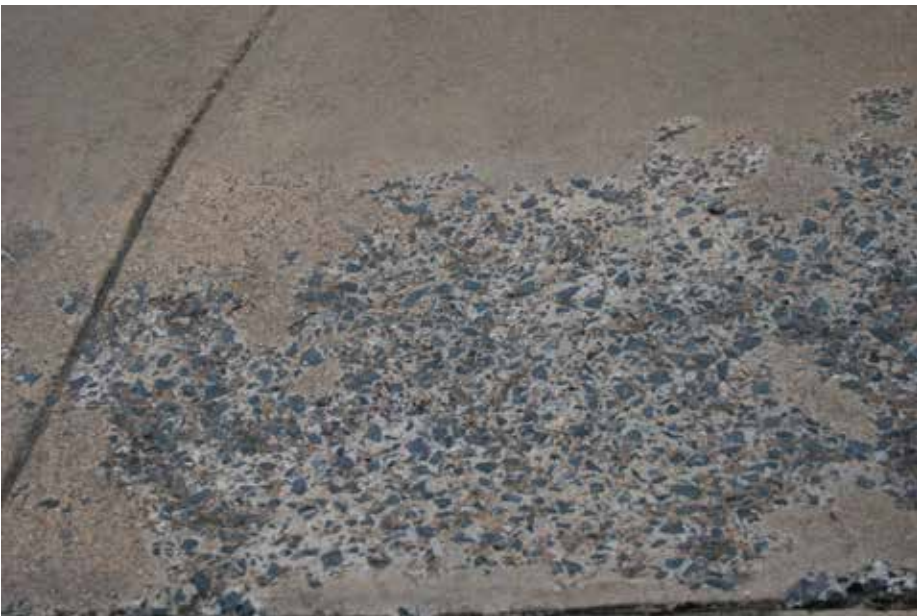
PHOTO #12

Concrete surface scaling is the result of many factors including ice melt chemicals. While unsightly, it is not usually problematic until the surface is deteriorated enough to become a potential tripping hazard.

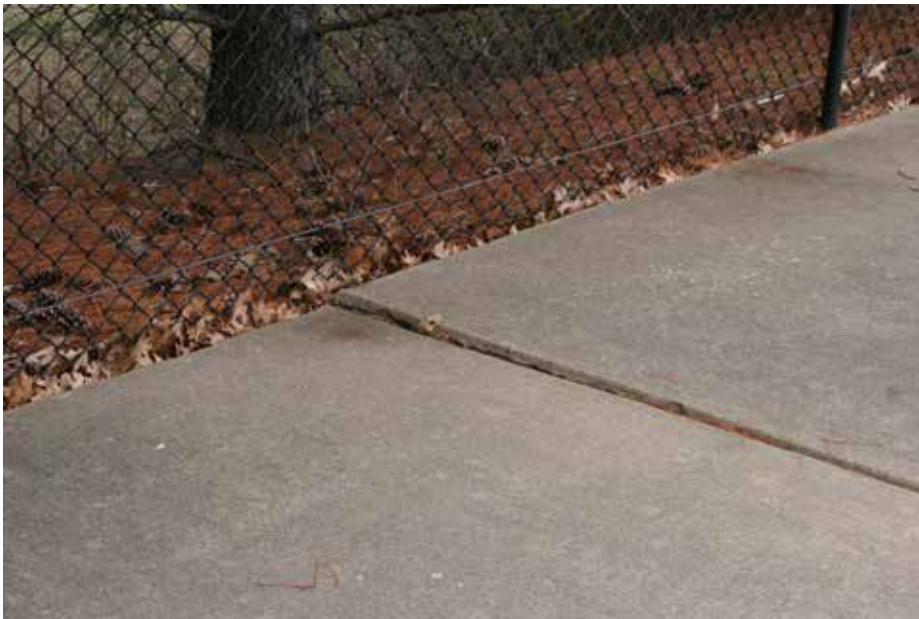
PHOTO #13
This potential tripping hazard is located in a remote part of the pool deck. Pool deck repairs are scheduled in 2016 and this will be one of the deficiencies addressed at that time.

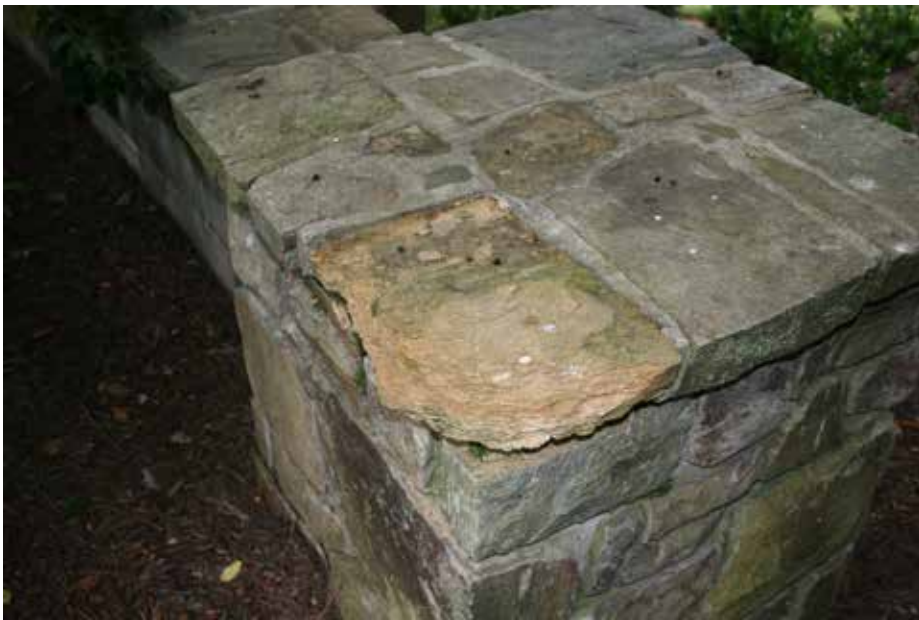
PHOTO #14
The monuments have always been considered permanent structures requiring periodic maintenance under operations. We observed a few highly fissile stones that are deteriorating and should be replaced along with minor mortar replacement on the top surface.

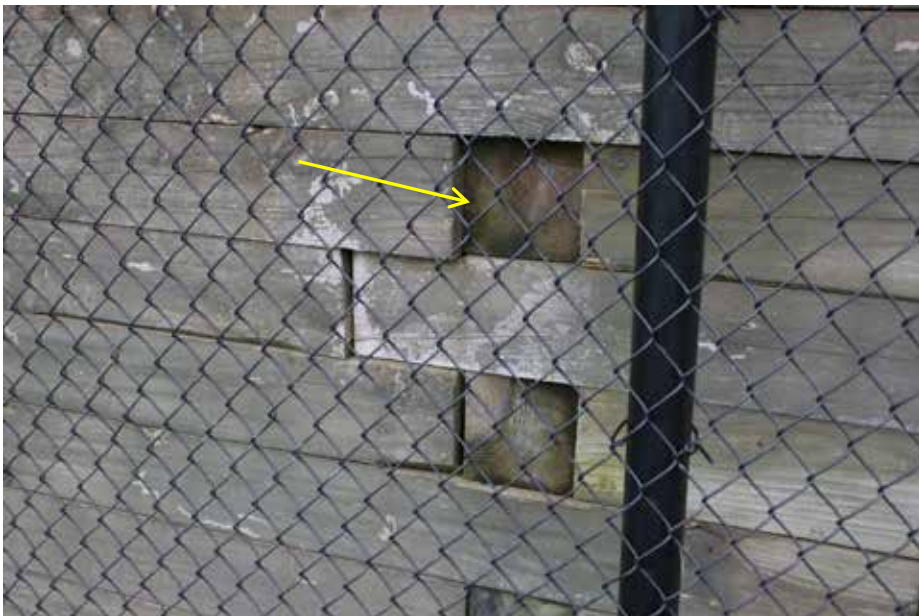
PHOTO #15
The pressure-treated timber retaining wall adjacent to the Community Center tennis court is continuing to deflect as evidenced by the reveal at the deadmen anchors. Due to location, this will be a difficult replacement. The structure should be capable of a few additional years of service, but should be monitored for movement.

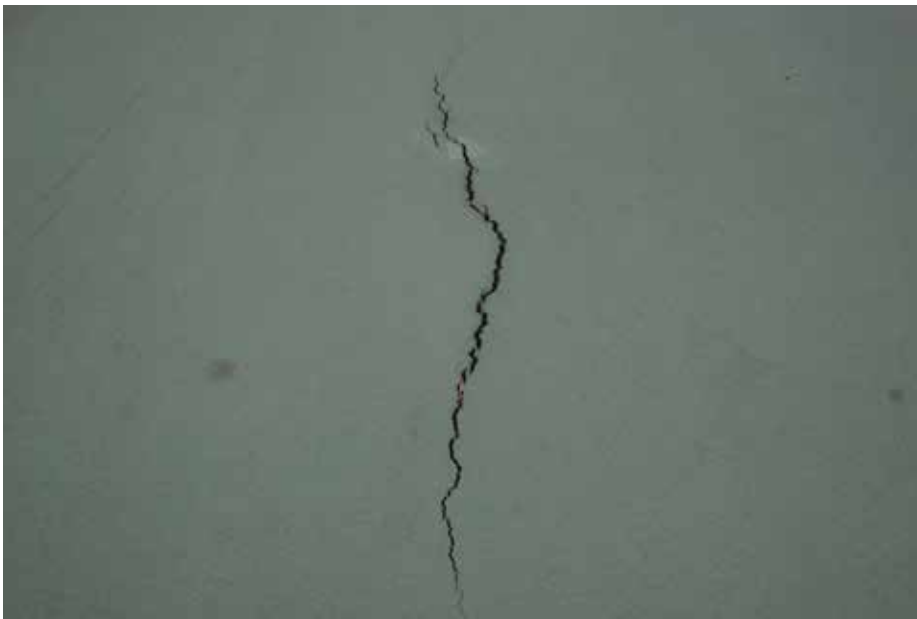
PHOTO #16
The cracking at the Community Center tennis court has reappeared or continues in spite of the 2007 engineered repairs to the supporting masonry retaining wall. The cracks should be patched as part of the next color coat temporarily until the court is fully restored in 2018.

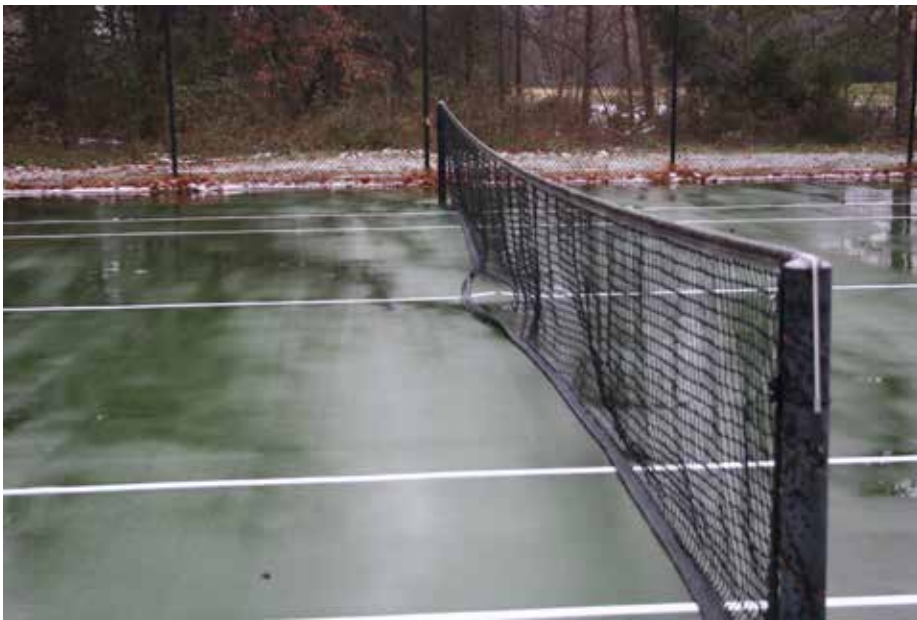
PHOTO #17
The Section 4 tennis court is in continuing good condition with no significant deficiencies currently. Though the color coat is older and somewhat faded, it is still serviceable with newly applied striping.

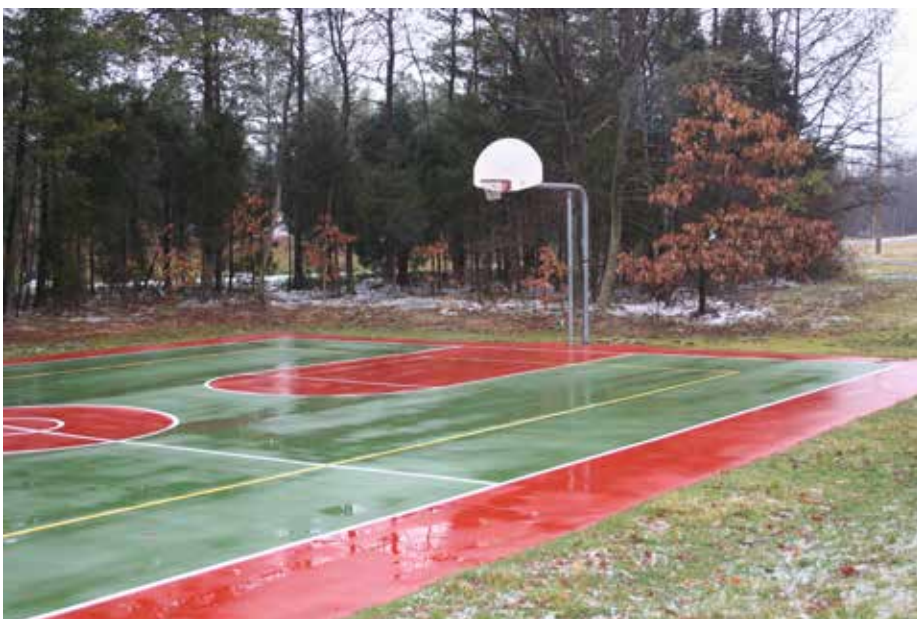
PHOTO #18
The multi-purpose court was converted to a basketball court as part of a full restoration in 2011 including drainage improvements.

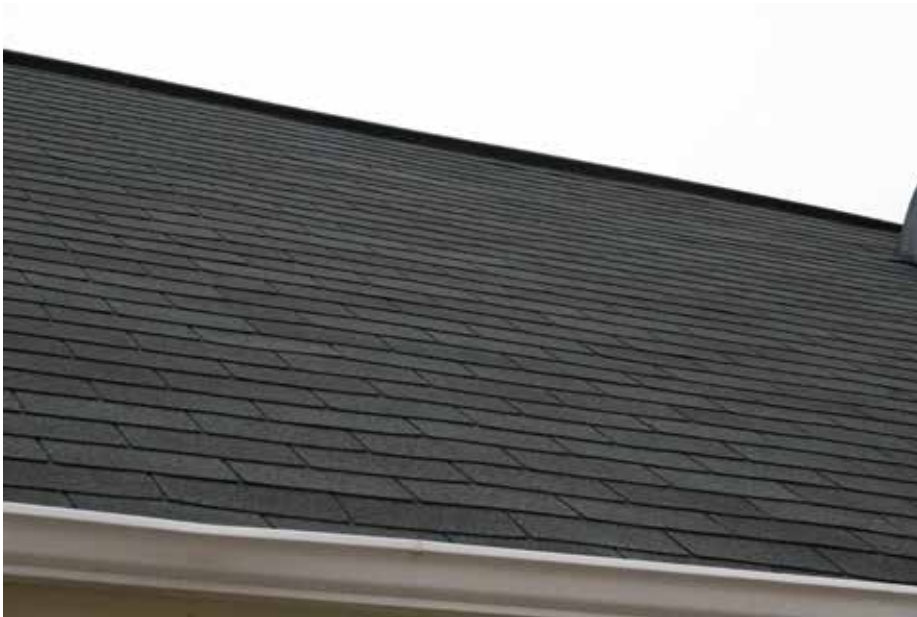
PHOTO #19
The asphalt shingle roofing appears to be in continuing good condition with no significant deficiencies observed.

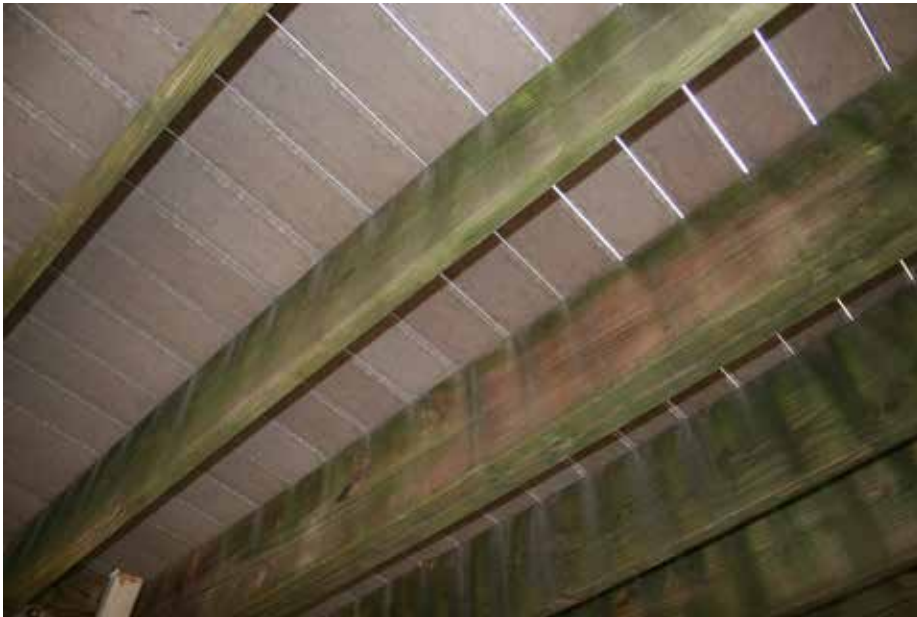
PHOTO #20
The Community Center wood decking was replaced with composite decking in 2009. Eventually, the pressure-treated wood joists supporting it will require replacement, but the decking may be re-useable at that time.

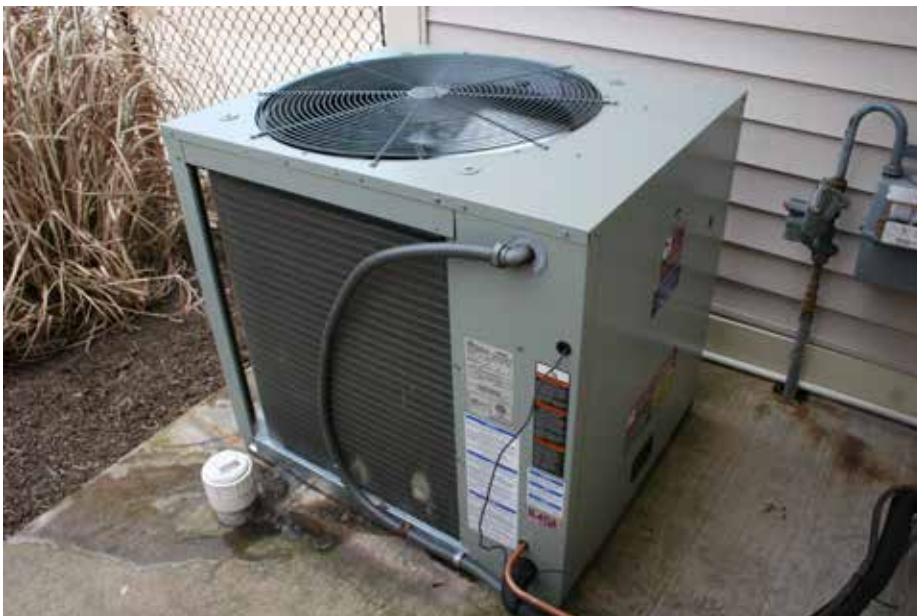
PHOTO #21
The condenser and air handler of HVAC Unit #3 was replaced in 2011. Its sister Unit #1 is still operating.

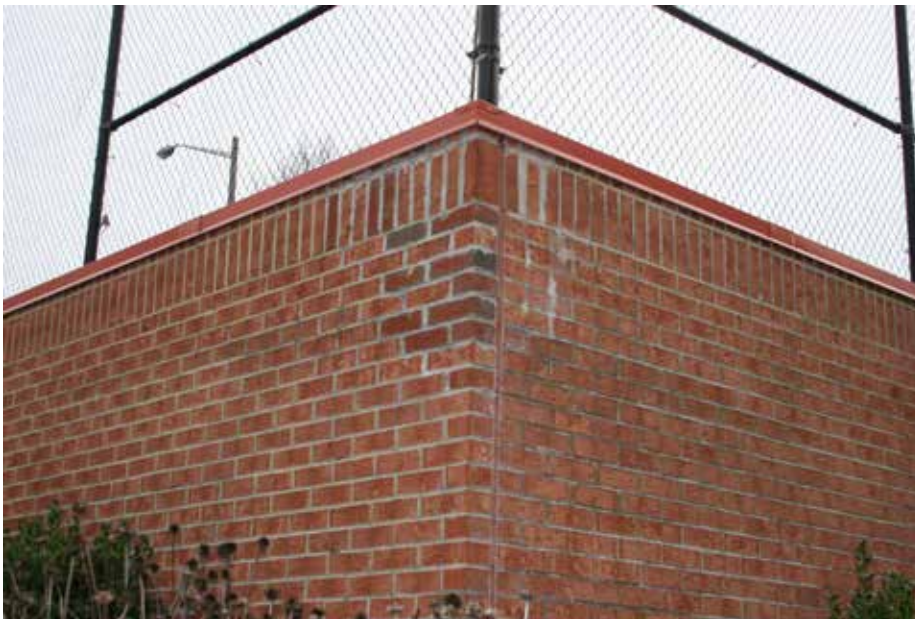
PHOTO #22
The 2007 recommended engineered repairs to the masonry retaining wall appear to have been successful.

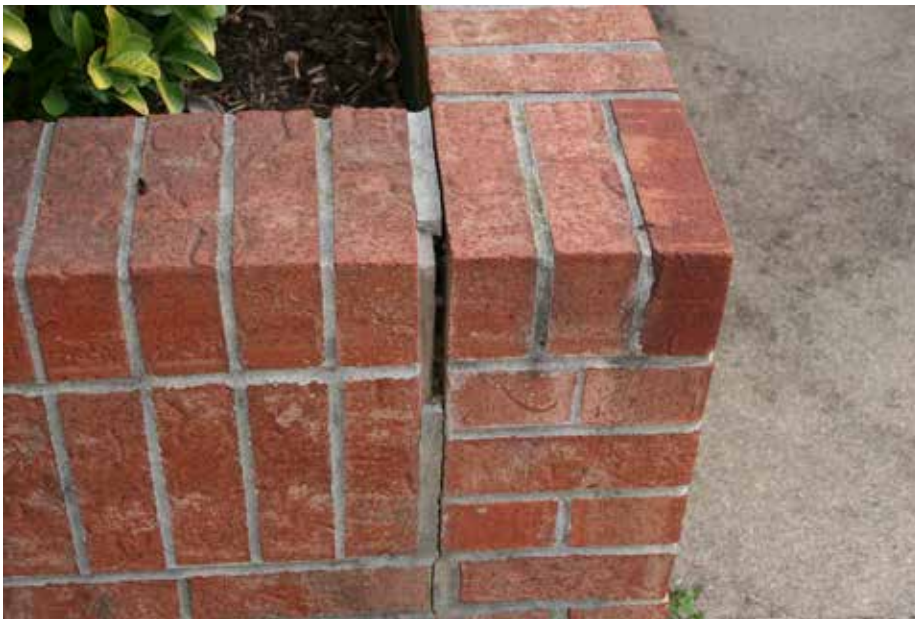
PHOTO #23
Additional tuckpointing and masonry repairs/waterproofing of planters will be necessary on an on-going basis, and we have programmed the component accordingly.

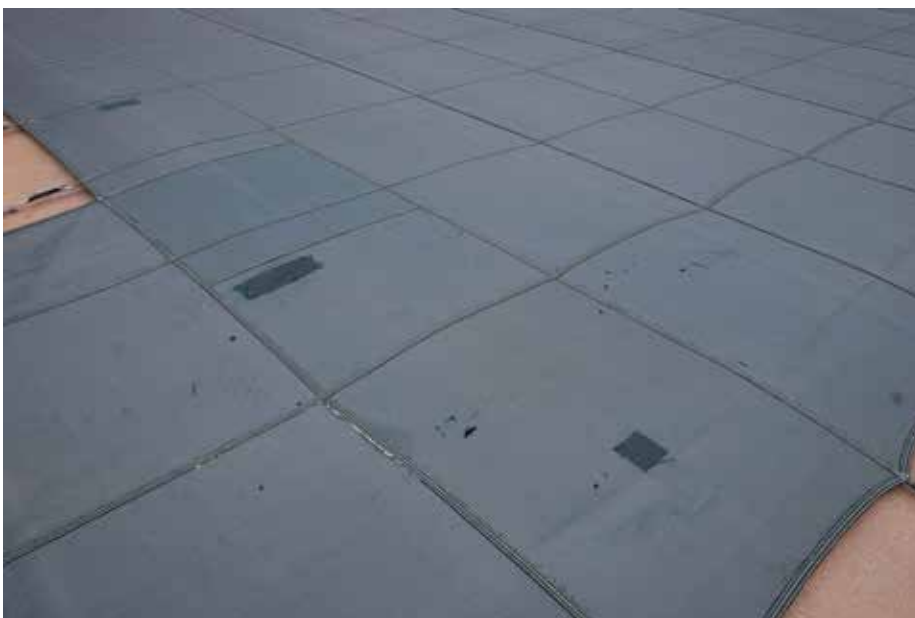
PHOTO #24
The pool cover is aging and tired. We have scheduled replacement in 2013.
