Condition Assessment
and
Reserve Fund Plan Update
2012

Sample Place

Location, Virginia

RE: **CONDITION ASSESSMENT AND RESERVE FUND PLAN UPDATE 2012**
Sample Place
Sample Location, Virginia
Project No. 9110

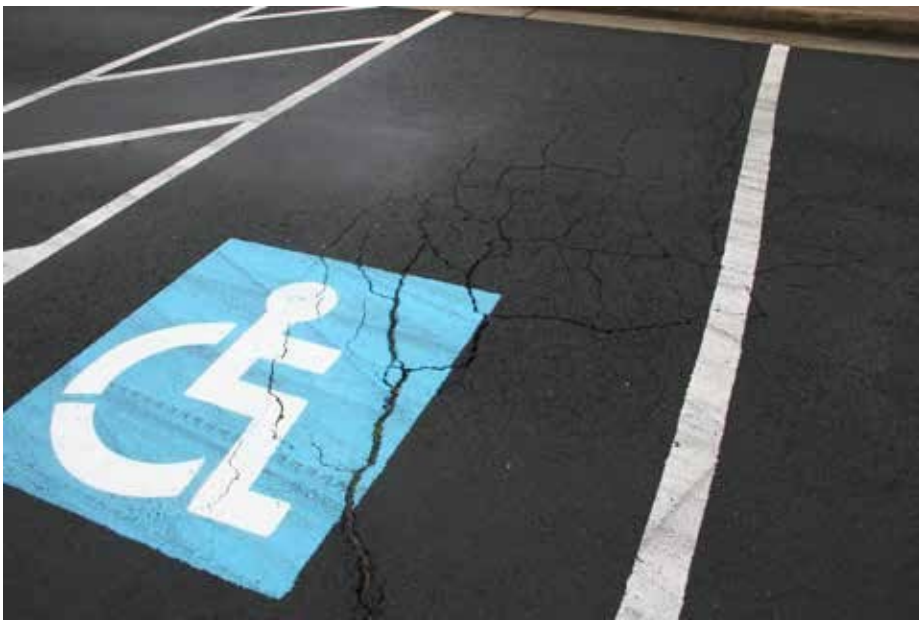
PHOTO #1
Although the Community Center parking lot was restored in 2007, this area is now in beginning failure, and requires full-depth repairs. The new pavement elsewhere is in continuing good condition.

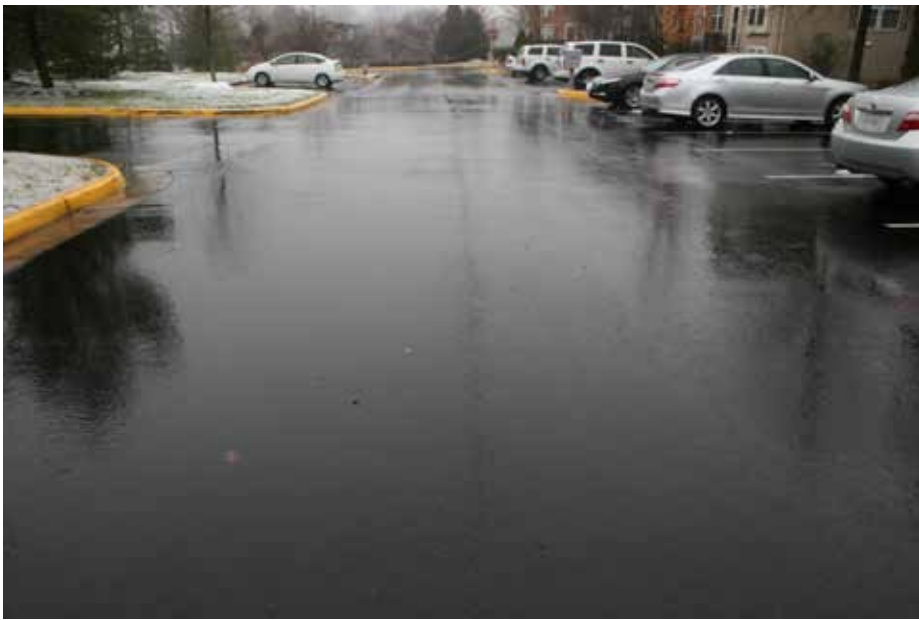
PHOTO #2
Folly Court, one of six streets that were fully restored in 2011, now appearing to be in like-new condition.

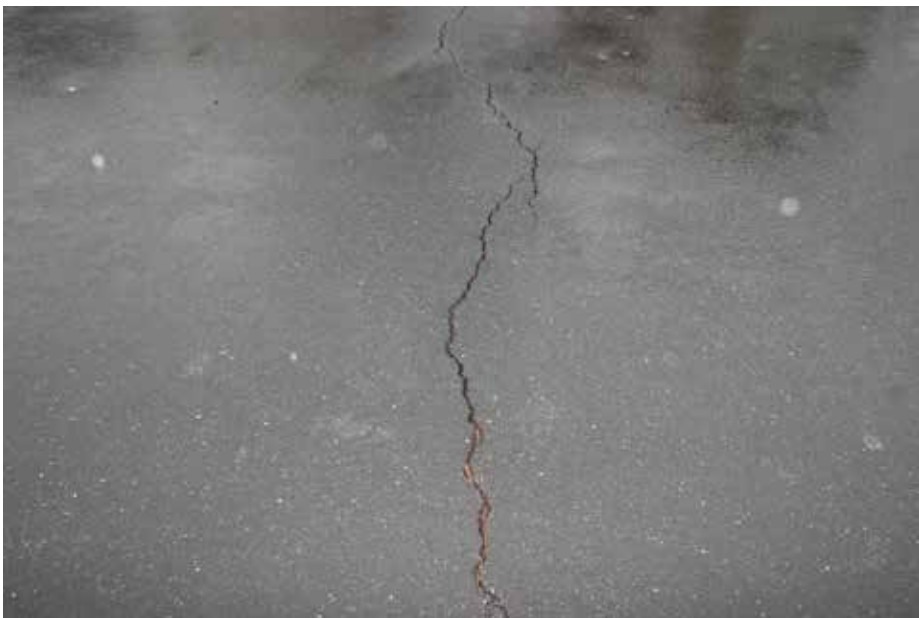
PHOTO #3
New crack appearing on older streets that were repaired and cracked filled in 2007. This will continue until the streets are restored.

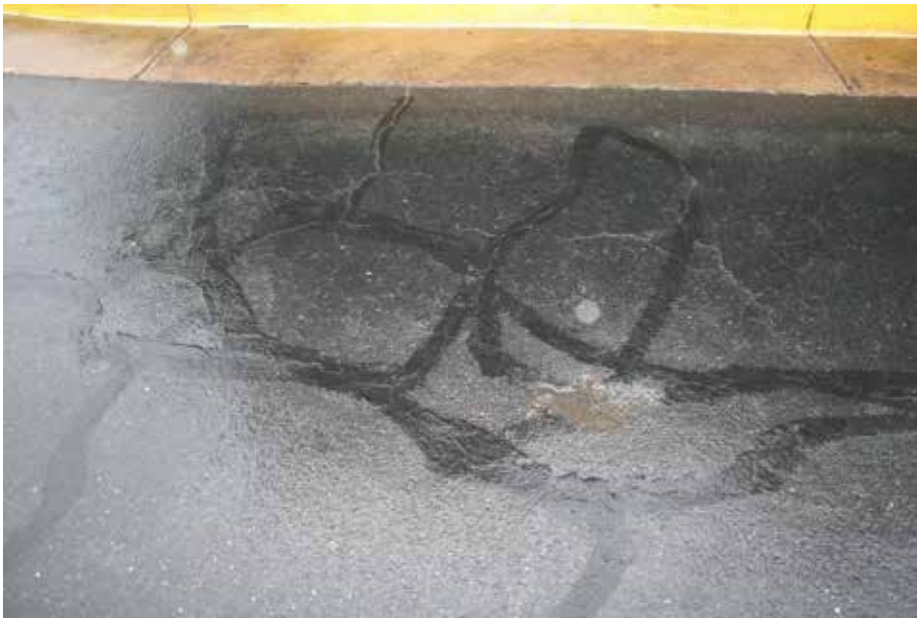
PHOTO #4

While this area was crack filled in 2007, it is obvious that additional deflection is now present. Areas like this should be milled to the appropriate depth and replaced in the next pavement restoration.

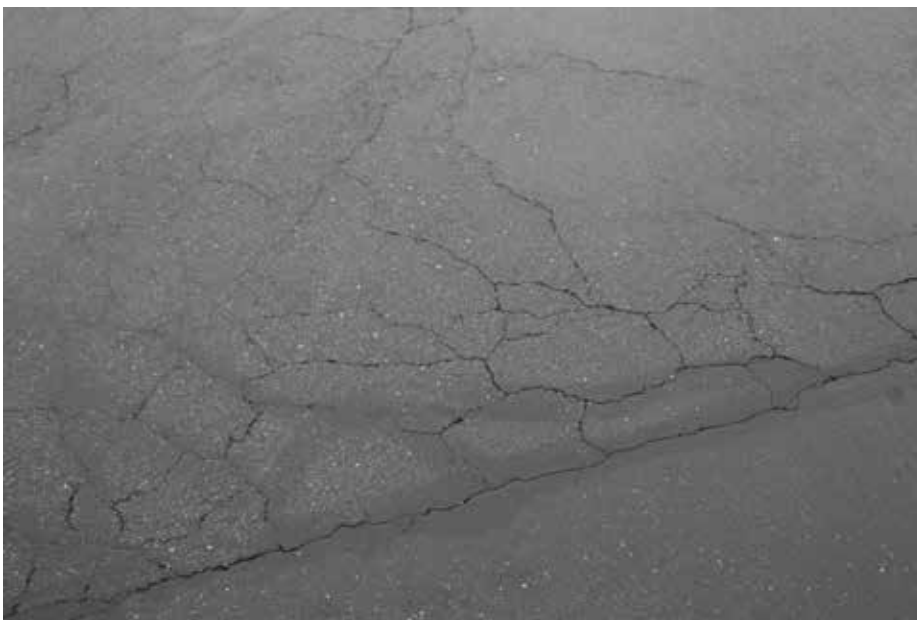
PHOTO #5

Some older crack filling is still visible here, but note the extensive new cracking as this pavement reaches the end of its service life.

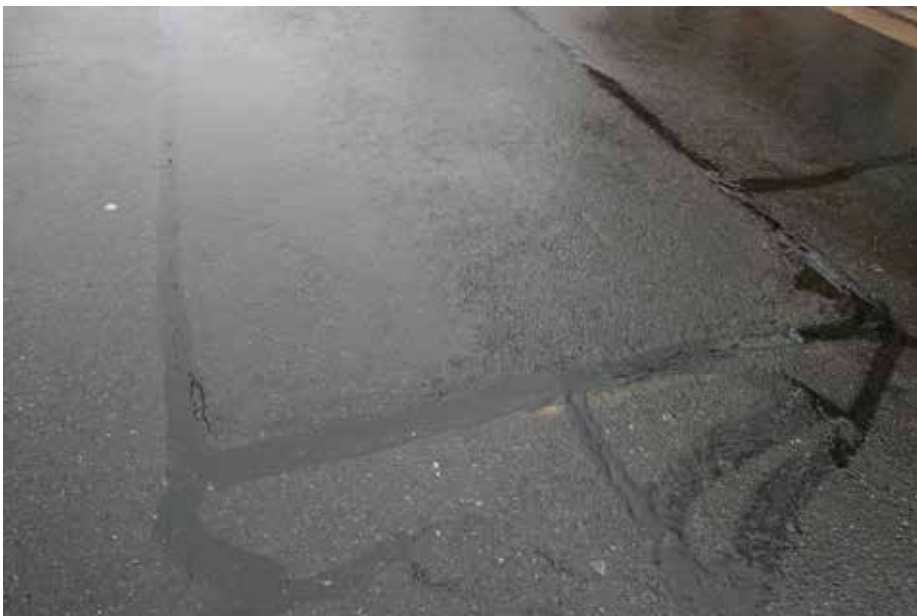
PHOTO #6

Here a 2007 extensive full-depth repair is present and holding up well. Note that there is little continuing radiating cracking on the perimeter of the patch. Also note the crack fill on the perimeter of the patch, which is the proper procedure and is often overlooked by pavers.

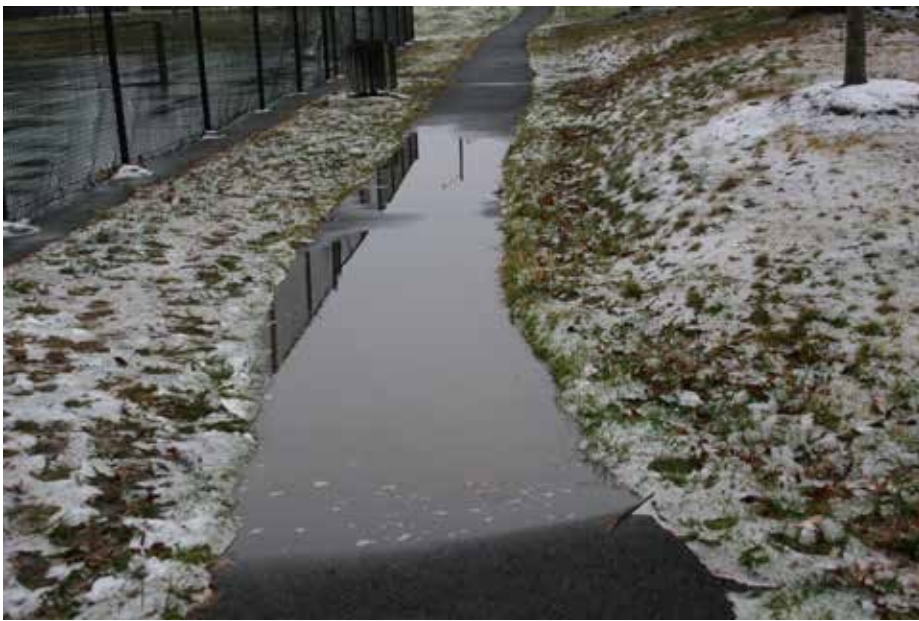
PHOTO #7
The Section 4 asphalt footpath is under water here. This could be considered a hazard, especially in freezing temperatures, when it will become ice.

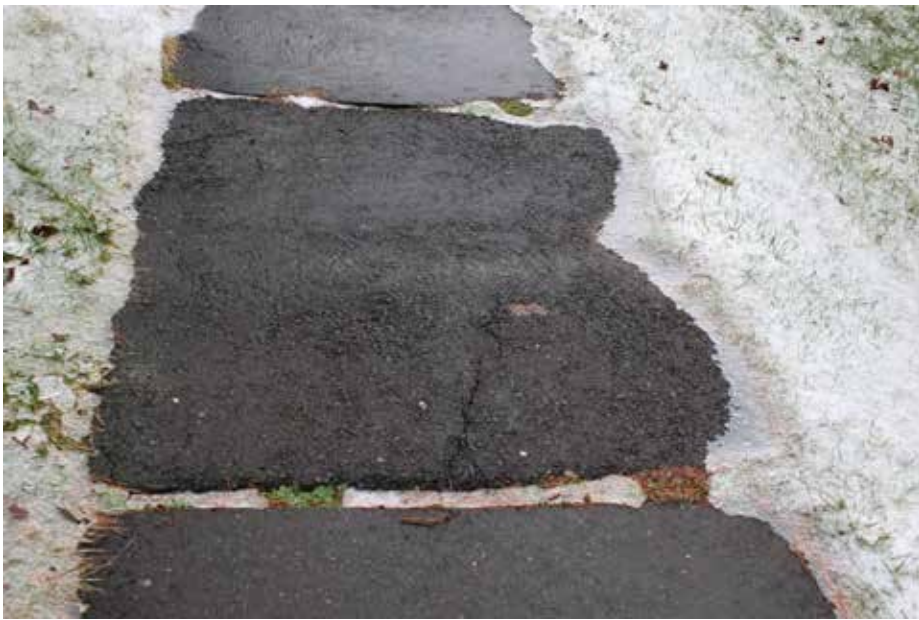
PHOTO #8
Areas like this now require localized full-depth repair. The material should be removed, new gravel base installed and the path repaved. Only about 13% of the system requires repairs at this time.

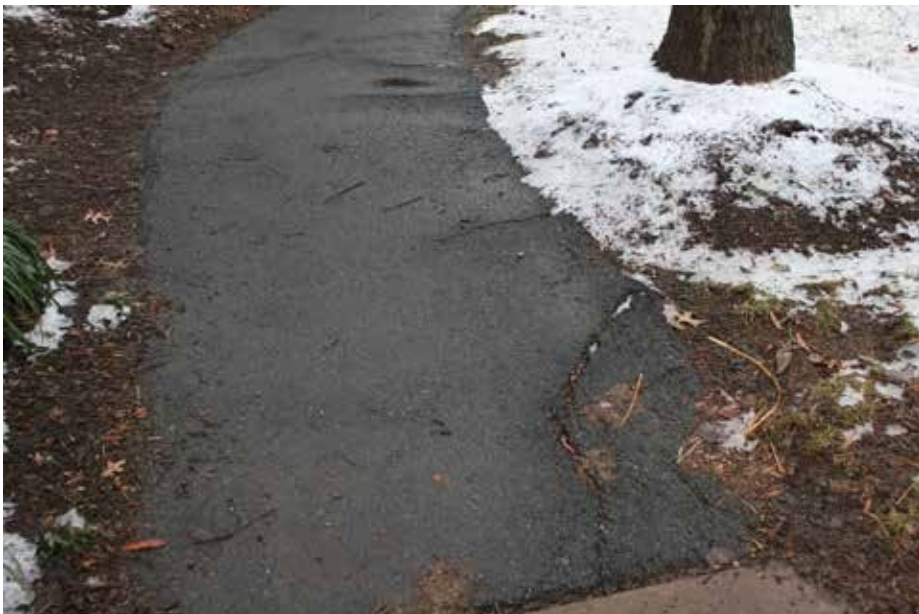
PHOTO #9
This is an example of typical tree root damage to footpaths. Eventually the heaves become tripping hazards and the roots must be removed before new pavement is installed.

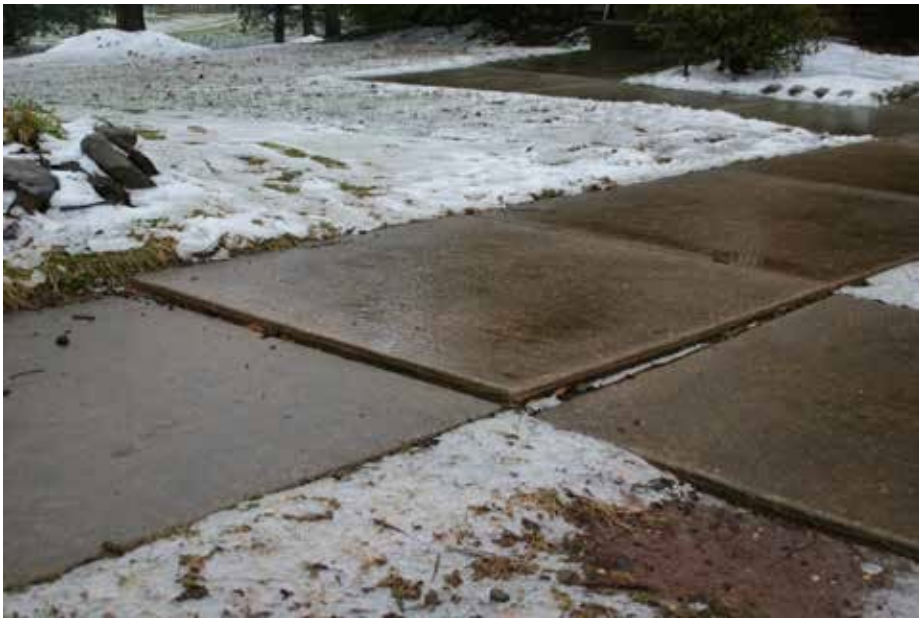
PHOTO #10

This is the worst of only a few heaved sidewalk panels. This is an obvious tripping hazard requiring replacement near-term.

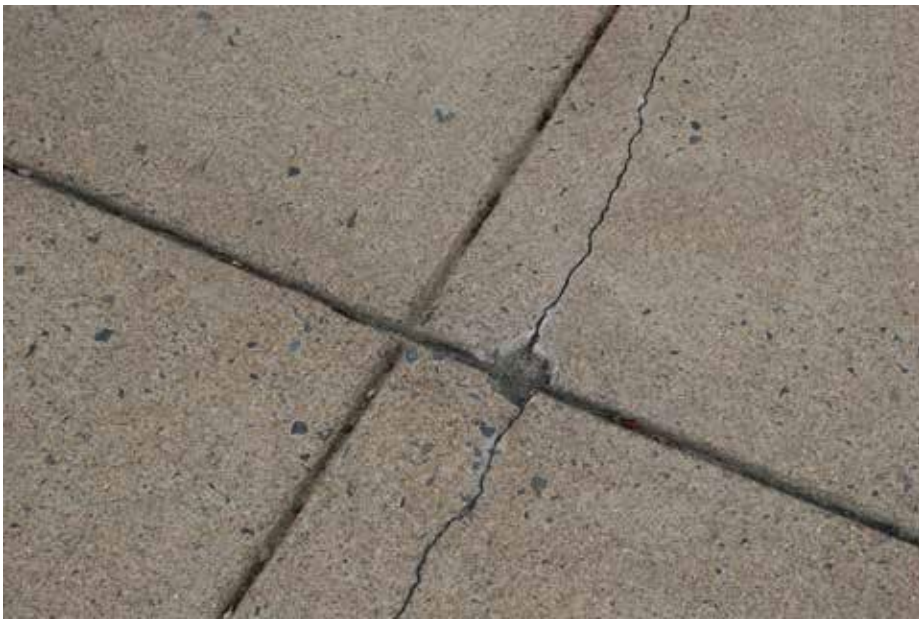
PHOTO #11

This crack is still quite tight and probably not at the point to justify the expense of replacement.

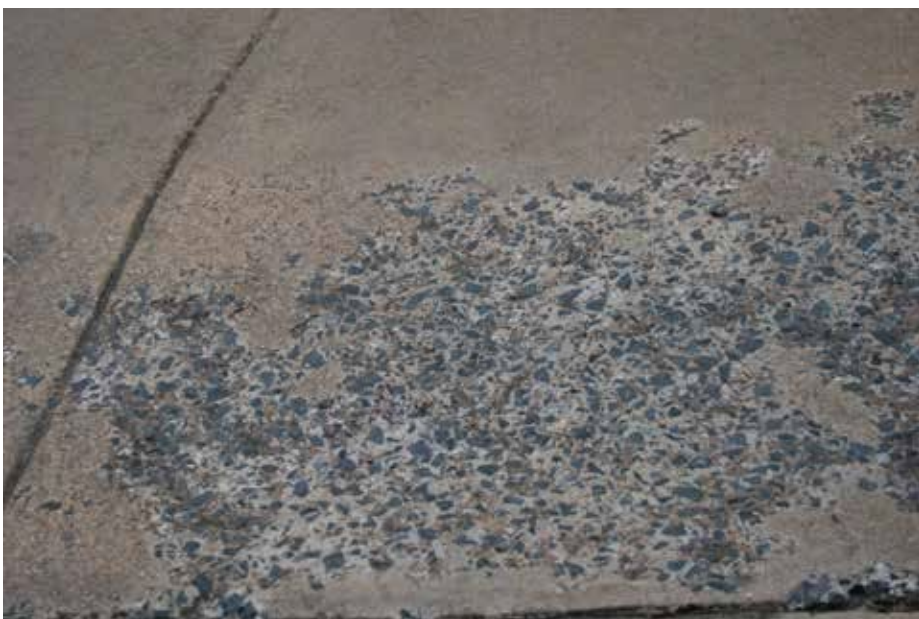
PHOTO #12

Concrete surface scaling is the result of many factors including ice melt chemicals. While unsightly, it is not usually problematic until the surface is deteriorated enough to become a potential tripping hazard.

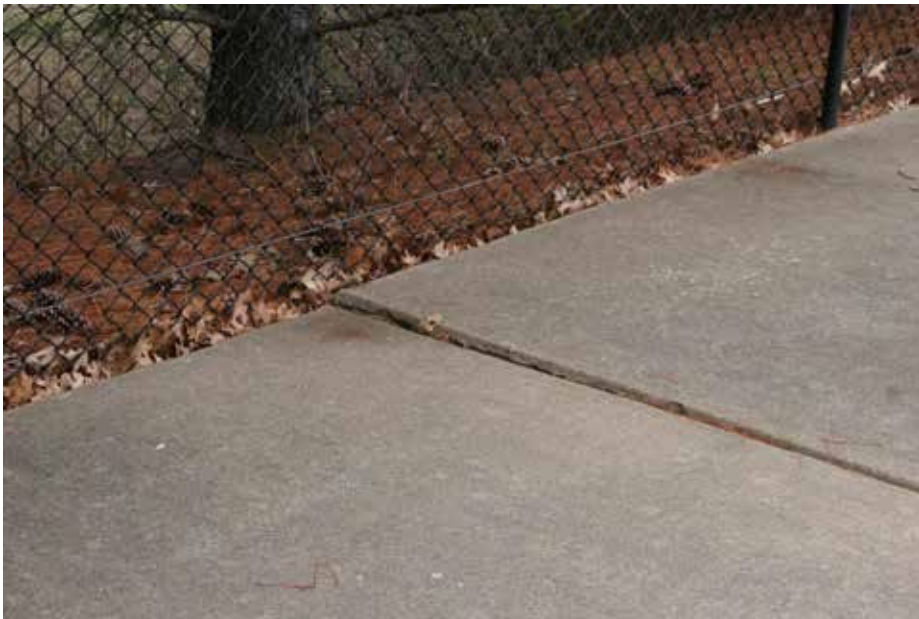
PHOTO #13

This potential tripping hazard is located in a remote part of the pool deck. Pool deck repairs are scheduled in 2016 and this will be one of the deficiencies addressed at that time.

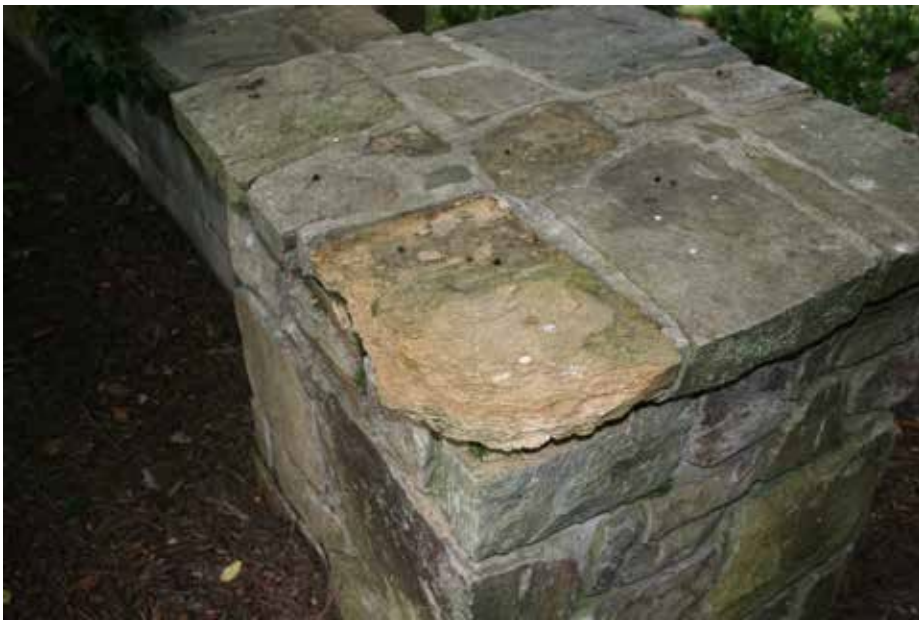
PHOTO #14

The monuments have always been considered permanent structures requiring periodic maintenance under operations. We observed a few highly fissile stones that are deteriorating and should be replaced along with minor mortar replacement on the top surface.

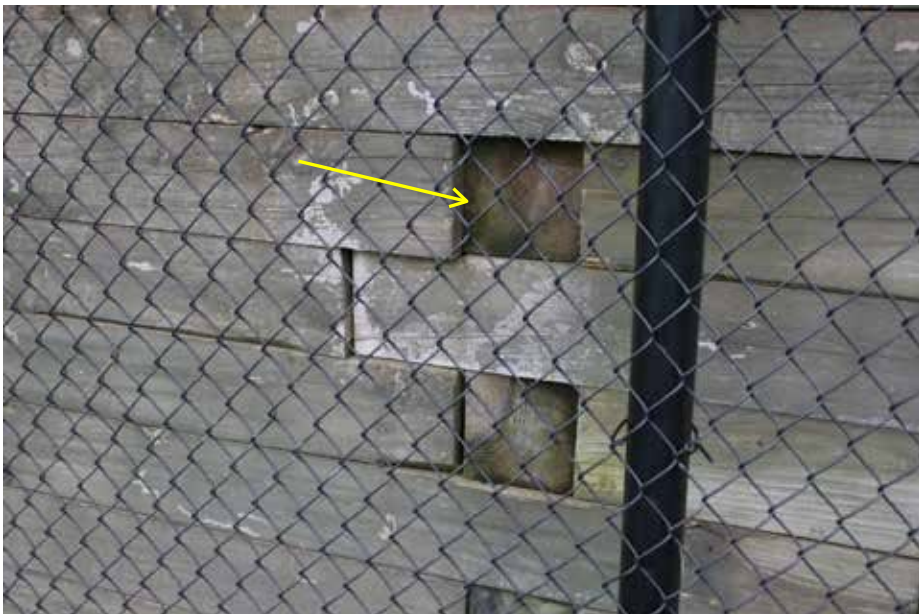
PHOTO #15

The pressure-treated timber retaining wall adjacent to the Community Center tennis court is continuing to deflect as evidenced by the reveal at the deadmen anchors. Due to location, this will be a difficult replacement. The structure should be capable of a few additional years of service, but should be monitored for movement.

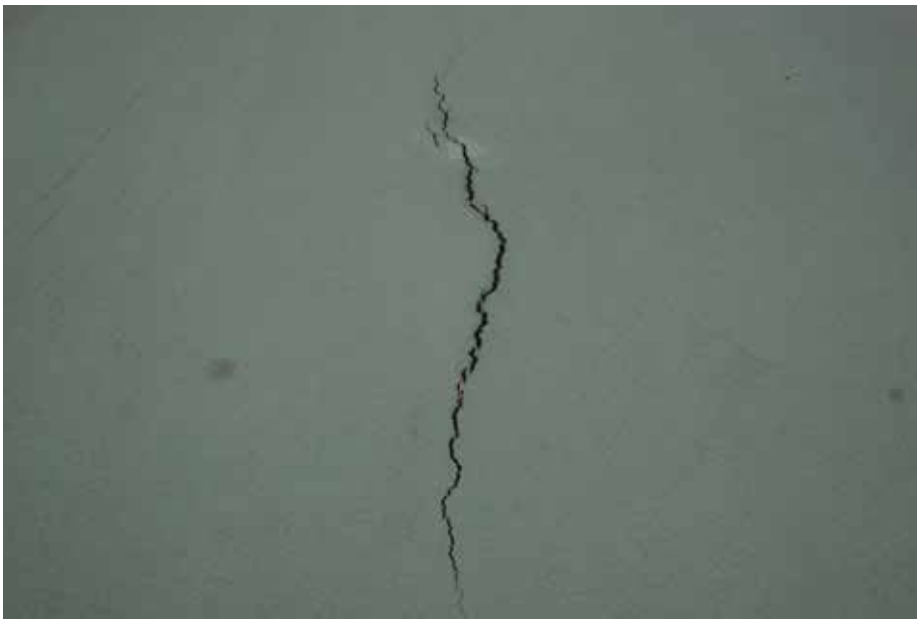
PHOTO #16

The cracking at the Community Center tennis court has reappeared or continues in spite of the 2007 engineered repairs to the supporting masonry retaining wall. The cracks should be patched as part of the next color coat temporarily until the court is fully restored in 2018.

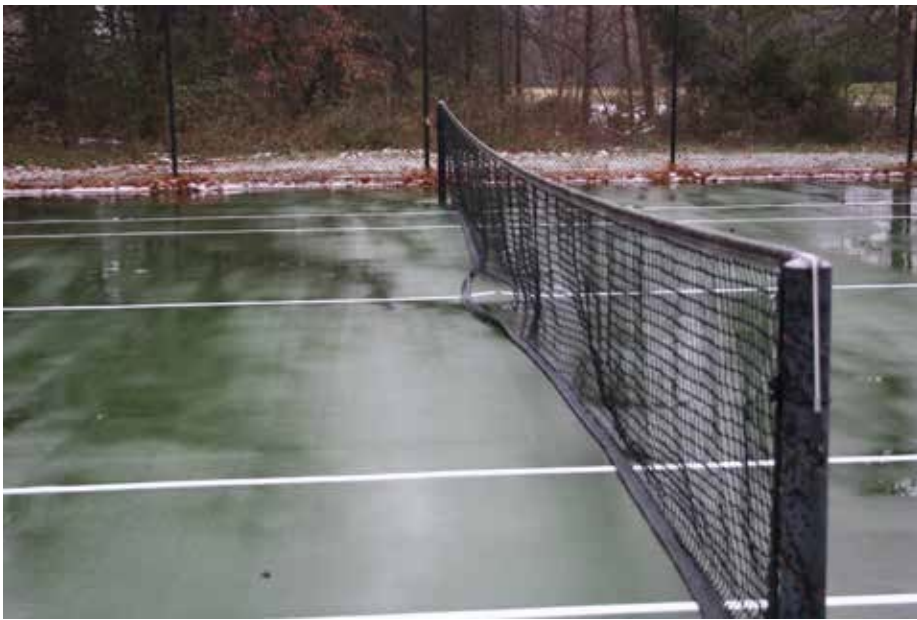
PHOTO #17

The Section 4 tennis court is in continuing good condition with no significant deficiencies currently. Though the color coat is older and somewhat faded, it is still serviceable with newly applied striping.

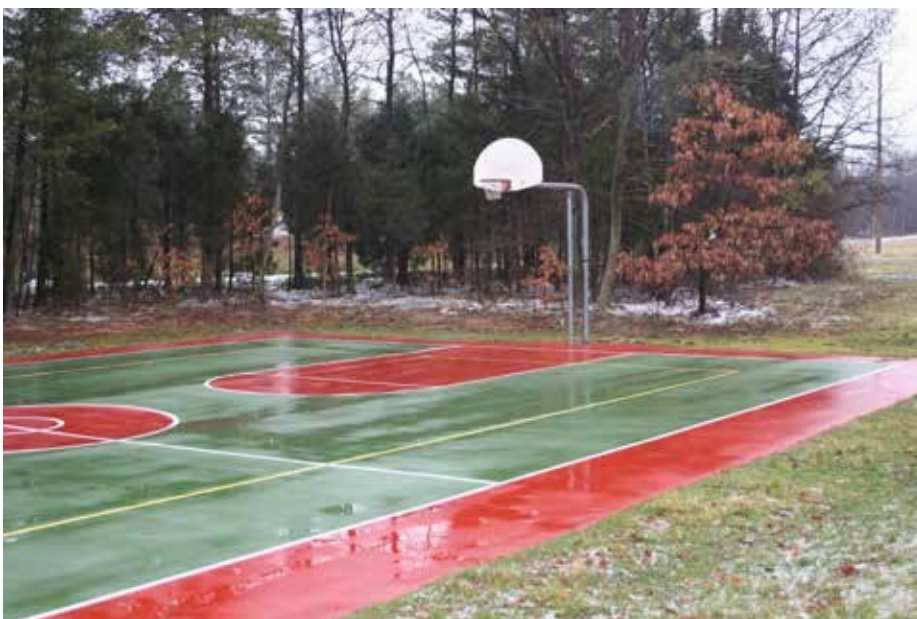
PHOTO #18

The multi-purpose court was converted to a basketball court as part of a full restoration in 2011 including drainage improvements.

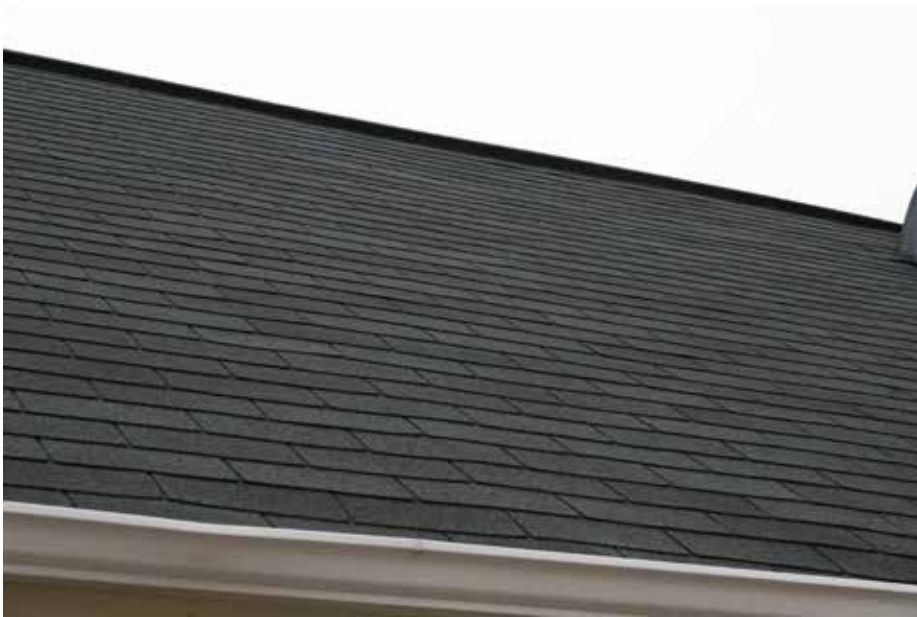
PHOTO #19
The asphalt shingle roofing appears to be in continuing good condition with no significant deficiencies observed.

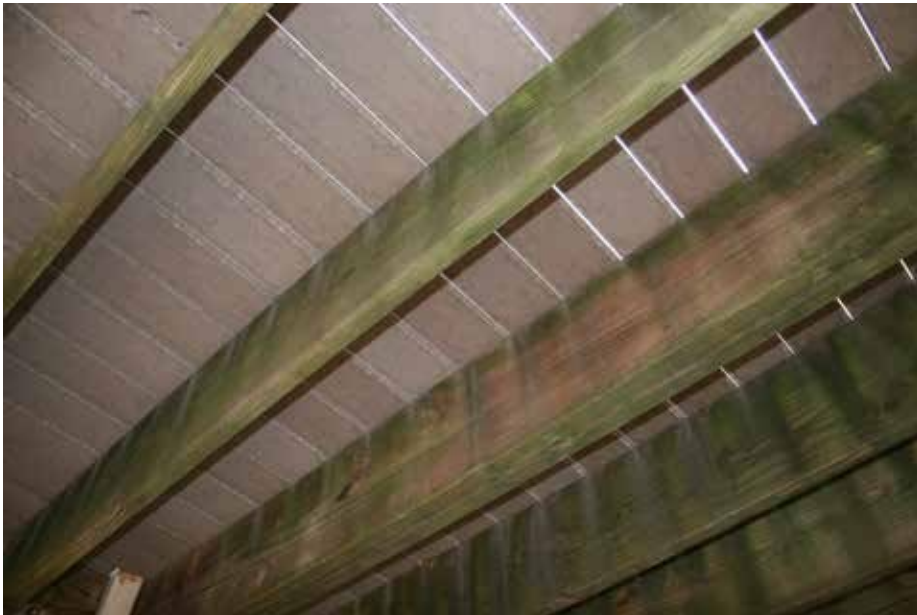
PHOTO #20
The Community Center wood decking was replaced with composite decking in 2009. Eventually, the pressure-treated wood joists supporting it will require replacement, but the decking may be re-useable at that time.

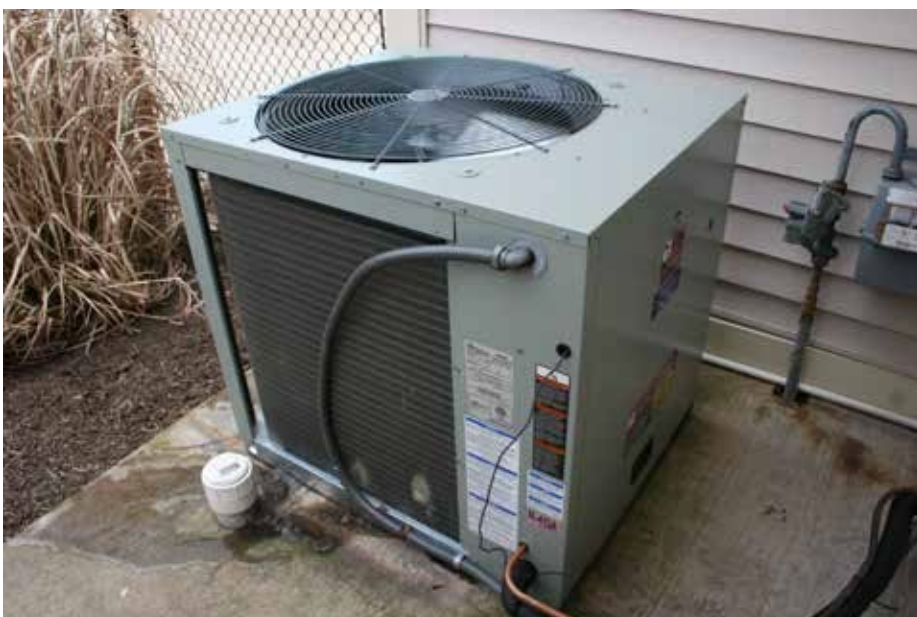
PHOTO #21
The condenser and air handler of HVAC Unit #3 was replaced in 2011. Its sister Unit #1 is still operating.

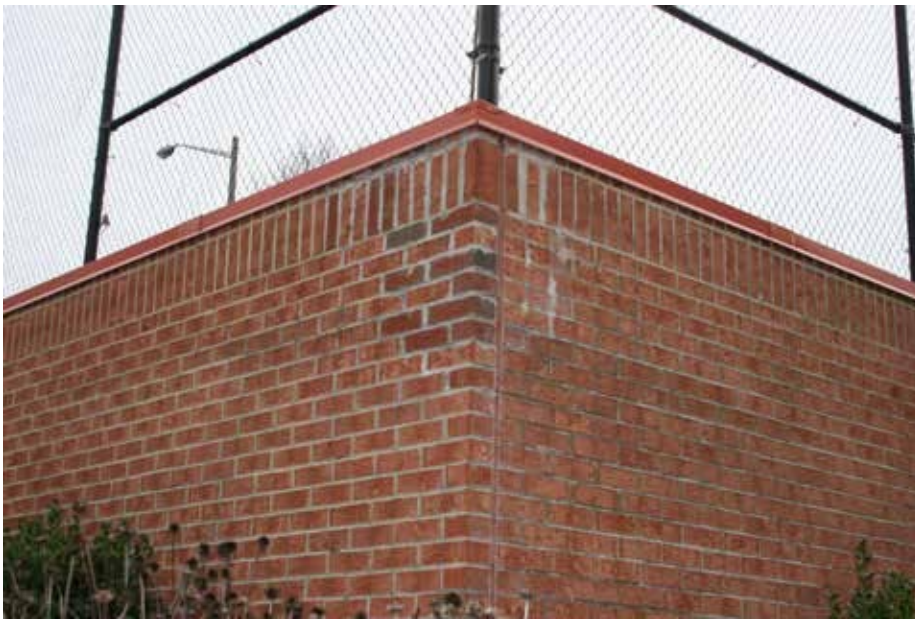
PHOTO #22
The 2007 recommended engineered repairs to the masonry retaining wall appear to have been successful.

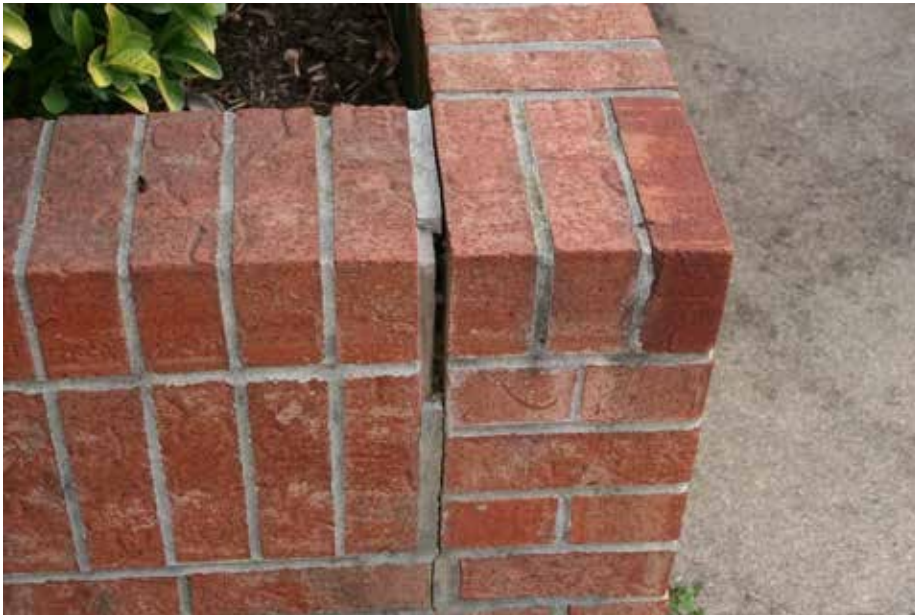
PHOTO #23
Additional tuckpointing and masonry repairs/waterproofing of planters will be necessary on an on-going basis, and we have programmed the component accordingly.

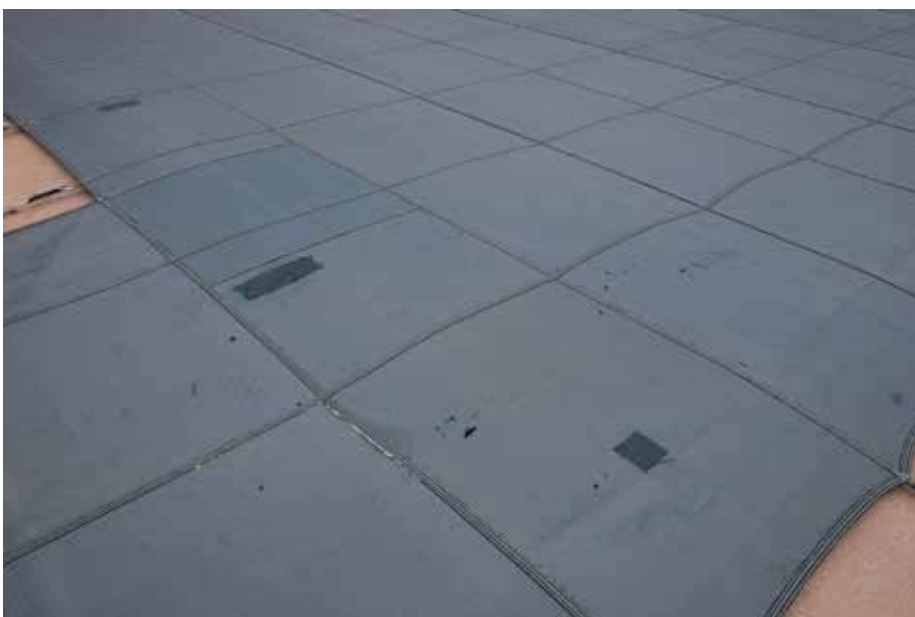
PHOTO #24
The pool cover is aging and tired. We have scheduled replacement in 2013.
