Condition Assessment
&
Reserve Fund Plan
2015
Sample Townhomes

Manassas, Virginia

RE: **CONDITION ASSESSMENT AND RESERVE FUND PLAN 2015**
Sample Townhomes Homeowners Association
Manassas, Virginia
Project No. 88888

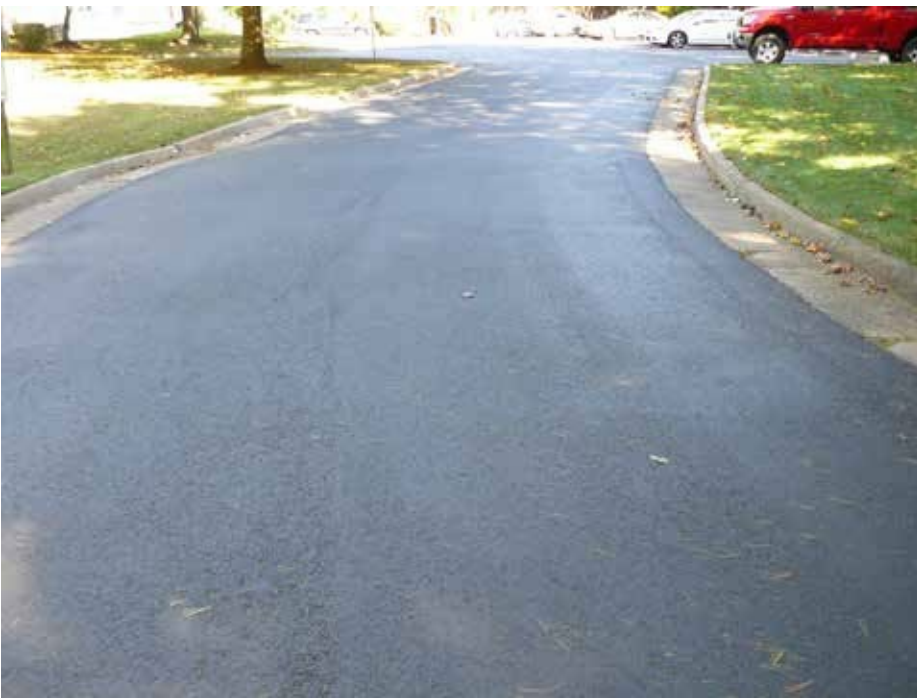
PHOTO #1
All five drivelaners are in overall good condition. No major deflection was observed.

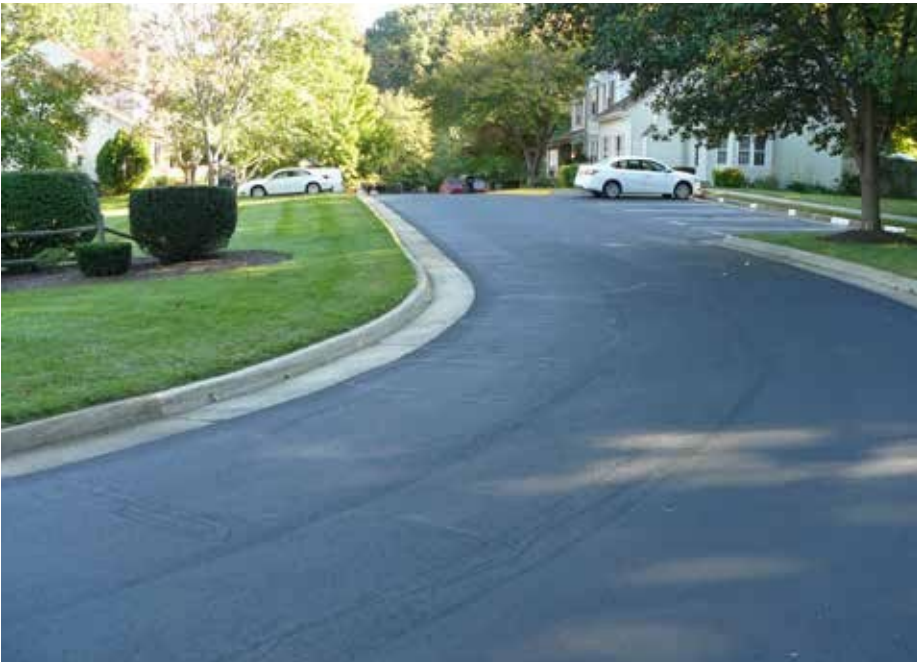
PHOTO #2
All streets have received crack filling, seal coating, and restriping in the last three years.

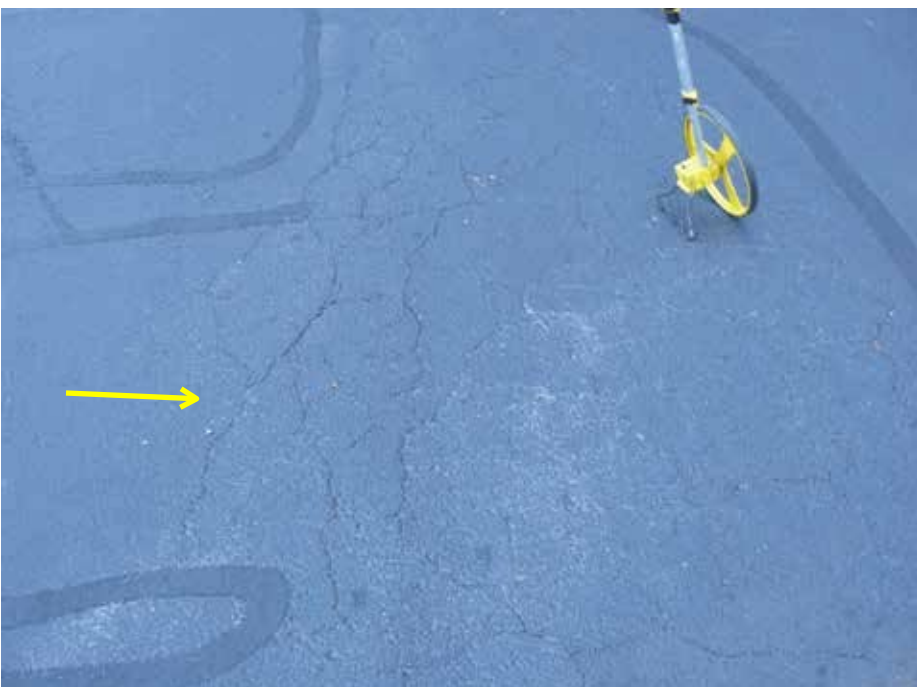
PHOTO #3
A minor amount of deflected cracking was observed. These areas should receive full-depth repair during the next pavement maintenance cycle.

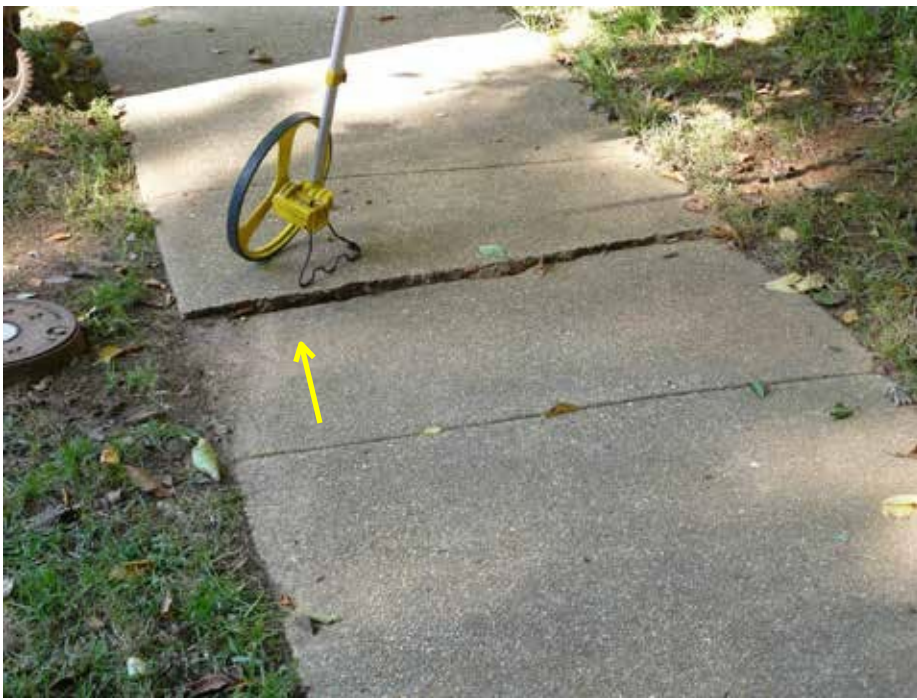
PHOTO #4
A few concrete sidewalk panels have cracked and settled. These are potential tripping hazards. These deficient sections of concrete should receive cyclic near-term repair.

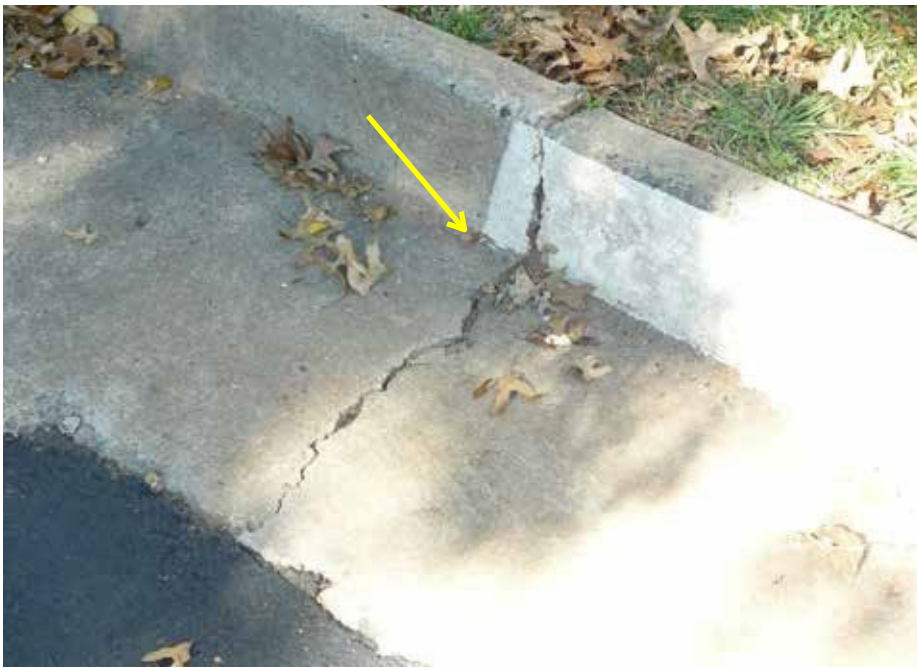
PHOTO #5
A few of the concrete curb and gutter sections have also cracked and settled, requiring near-term replacement.

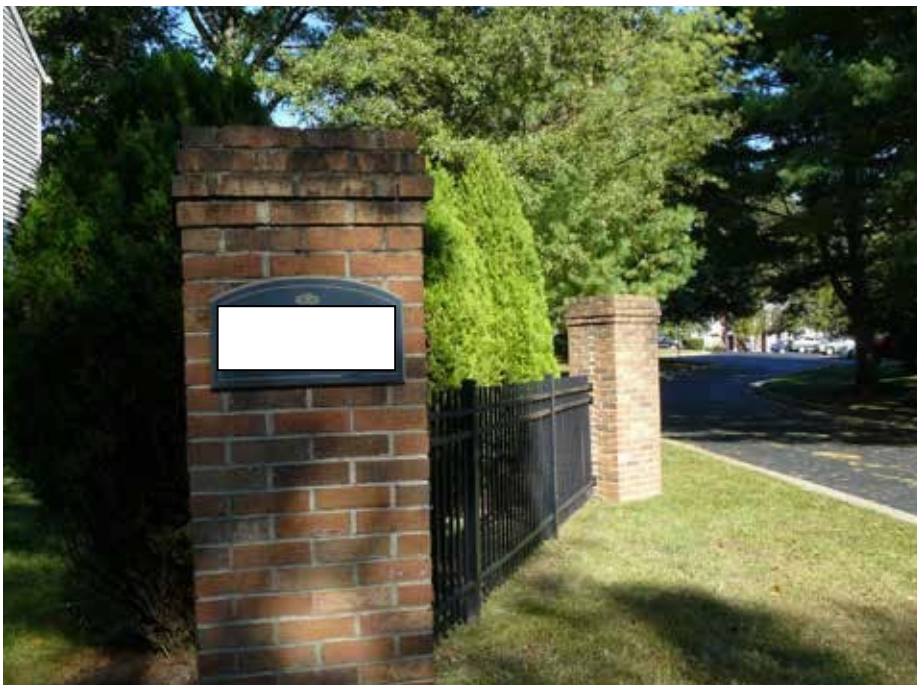
PHOTO #6
The two brick and mortar entrance monuments on Hot Lane are in good condition for their age. Maintenance such as pressure-washing and eventual tuckpointing will help to extend their service life.

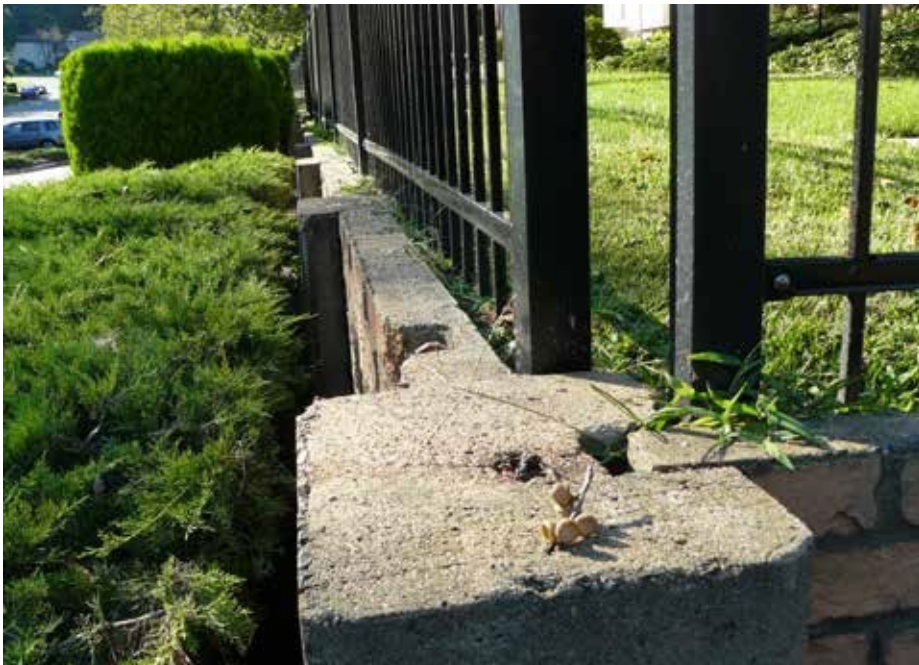
PHOTO #7

The concrete retaining walls constructed in front of several townhomes on Cold Drive are pre-cast panels, supported by cast in place concrete forms. The retaining walls are in good condition with no deflection observed.

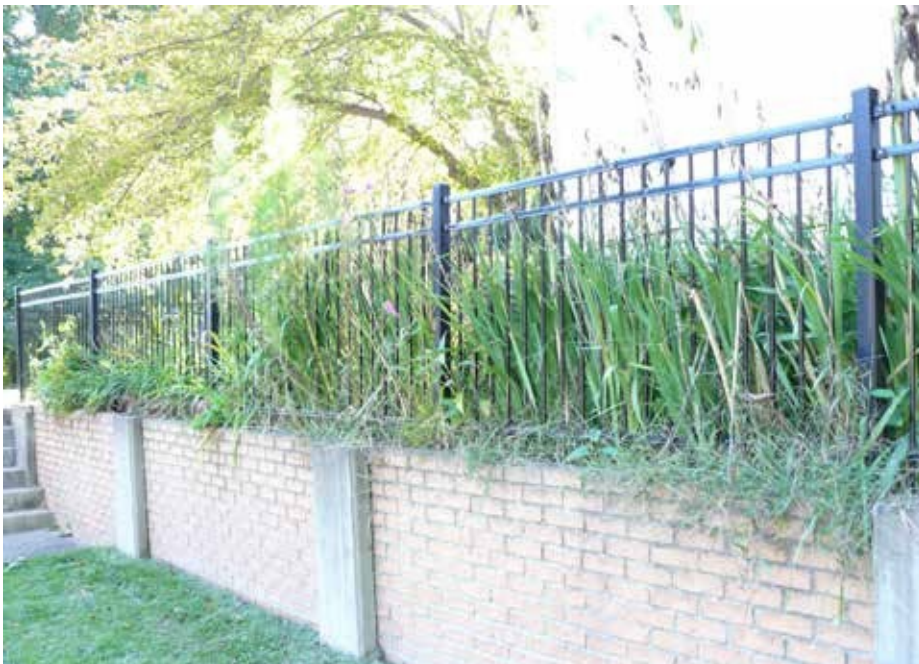
PHOTO #8

The metal railing installed for safety above the retaining wall is also in good condition.

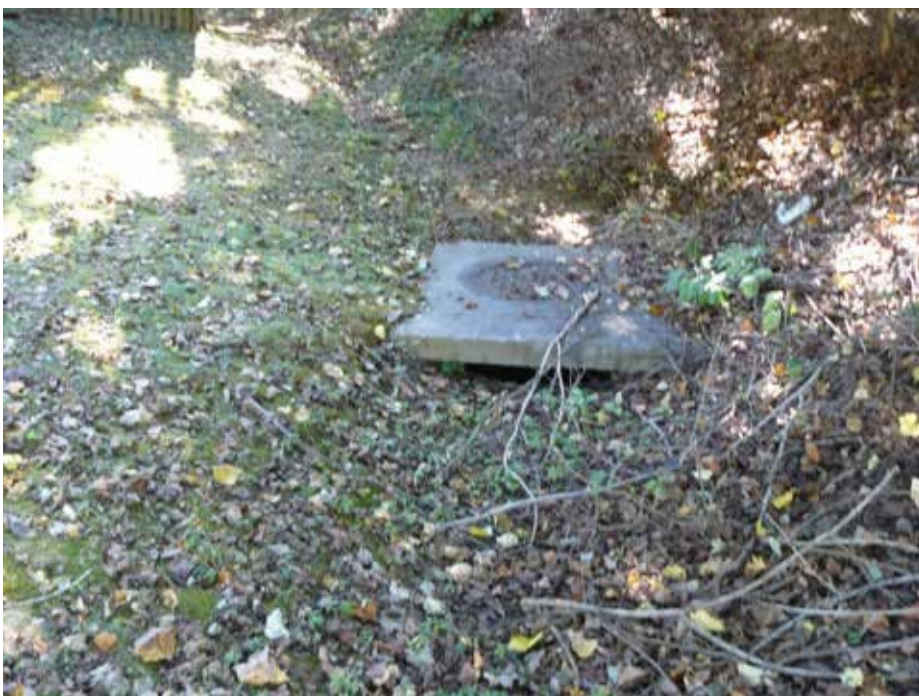
PHOTO #9

Several curb drop inlets and concrete yard drains were observed, which should be kept clear of debris for proper drainage.
